**THE SHELL PETROLEUM DEVELOPMENT COMPANY OF NIGERIA LIMITED.**

JOINT INVESTIGATION REPORT FOR INCIDENT NO: 1182492(B) JIV report S/N: 0531

1. Spill incident Number: 1182492(B) 2. Type of incident\* OIL SPILL  
 3. Name of Location SOKU WELL 48L WELL HEAD SLOT.  
 4. Name of nearest community RUSSIA 5. State: RIVERS 6. LGA AKUKU - TORU  
 7. Type of Production facility/Installation WELL HEAD 8. Asset owner/District SWAMP1/SOKU.

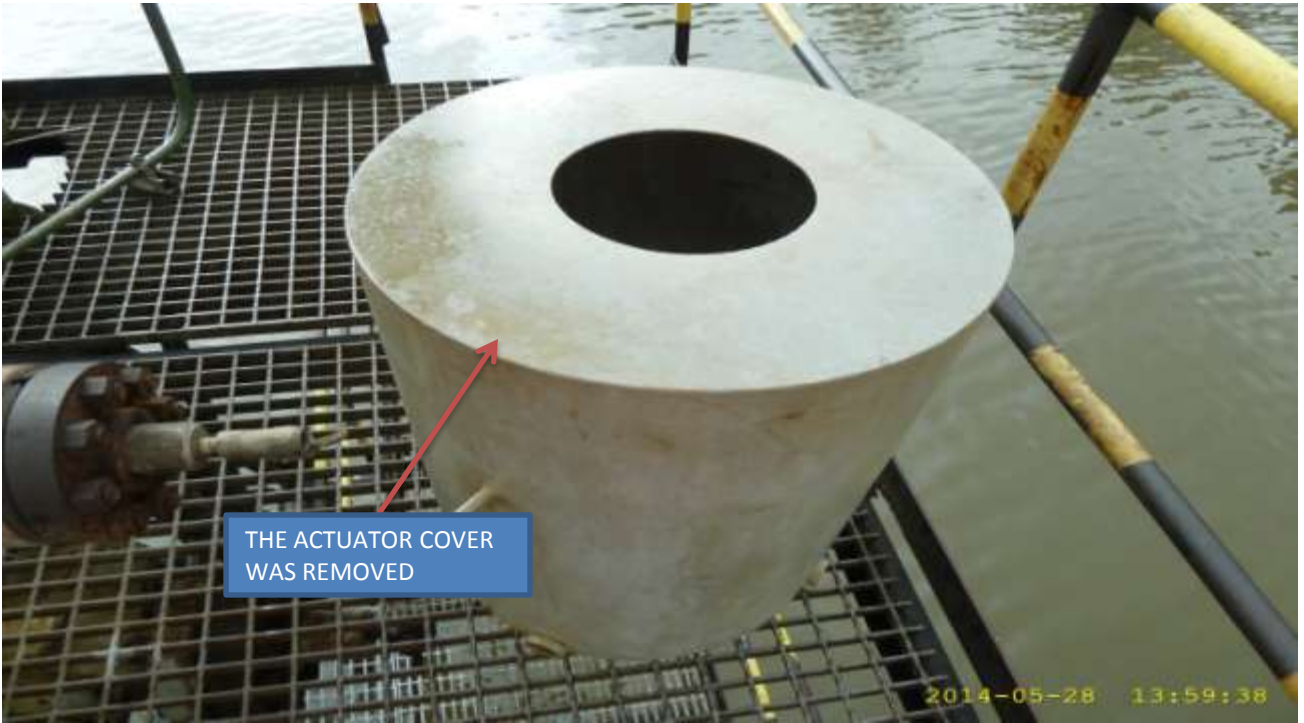
| <input type="checkbox"/> Relief valve failure | <input checked="" type="checkbox"/> Others (specify) <u>THE ACTUATOR COVER WAS REMOVED</u> | |

- f. Incident caused by: AND BEAM BOX VALVE WAS TAMPERED
- Third party interference (Sabotage ; crude theft ; Line theft ; Accidental 3<sup>rd</sup> party damage   
 Operational  Others (including Mystery spills) \_\_\_\_\_

**BELOW IS PICTORIAL VIEW OF SOKU WELL 48L WELL HEAD AT RUSSIA  
SHOWING THIRD PARTY TAMPERING WITH WELLHEAD**

REPAIR WORK, PLANNED

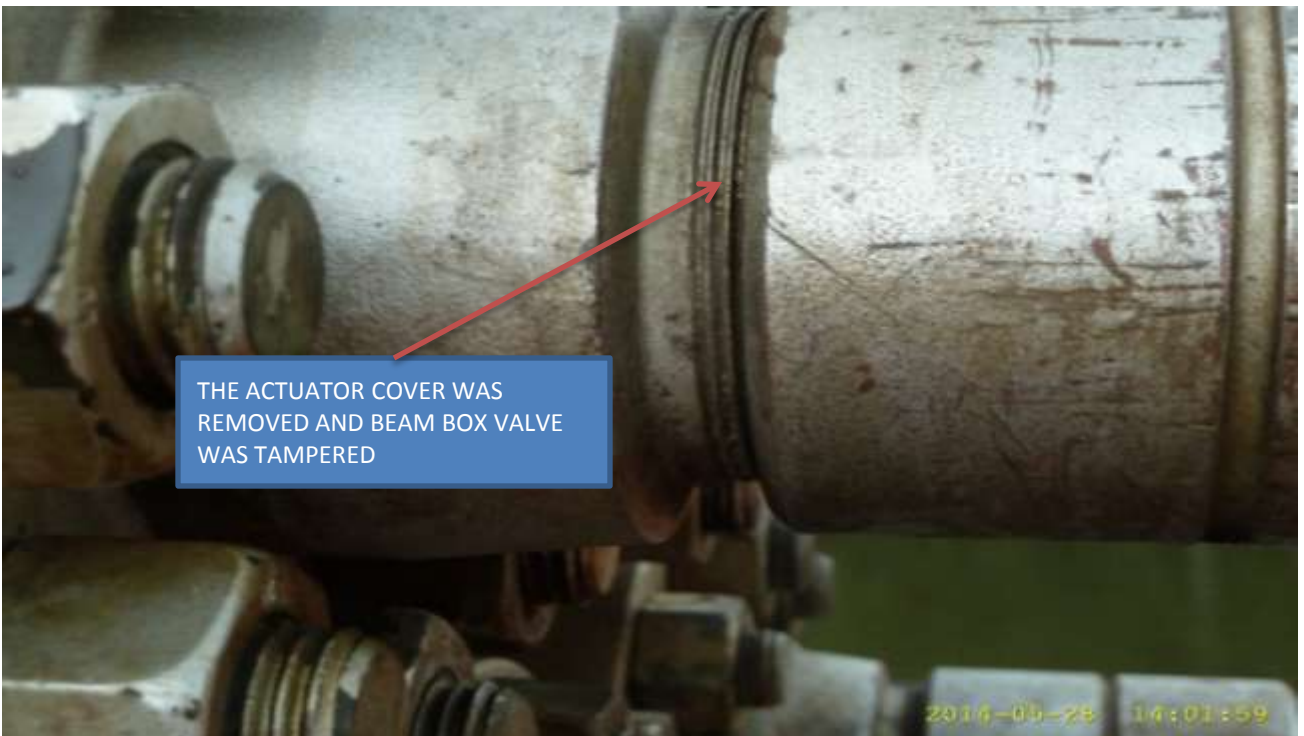
**BELOW IS PICTORIAL VIEW OF SOKU WELL 48L WELL HEAD AT RUSSIA  
SHOWING THIRD PARTY TAMPERING WITH WELLHEAD**
