THE SHELL PETROLEUM DEVELOPMENT COMPANY OF NIGERIA LIMITED.

JOINT INVESTIGATION REPORT FOR INCIDENT NO: 1171045 JIV report S/N: 0568

1. Spill incident Number: 1171045 2. Type of incident* OIL SPILL
 3. Name of Location BENISEDE - AKONO WELL - 1S FLOWLINE
 4. Name of nearest community OJODO 5. State: BAYELSA 6. LGA EKEREMOR
 7. Type of Production facility/Installation FLOWLINE 8. Asset owner/District SWAMP WEST/BENISEDE

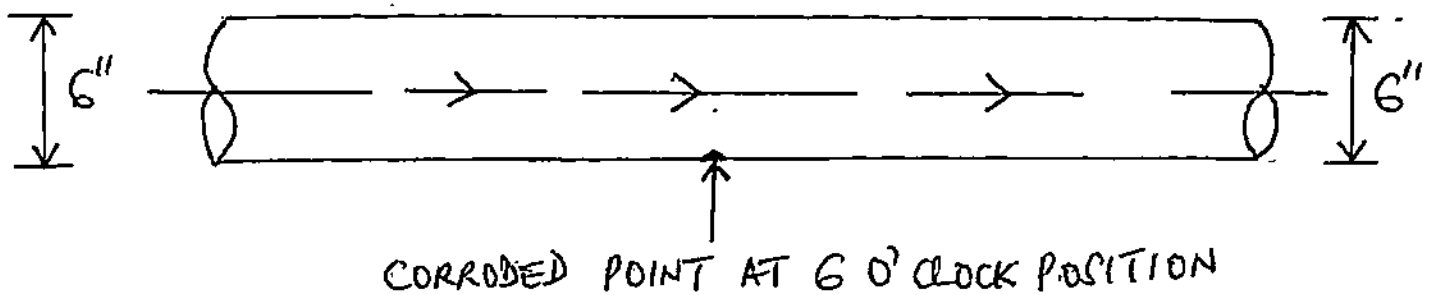
Additional observations around the spill point: THE SPILL POINT WAS SUBMERGED IN WATER.

| <input checked="" type="checkbox"/> Corrosion | <input type="checkbox"/> Saver-pit over flow, | <input type="checkbox"/> Surge vessel overflow, |

SECTION OF 6" BENUEFEDE - AKONO WELL - 1'S FLOWLINE AT OJOBO
SHOWING CORRODED POINT AT 6 O'CLOCK POSITION

If yes to item 14, give brief description: REPAIR IS BEING PLANNED BY ASSET ENGINEERING.

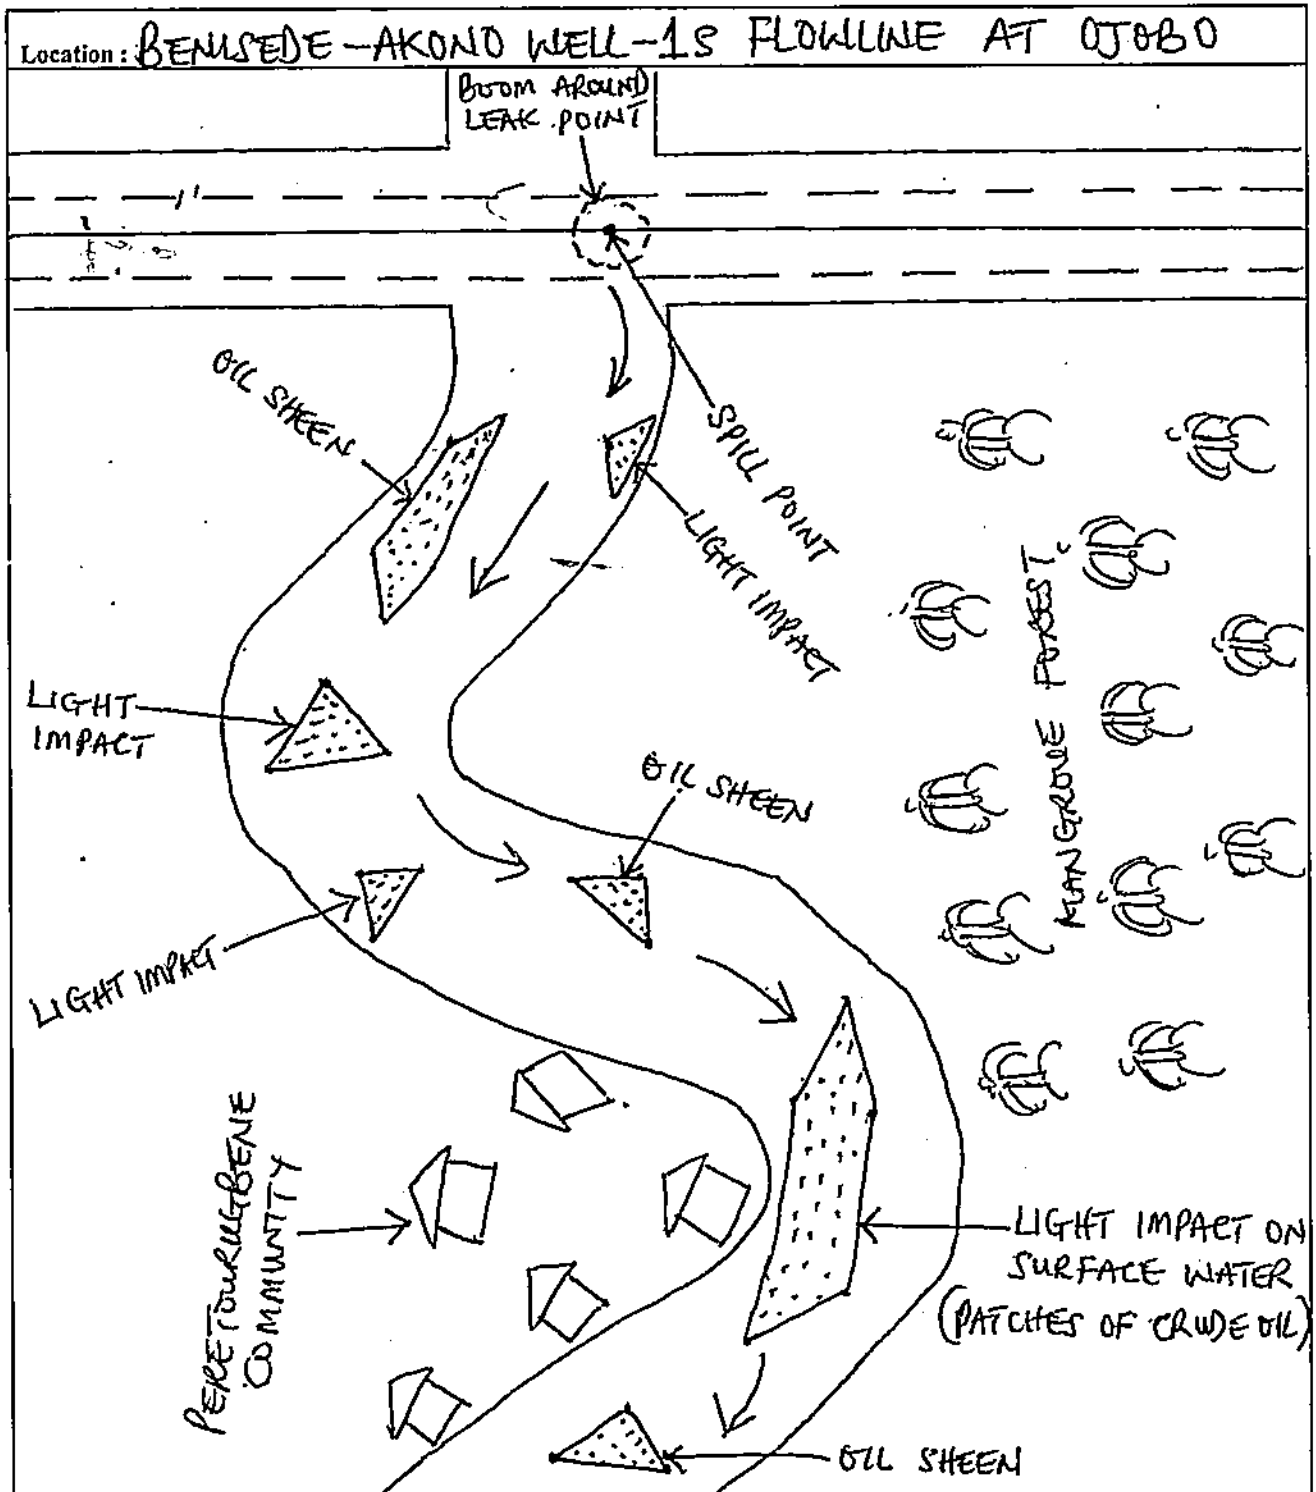
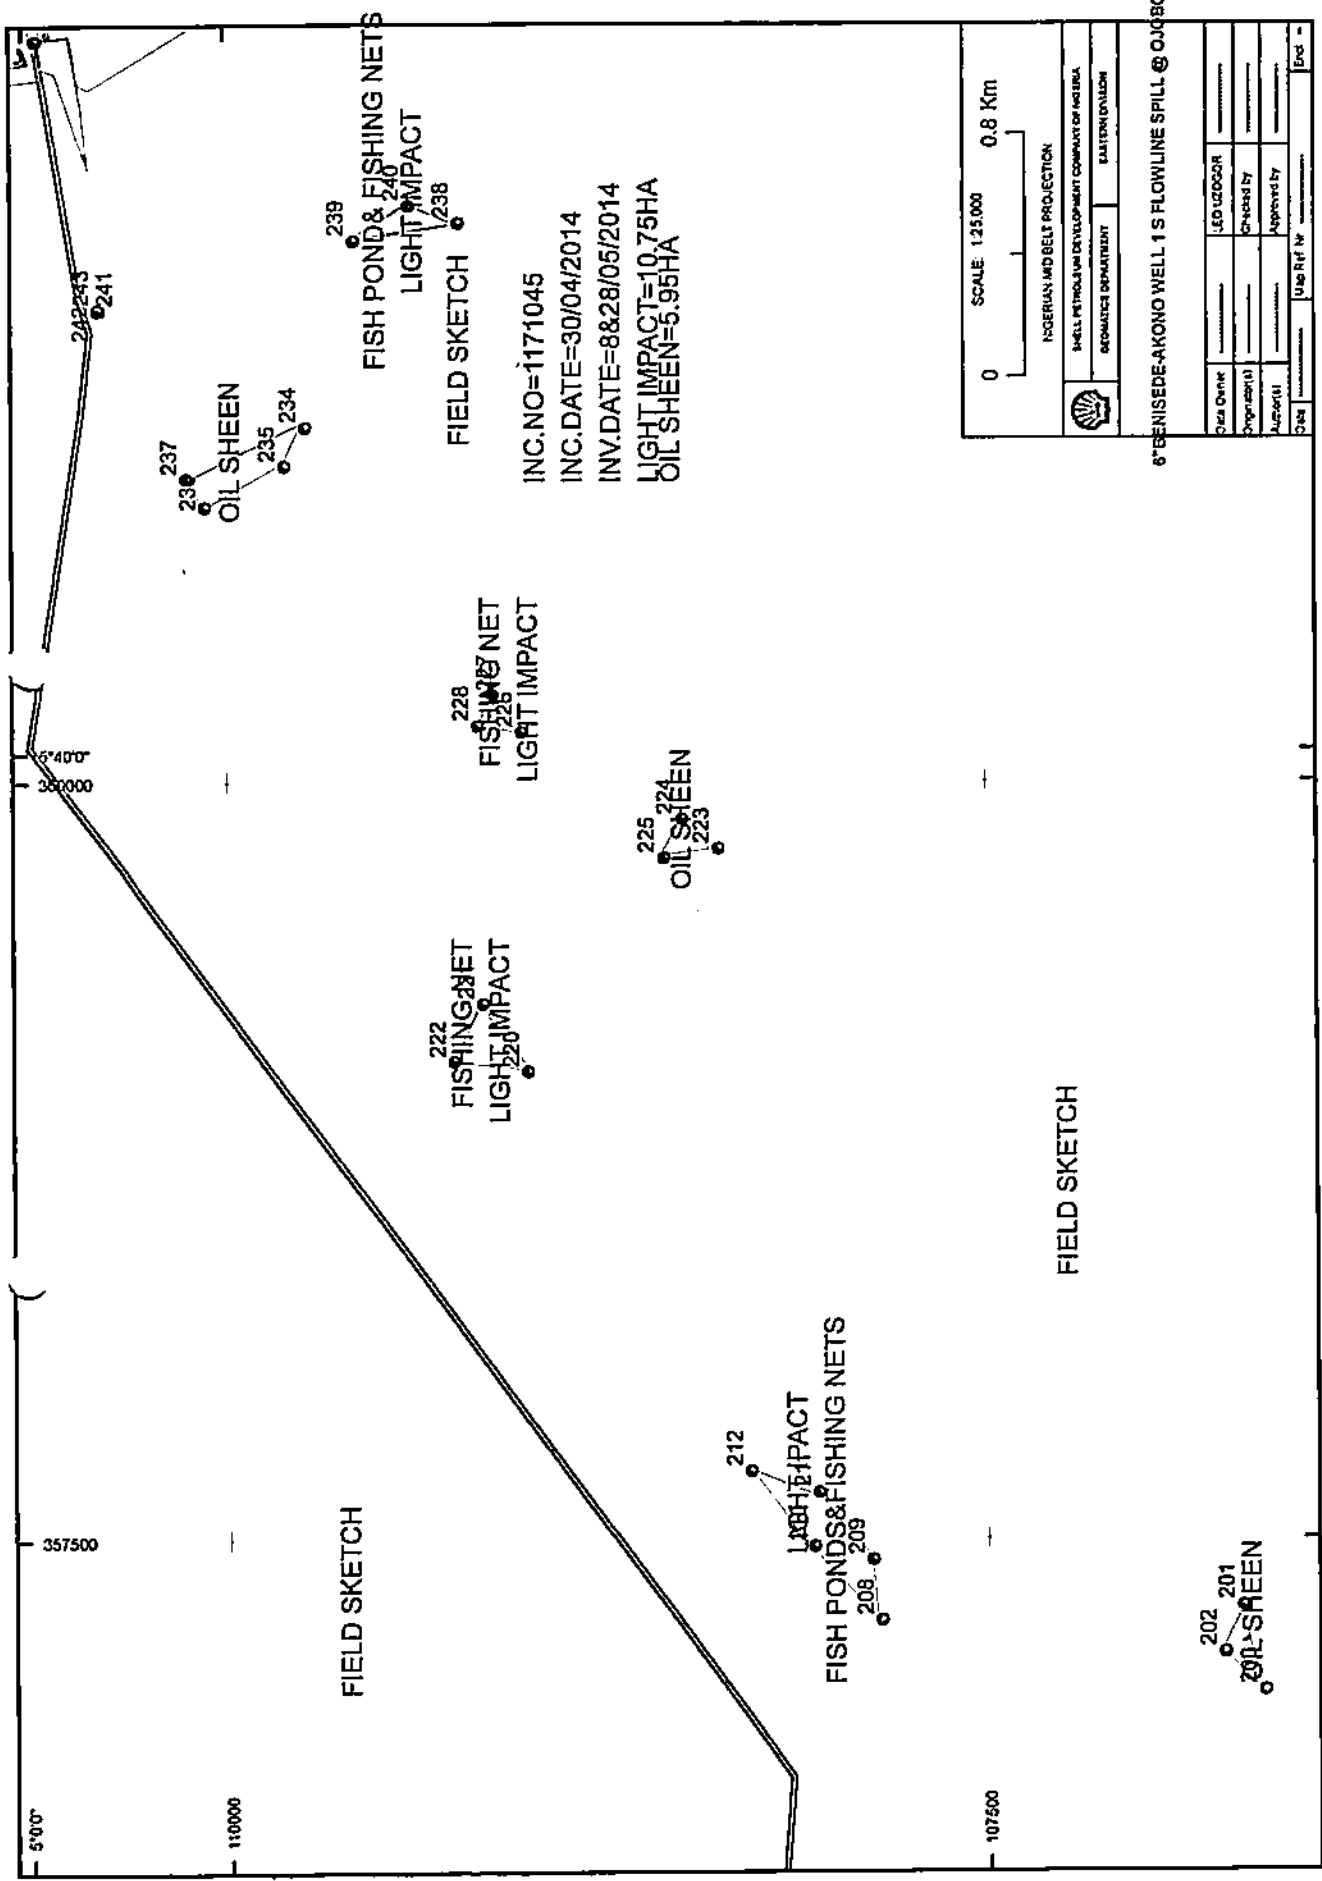
25. Appendix 1: Overview sketch of the site

6" BENISEDE-AKONO WELL 1 S FLOWLINE SPILL @ OJORO
