THE SHELL PETROLEUM DEVELOPMENT COMPANY OF NIGERIA LIMITED.

JOINT INVESTIGATION REPORT FOR INCIDENT NO: 1293461 JIV report S/N: 00621

1. Spill incident Number: 1293461 2. Type of incident* OIL SPILL
 3. Name of Location TUNU WELLHEAD - 4L/S
 4. Name of nearest community BILABIRI 5. State: BAYELSA 6. LGA EKEREMOR
 7. Type of Production facility/Installation WELLHEAD 8. Asset owner/District SWAMP WEST/TUNU

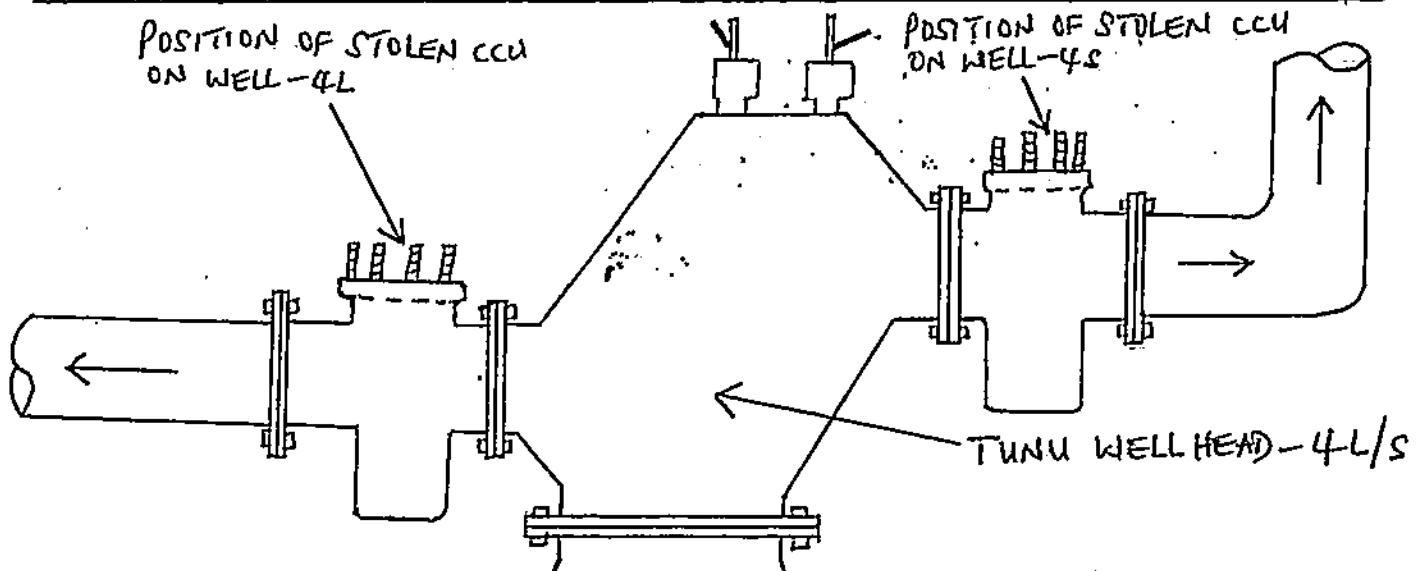
Additional observations around the spill point: UPON INVESTIGATION, THE JIT OBSERVED THAT THE CAMERON CONTROL UNITS ON BOTH TUNU WELLHEAD - 4L AND 4S WERE REMOVED (STOLEN) BY UNKNOWN PERSONS.

| <input type="checkbox"/> Relief valve failure | <input checked="" type="checkbox"/> Others (specify) <u>THEFT OF WELL HEAD CAMERON CONTROL UNITS.</u> | <input type="checkbox"/> Cold vent |

SECTION OF TUNU WELLHEAD-4L/S, SHOWING POSITIONS OF STOLEN CCU

REPAIR IS BEING PLANNED BY ASSET
ENGINEERING.

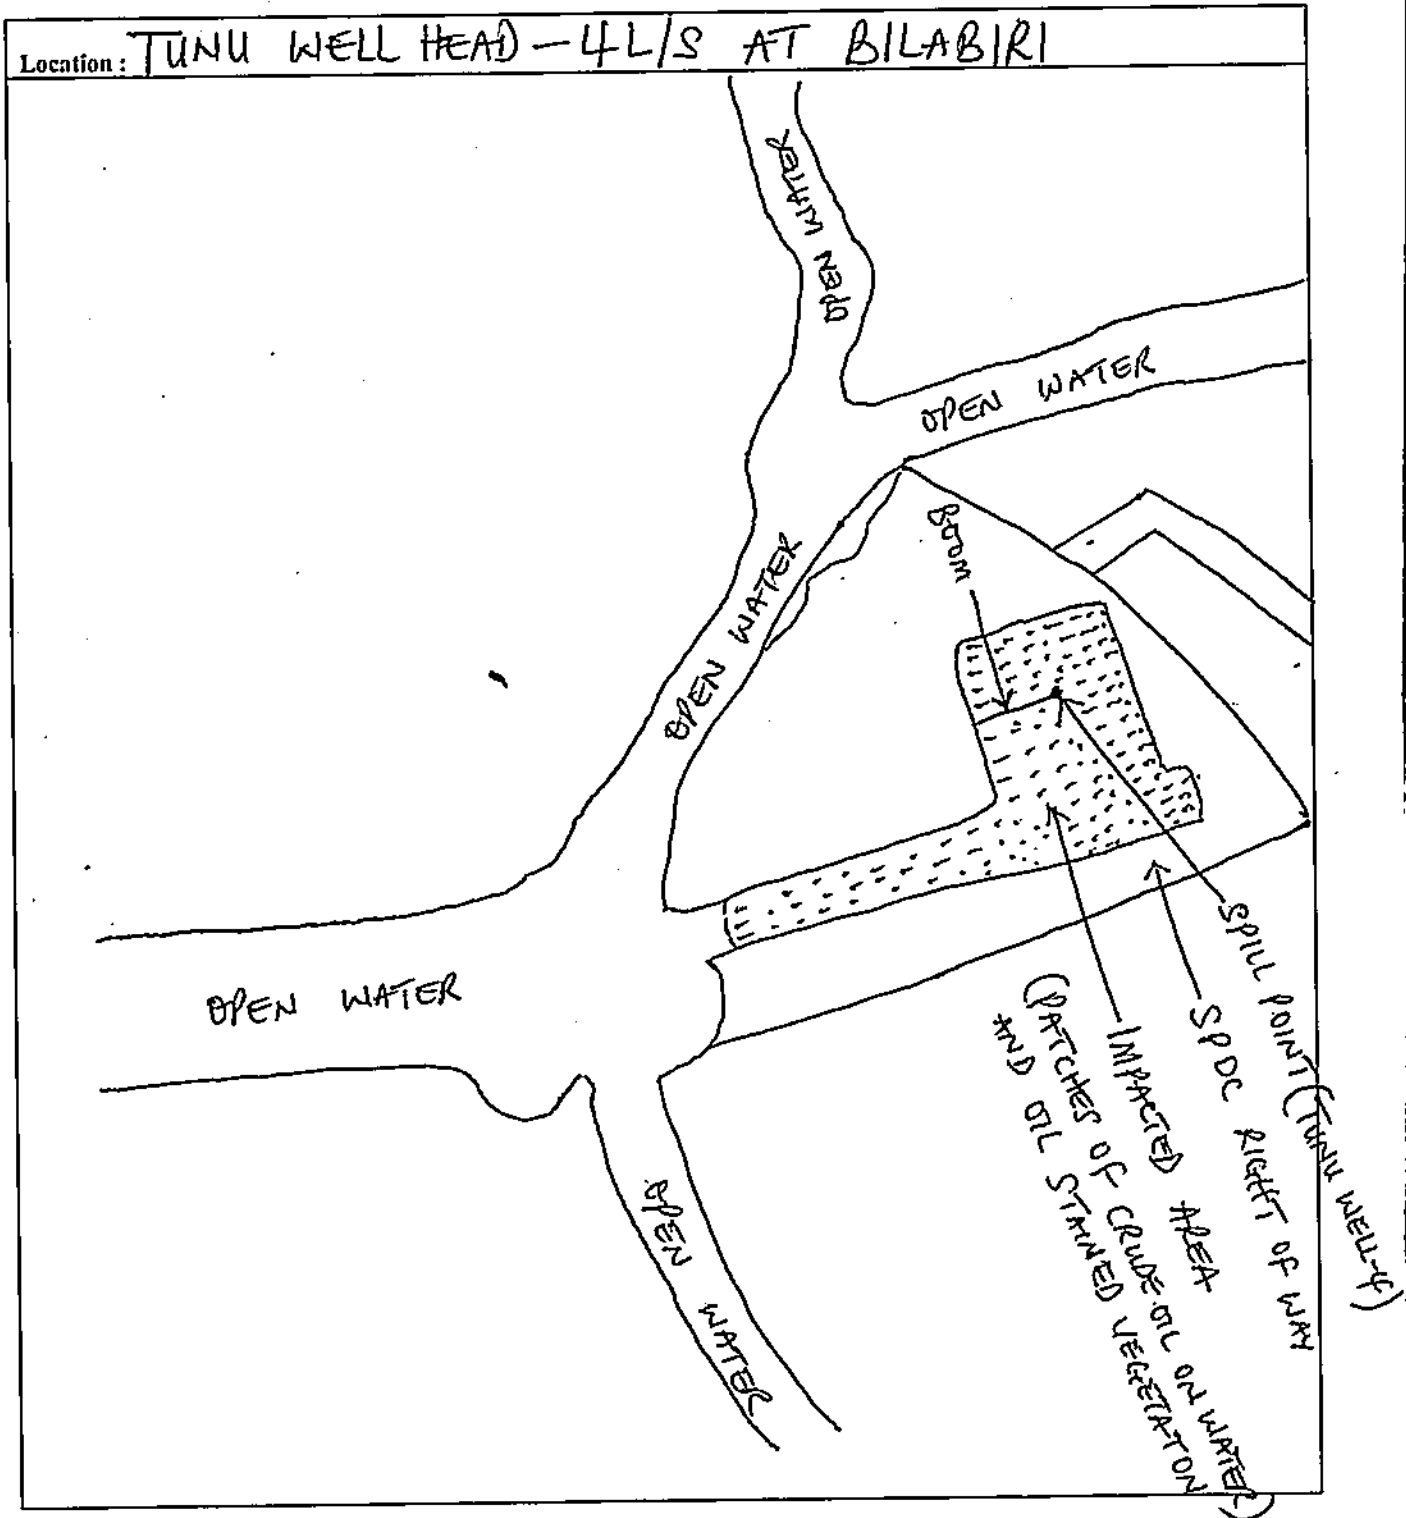
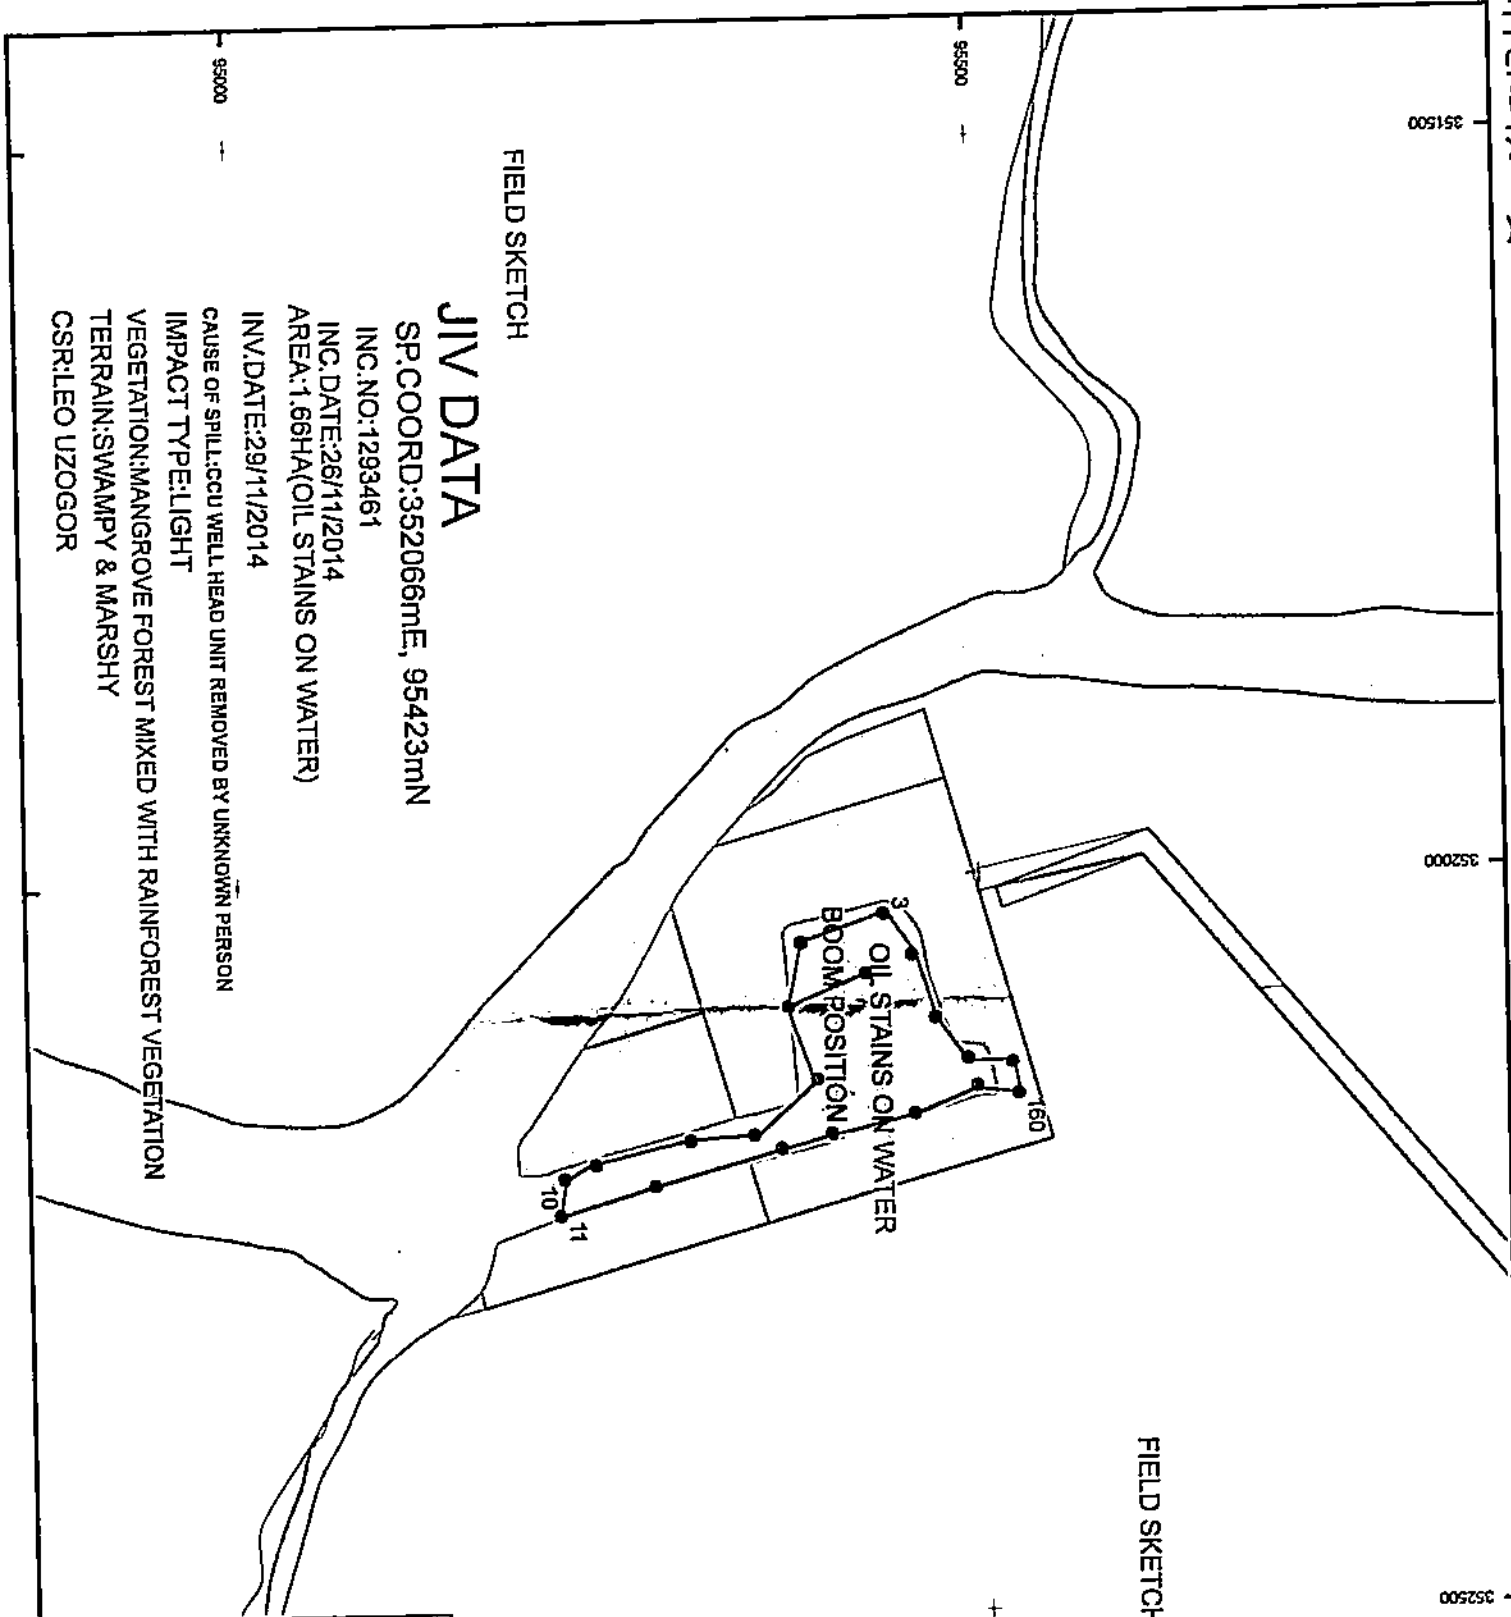
25. Appendix 1: Overview sketch of the site

SP. COORD: 352066mE, 95423mN
 INC. NO: 1293461
 INC. DATE: 26/11/2014
 AREA: 1.66HA (OIL STAINS ON WATER)
 INV. DATE: 29/11/2014
 CAUSE OF SPILL: CGU WELL HEAD UNIT REMOVED BY UNKNOWN PERSON
 IMPACT TYPE: LIGHT
 VEGETATION: MANGROVE FOREST MIXED WITH RAINFOREST VEGETATION
 TERRAIN: SWAMPY & MARSHY
 CSR: LEO UZOGOR
