THE SHELL PETROLEUM DEVELOPMENT COMPANY OF NIGERIA LIMITED.

JOINT INVESTIGATION REPORT FOR INCIDENT NO: 1287500 JIV report S/N: 00167

1. Spill incident Number: 1287500 2. Type of incident* OIL SPILL
 3. Name of Location ALAKIRI WELL 311 WELL HEAD
OFIOMINA - AMA
 4. Name of nearest community ALAKIRI 5. State: RIVERS 6. LGA OKRIKA
 7. Type of Production facility/Installation WELL HEAD 8. Asset owner/District SWAMP I

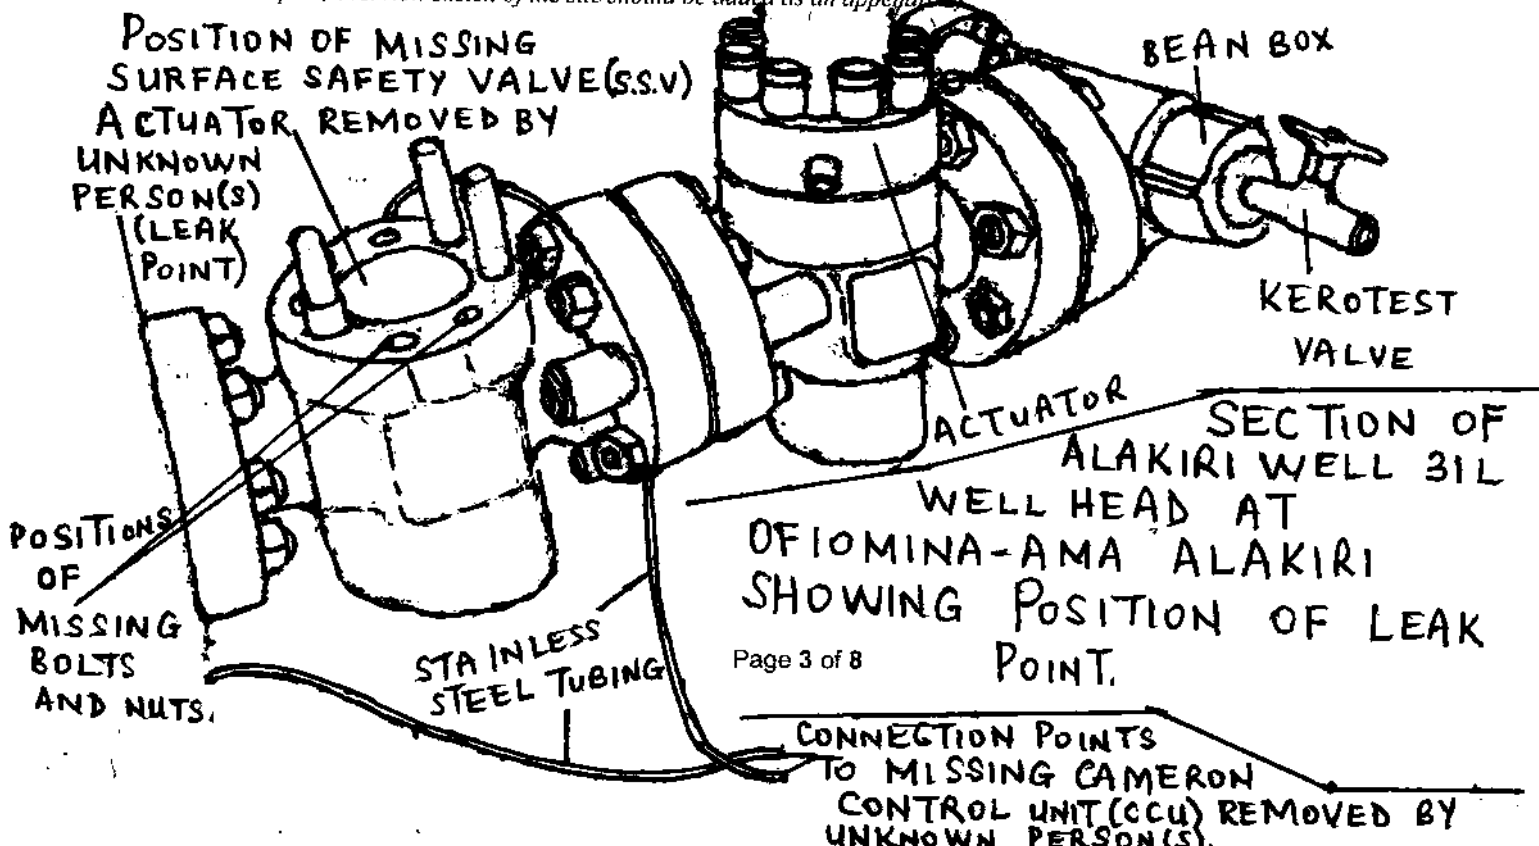
E. GRAPHIC DESCRIPTION OF LEAK POINT (while detail report of the leak point should be contained in the leak report, overview sketch of the site should be added as an appendix 1)

Additional observations around the spill point: **SPILL OCCURRED ON THE WELL 311 ARM OF THE WELL HEAD DUE TO REMOVAL OF THE SURFACE SAFETY VALVE (S.S.V) ACTUATOR (ALONG WITH SOME BOLTS AND NUTS) BY UNKNOWN PERSON(S). THE CAMERON CONTROL UNIT (CCU) WAS OBSERVED ALSO MISSING. SOME CRUDE OIL WAS OBSERVED INTERNALLY AT THE POSITION OF THE MISSING SSV ACTUATOR, HOWEVER, NO RESIDUAL SPILL IMPACT WAS NOTICEABLE**

| <input type="checkbox"/> Relief valve failure | <input checked="" type="checkbox"/> Others (specify) SURFACE SAFETY VALVE (SSV) ACTUATOR AND CAMERON CONTROL UNIT (CCU) REMOVAL BY UNKNOWN PERSON(S). | |
