THE SHELL PETROLEUM DEVELOPMENT COMPANY OF NIGERIA LIMITED.

JOINT INVESTIGATION REPORT FOR INCIDENT NO: 1261785 JIV report S/N: 00727

1. Spill incident Number: 1261785 2. Type of incident* OIL SPILL
 3. Name of Location 10" DIEBU CREEK - NUN RIVER PIPELINE
 4. Name of nearest community OPOROMIA 5. State: BAYELSA 6. LGA SOUTHERN IJAW
 7. Type of Production facility/Installation OIL PIPELINE 8. Asset owner/District PIPELINE

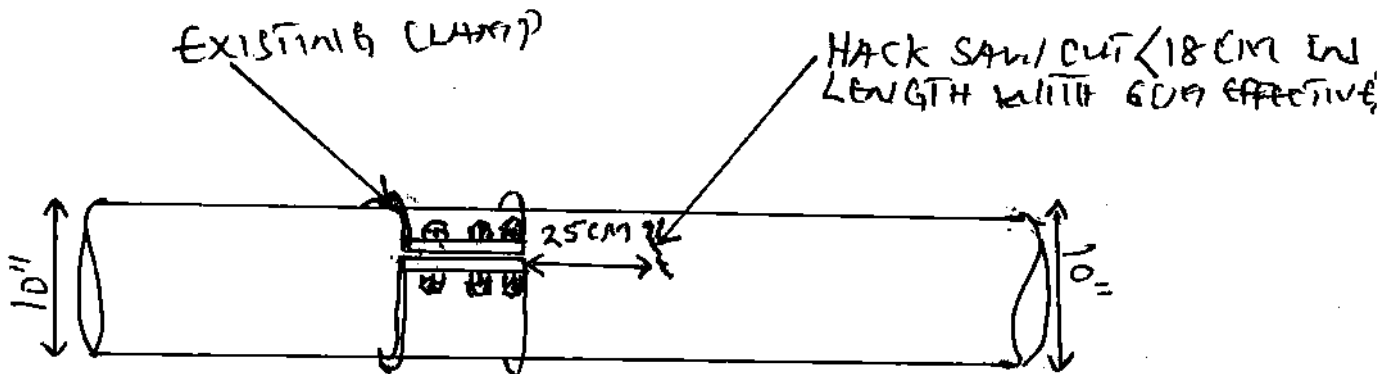
E. GRAPHIC DESCRIPTION OF LEAK POINT (while detail report of the leak point should be contained in the leak report, overview sketch of the site should be added as an appendix)

| <input type="checkbox"/> Drilled hole | <input checked="" type="checkbox"/> Hack saw cut | <input type="checkbox"/> Tear (_____), |

SECTION OF 10" DIEBU CREEK - NUNI RIVER PIPELINE AT DPOROMA SHOWING POSITION OF HACK SAW CUT AT 1 O'CLOCK POSITION.

FROM DIEBU CREEK TO NUNI RIVER

RECOVERY ACTIVITIES ON GOING.
REPAIR WORK WAS DONE BY CLAMPING.
