THE SHELL PETROLEUM DEVELOPMENT COMPANY OF NIGERIA LIMITED.

JOINT INVESTIGATION REPORT FOR INCIDENT NO: 1267525 JIV report S/N: 00725

1. Spill incident Number: 1267525 2. Type of incident* OIL SPILL
 3. Name of Location 28" NKPOKU - BOMU PIPELINE
 4. Name of nearest community G10 5. State: RIVERS 6. LGA TAI
 7. Type of Production facility/Installation PIPELINE 8. Asset owner/District PIPELINE

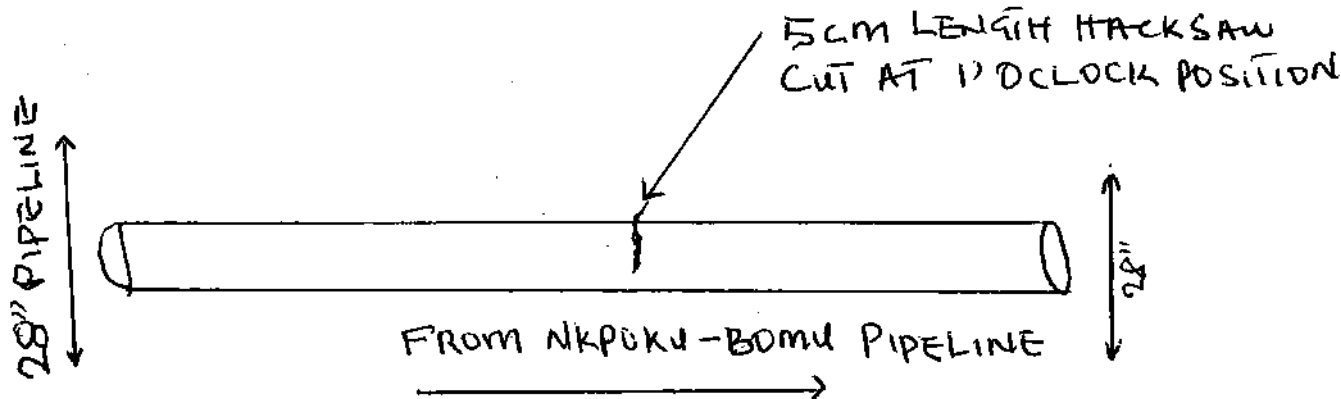
| <input type="checkbox"/> Drilled hole | <input checked="" type="checkbox"/> Hack saw cut | <input type="checkbox"/> Tear (_____), |

SECTIONAL VIEW OF 28" NKPOKU - BOMU PIPELINE AT GID
SHOWING HACKSAW CUT AT 12 O'CLOCK POSITION

AFFECTED PIPELINE WAS CLAMPED BY THE REPAIR TEAM DURING JIONT INVESTIGATION VISIT
