THE SHELL PETROLEUM DEVELOPMENT COMPANY OF NIGERIA LIMITED.

JOINT INVESTIGATION REPORT FOR INCIDENT NO: 1267811(A) report S/N: 00739

1. Spill incident Number: 1267811 2. Type of incident* OIL SPILL
 3. Name of Location 12" IMO RIVER — OGALE PIPELINE
 4. Name of nearest community OWAZA 5. State: ABIA 6. LGA UKWA WEST
 7. Type of Production facility/Installation OIL PIPELINE 8. Asset owner/District PIPELINE

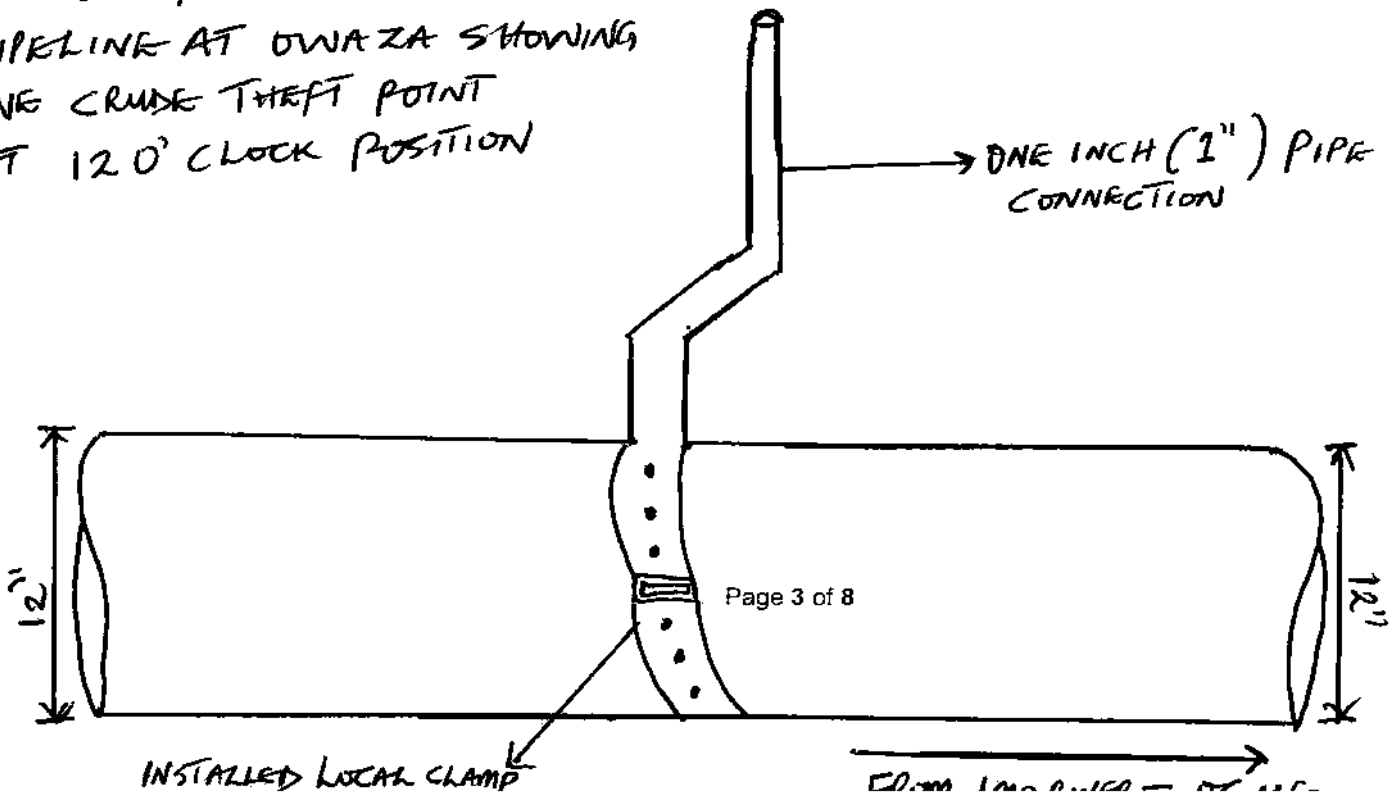
SECTION OF IMO RIVER - OGALE
 PIPELINE AT OWAZA SHOWING
 ONE CRUDE THEFT POINT
 AT 12 O' CLOCK POSITION

If yes to item 14, give brief description:
CLAMPING OF THE AFFECTED PIPE SECTION WAS INITIATED
