THE SHELL PETROLEUM DEVELOPMENT COMPANY OF NIGERIA LIMITED.

JOINT INVESTIGATION REPORT FOR INCIDENT NO: 1270329 JIV report S/N: 00744

1. Spill incident Number: 1270329 2. Type of incident* OIL SPILL
3. Name of Location 4" KOLO CREEK WELL 3T FLOWLINE
4. Name of nearest community OTYASEGA 5. State: BAYELSA 6. LGA OGBIA
7. Type of Production facility/Installation OIL FLOWLINE 8. Asset owner/District NEL 2 / KOLOCREEK

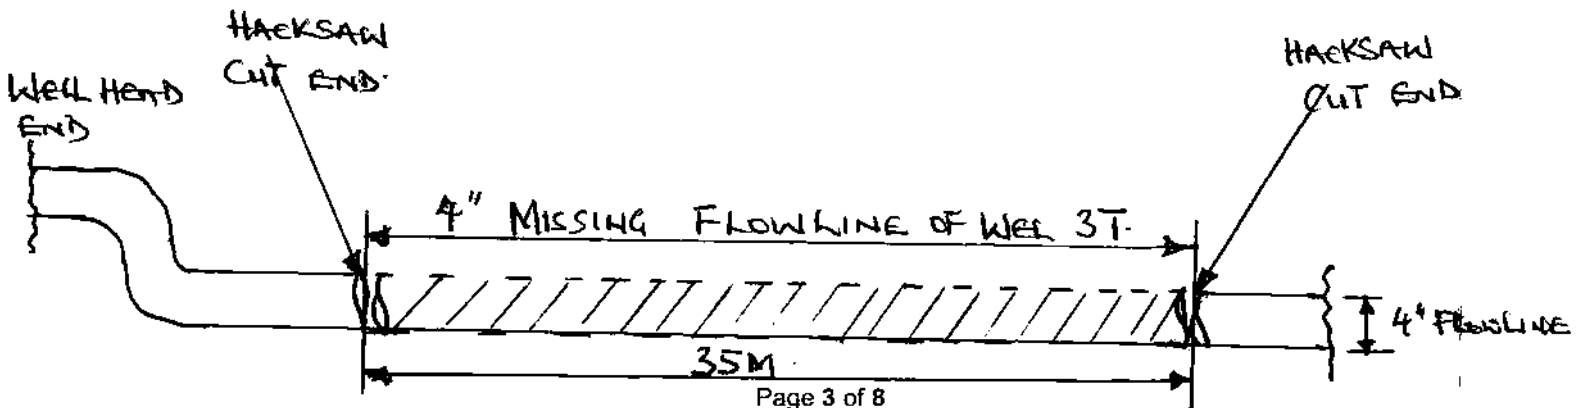
Additional observations around the spill point: JIV TEAM OBSERVED KOLO CREEK WELL 3T WAS SHUT DOWN DURING THE INCIDENT BY UNKNOWN PERSON. (KOLO CREEK WELL 3T IS A PRODUCING WELL)

| <input type="checkbox"/> Failed Weld-on illegal hot tap valve, | <input type="checkbox"/> Failed Clamp | <input checked="" type="checkbox"/> Missing Pipeline/Flowline |

SECTIONAL VIEW OF 4" KOLOCREEK WELL 3T FLOWLINE AT OTUASOGA
SHOWING: SABOTAGE SPILL (MISSING FLOWLINE OF WELL 3T)
