THE SHELL PETROLEUM DEVELOPMENT COMPANY OF NIGERIA LIMITED.

JOINT INVESTIGATION REPORT FOR INCIDENT NO: 1274368 JIV report S/N: 00755

1. Spill incident Number: 1274368 2. Type of incident* OIL SPILL
 3. Name of Location 18" ASSA - RUMUKEPE PIPELINE
 4. Name of nearest community EGBE DA 5. State: RIVERS 6. LGA EMOHUA
 7. Type of Production facility/Installation OIL PIPELINE 8. Asset owner/District NPE / RUMUAHIA (PIPELINE)

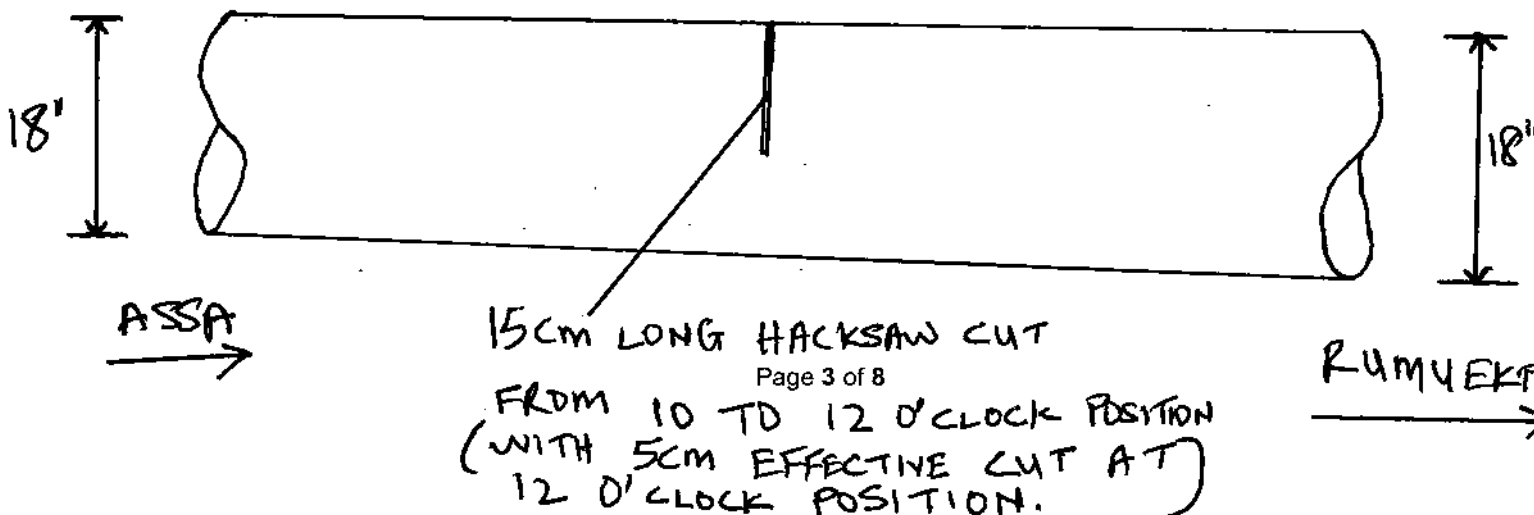
| <input type="checkbox"/> Drilled hole | <input checked="" type="checkbox"/> Hack saw cut | <input type="checkbox"/> Tear (_____), |

- Third party interference (Sabotage ; crude theft ; Line theft ; Accidental 3rd party damage
 Operational Others (including Mystery spills) _____

SECTION OF 18" ASSA - RUMUEKPE PIPELINE AT EGBEDA SHOWING POSITION OF HACKSAW CUT.

THE REPAIR WAS DONE BY CLAMPING THE PIPELINE USING 18" X 14" CLAMP.
