THE SHELL PETROLEUM DEVELOPMENT COMPANY OF NIGERIA LIMITED.

JOINT INVESTIGATION REPORT FOR INCIDENT NO: 1269019 JIV report S/N: 00785

1. Spill incident Number: 1269019 2. Type of incident* OIL SPILL
 3. Name of Location 28" NKPOKU - BOMU PIPELINE
 4. Name of nearest community EKPORO 5. State: RIVERS 6. LGA ELEME
 7. Type of Production facility/Installation OIL PIPELINE 8. Asset owner/District PIPELINE

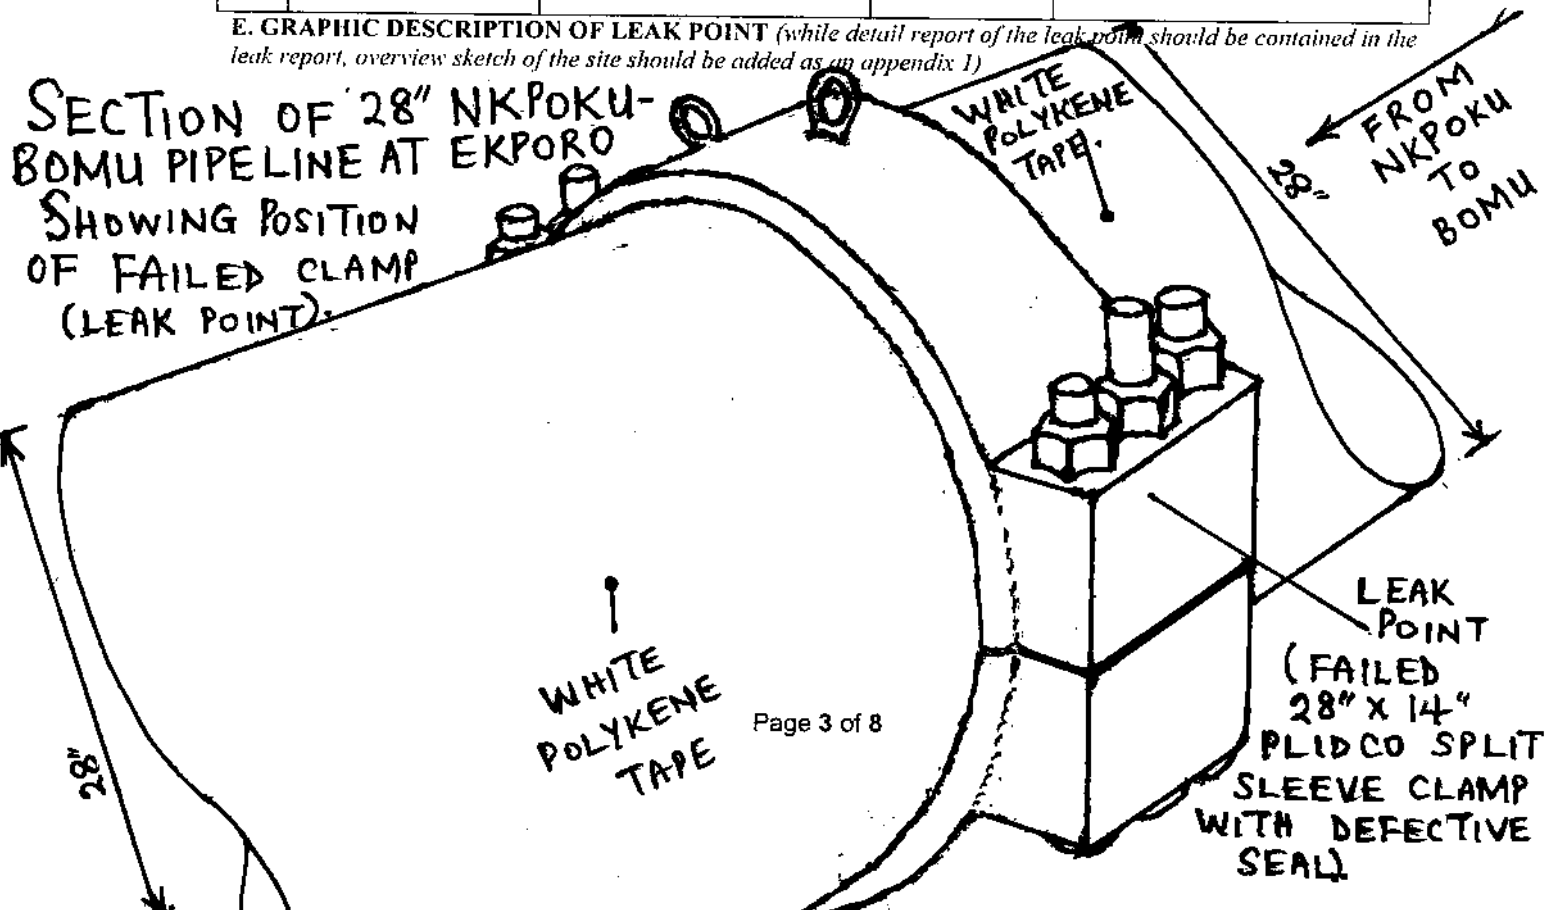
E. GRAPHIC DESCRIPTION OF LEAK POINT (while detail report of the leak point should be contained in the leak report, overview sketch of the site should be added as an appendix 1)

Additional observations around the spill point: **ALTHOUGH THE INCIDENT WAS EARLIER REPORTED AS A SUSPECTED CRUDE THEFT POINT (THOUGHT TO BE NON LEAKING) WITH INCIDENT DATE OF 15TH OCTOBER 2014, THE JOINT INVESTIGATION TEAM ON JIV DATE OF 26TH NOVEMBER 2014 OBSERVED A SPILL, UPON EXCAVATION AROUND INCIDENT POINT TO ASCERTAIN INCIDENT CAUSE, FROM A FAILED CLAMP. SPILL WAS CONTAINED WITHIN THE DITCH**

EXCAVATED AROUND SPILL POINT. THE JOINT INVESTIGATION TEAM CONFIRMED

- e. Description of leak point (tick as applicable); **THE CLAMP NUTS TO BE IN TACT (THAT IS, NOT TAMPERED WITH) WITH THE AID OF A SPANNER, UPON REMOVAL, THE CLAMP SEAL WAS OBSERVED DEFECTIVE.**

RECOVERY OF FREE-PHASE OIL WITHIN EXCAVATED DITCH WAS
DONE WHILE REPAIRS WERE EFFECTED BY REPLACING FAILED CLAMP
WITH A NEW ONE.
