**THE SHELL PETROLEUM DEVELOPMENT COMPANY OF NIGERIA LIMITED.**

JOINT INVESTIGATION REPORT FOR INCIDENT NO: 1258257 JIV report S/N: 00723

1. Spill incident Number: 1258257 2. Type of incident\* OIL SPILL  
 3. Name of Location 8" Umurechem - NKPOKU PIPELINE  
 4. Name of nearest community OMUNWEL 5. State: RIVERS 6. LGA IKWERRE  
 7. Type of Production facility/Installation OIL PIPELINE 8. Asset owner/District PIPELINE/PH2

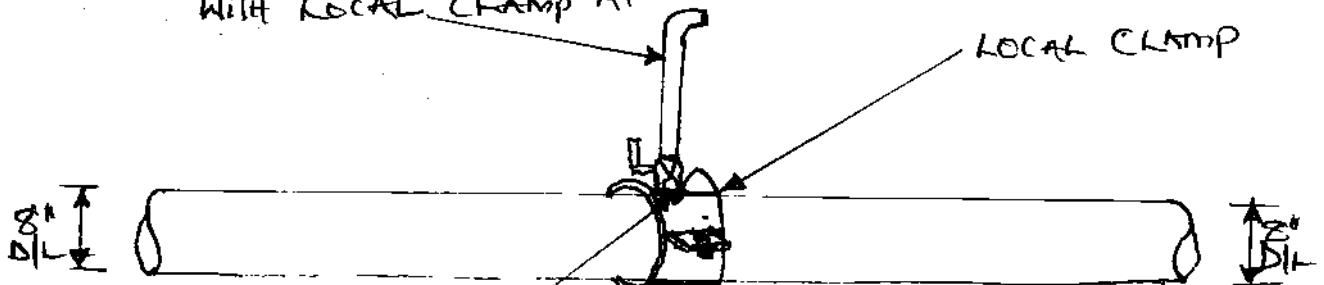
SECTIONAL VIEW OF 8" UMURCHEM - NKPOKU PIPELINE AT

OMUNKWEI SHOWING (BUNKERING FITTING POINT)

ILLEGALLY INSTALLED WITH LOCAL CLAMP

LEAK DUE TO 1" CONNECTION INSTALLED ILLEGALLY

WITH LOCAL CLAMP AT 12° CLOCK POSITION

UMURCHEM - NKPOKU PIPELINE

DRILL HOLE AT 12° CLOCK POSITION.

REPAIR WORK COMPLETED BY CLAMPING
