THE SHELL PETROLEUM DEVELOPMENT COMPANY OF NIGERIA LIMITED.

JOINT INVESTIGATION REPORT FOR INCIDENT NO: 1246112 JIV report S/N: 00672

1. Spill incident Number: 1246112 2. Type of incident* OIL SPILL
 3. Name of Location 48" FORCADOS CRUDE OIL EXPORT PIPELINE
 4. Name of nearest community OGULAGHA 5. State: DELTA 6. LGA BURUTU
 7. Type of Production facility/Installation EXPORT PIPELINE Asset owner/District FORCADOS TERMINAL

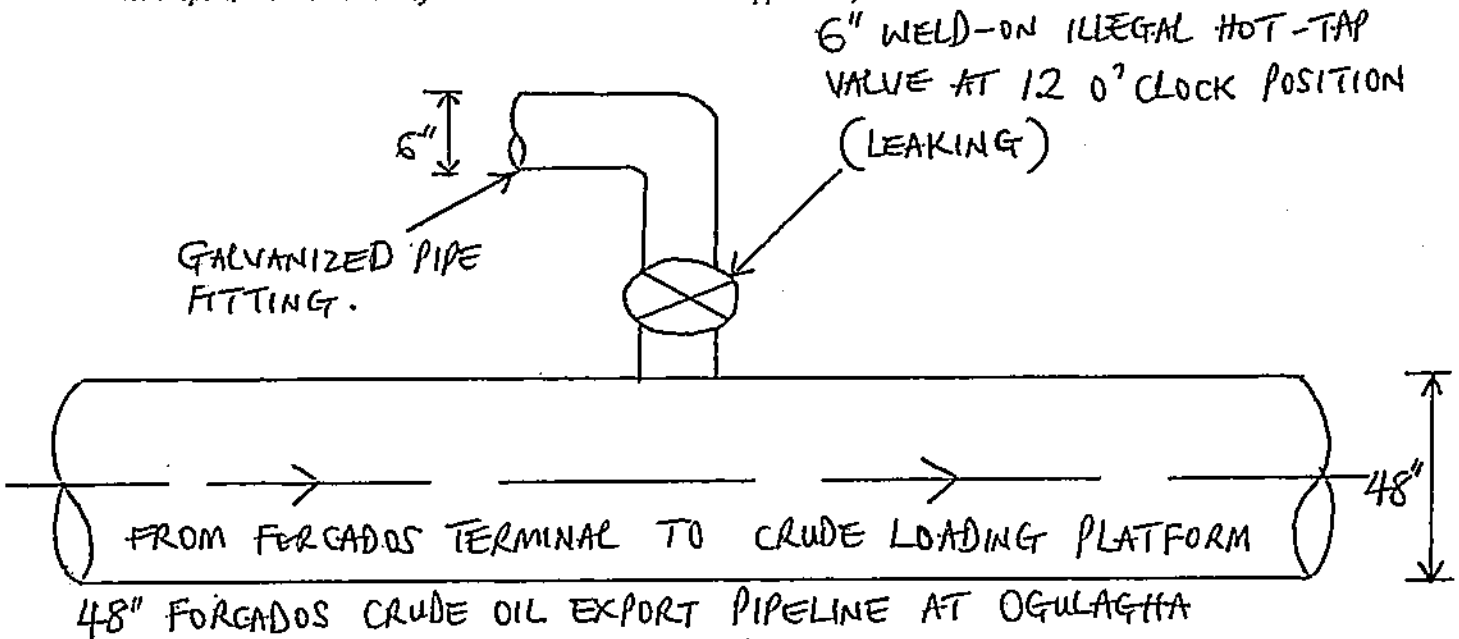
E. GRAPHIC DESCRIPTION OF LEAK POINT (while detail report of the leak point should be contained in the leak report, overview sketch of the site should be added as an appendix 1)

Additional observations around the spill point: UPON EXCAVATION, A 6" ILLEGAL HOT TAP VALVE WITH GALVANIZED PIPE FITTING WAS OBSERVED WELDED ON THE 48" CRUDE OIL EXPORT PIPELINE AT 12 O'CLOCK POSITION.

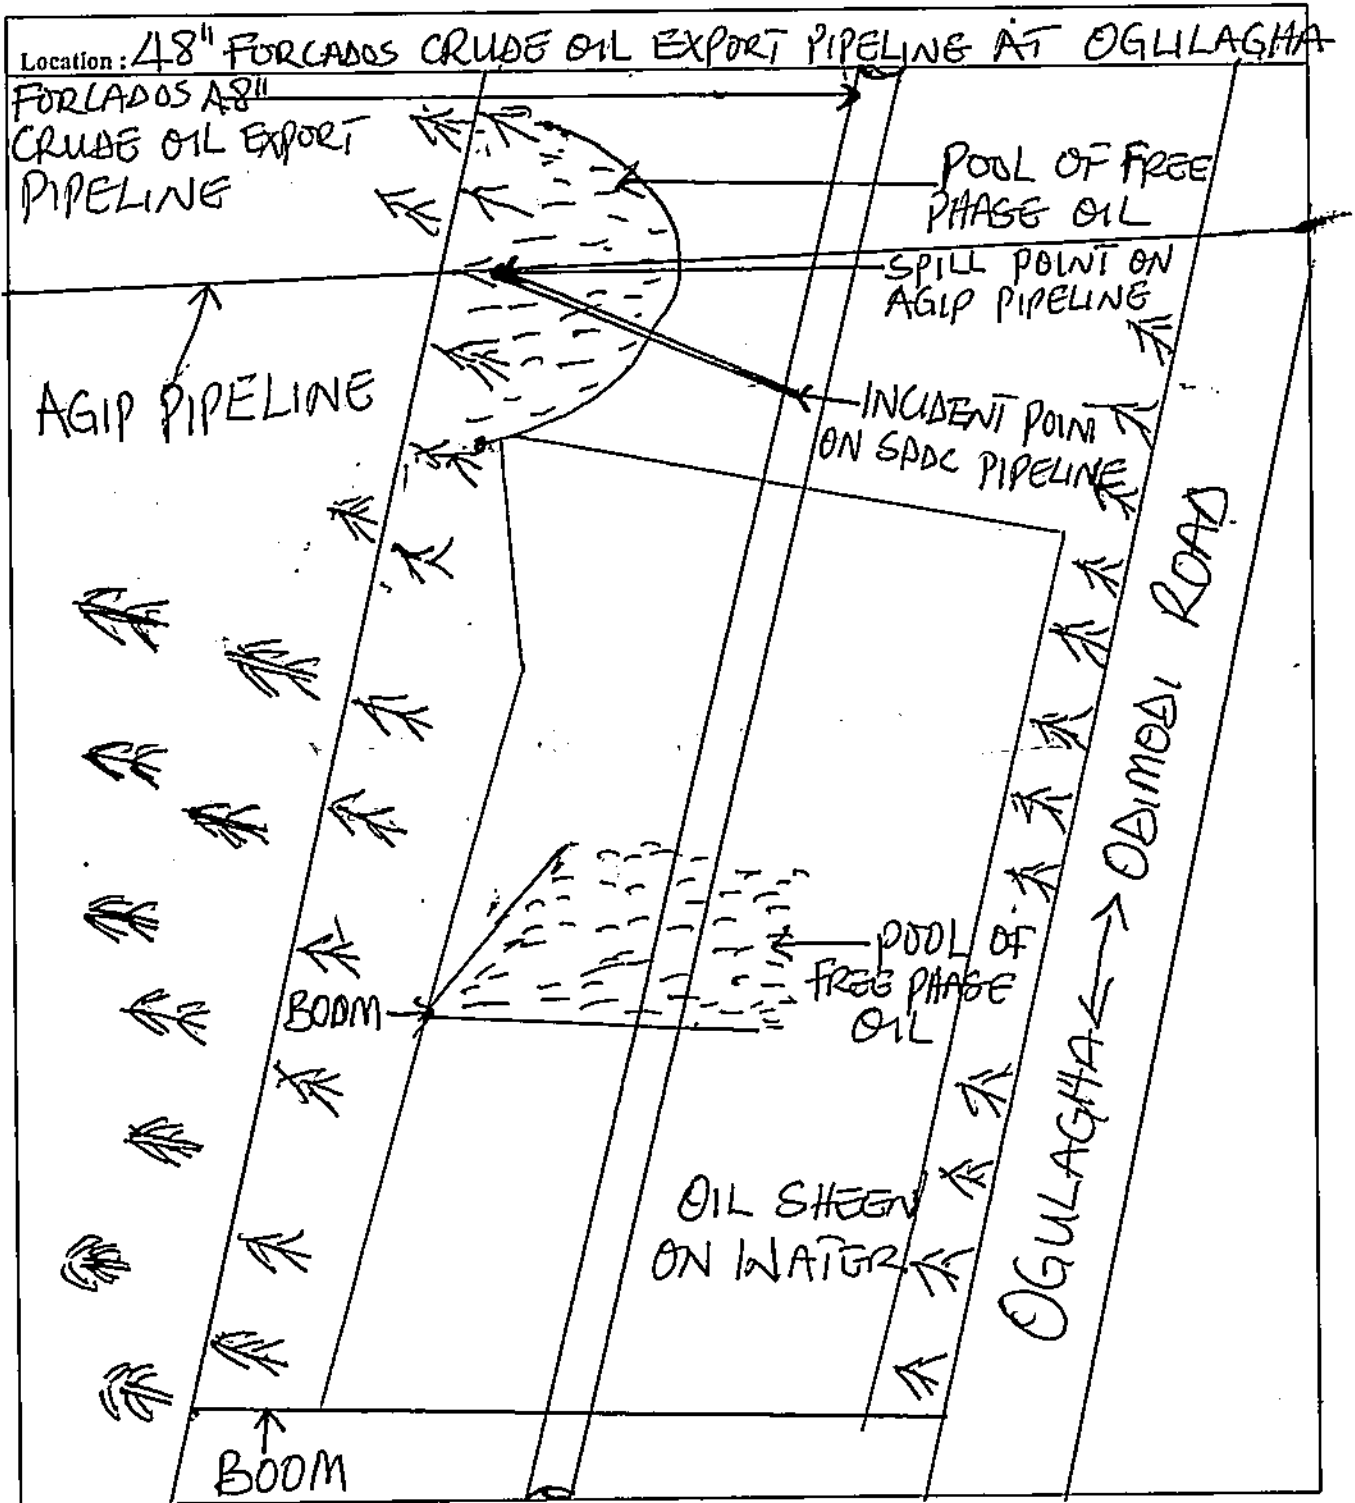
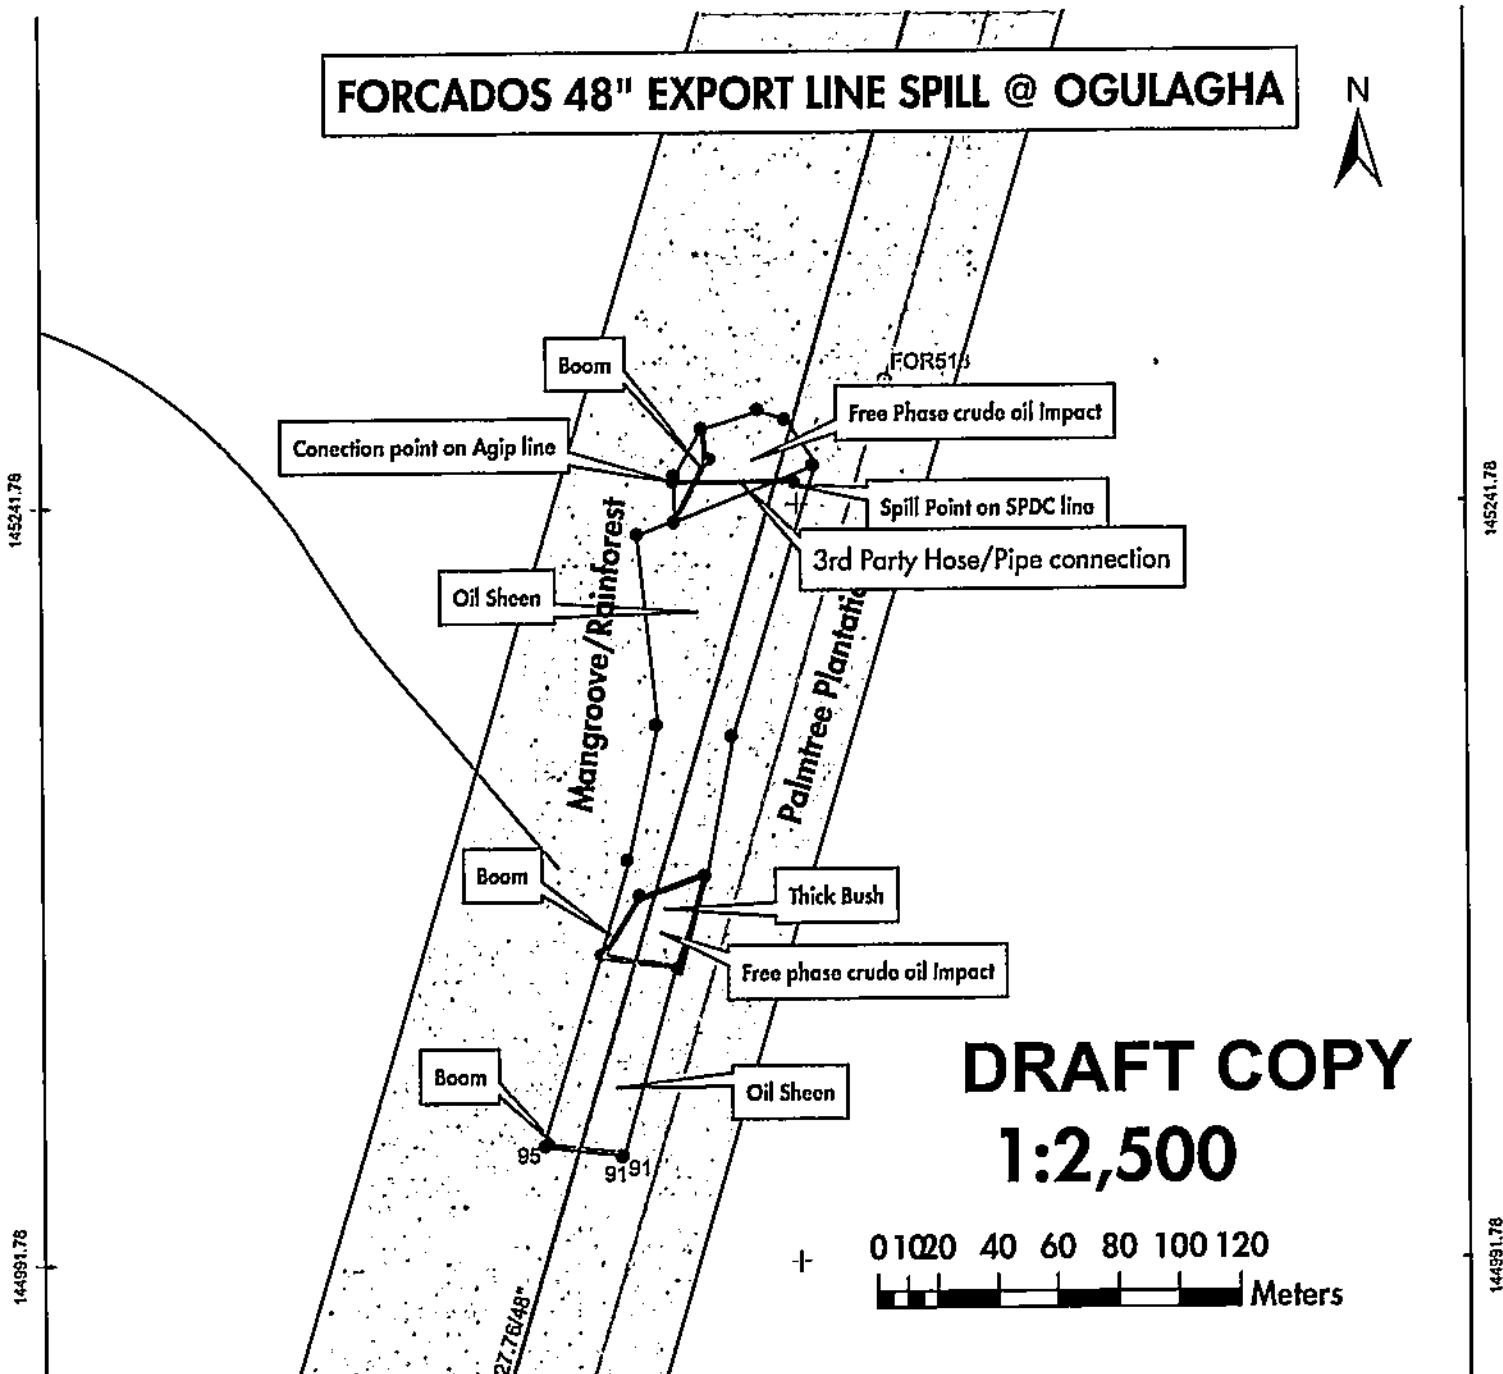
FORCADOS 48" EXPORT LINE SPILL @ OGULAGHA

INC.NO: 1246112
 INC.DATE: 07/09/2014
 INV.DATE: 09/09 & 04/10/2014
 SP.: 323443mE; 145249mN(Minna West-Belt)
 TOTAL IMPACTED AREA: 0.765469Ha
 Free Phase: 0.16Ha; Oil sheen: 0.61Ha
 IMPACTED FEATURES: Water and Bushes
 IMPACT TYPE: Free Phase and Oil Sheen crude oil impact
 VEG./TERRAIN: Mangroove/Rainforest / Swamp
 CSR: JONATHAN OBASOHAN
