THE SHELL PETROLEUM DEVELOPMENT COMPANY OF NIGERIA LIMITED.

JOINT INVESTIGATION REPORT FOR INCIDENT NO: 1248283 JIV report S/N: 00789

1. Spill incident Number: 1248283 2. Type of incident* OIL SPILL
 3. Name of Location 11" OBELE - IBAA PIPELINE
 4. Name of nearest community IBAA (OMUEZE) State: RIVERS 6. LGA EMOHUA
 7. Type of Production facility/Installation OIL PIPELINE 8. Asset owner/District PIPELINE

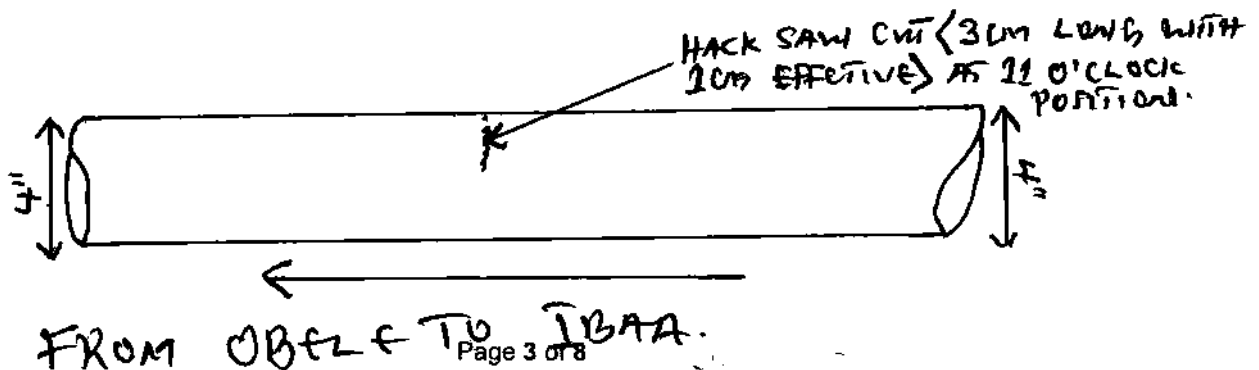
| <input type="checkbox"/> Drilled hole | <input checked="" type="checkbox"/> Hack saw cut | <input type="checkbox"/> Tear (_____), |

- f. Incident caused by:
- Third party interference (Sabotage ; crude theft ; Line theft ; Accidental 3rd party damage
 Operational Others (including Mystery spills) _____

SECTION OF 4" OBELE - IBAA PIPELINE AT IBAA (OMUTZE) SHOWING POSITION OF HACK SAW CUT AT 11 O'CLOCK POSITION.

If yes to item 14, give brief description: REPAIR WORK WAS DONE BY CLAMPING.
