JOINT INVESTIGATION REPORT

INCIDENT NO: 1537652 JIV report S/N: Nº 0000399

1. Spill incident Number: 1537652 2. Type of incident* OIL SPILL
3. Name of Location 20" OTUMARA - ESCRAVOS PIPELINE
4. Name of nearest community OGIDIGBEN 5. State: DELTA 6. LGA WARRI SOUTH-WEST
7. Type of Production facility/Installation OIL PIPELINE
8. Asset owner/District THE SHELL PETROLEUM DEVELOPMENT COMPANY OF NIGERIA LIMITED

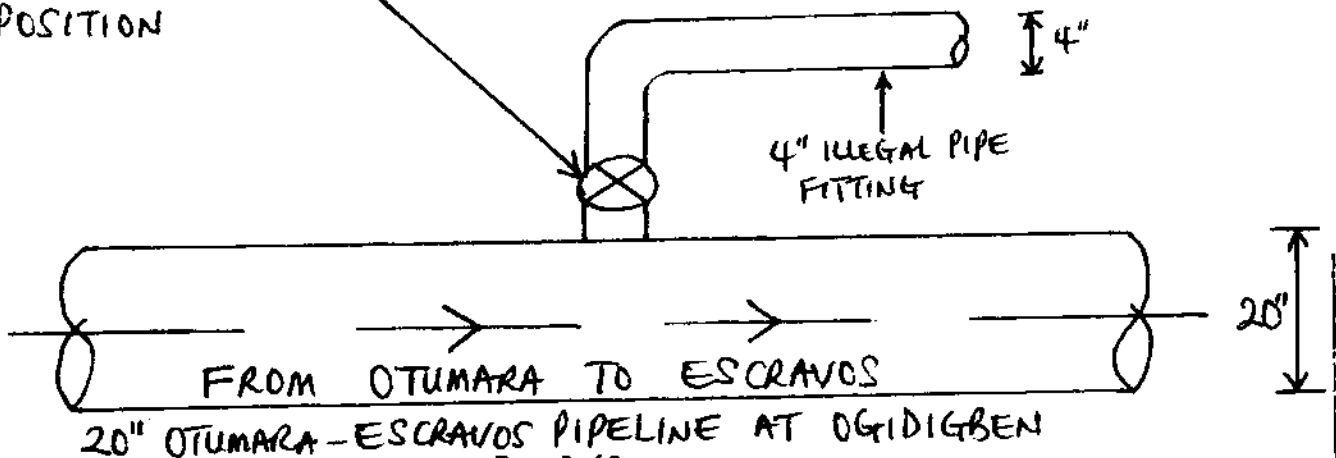
E. GRAPHIC DESCRIPTION OF LEAK POINT (while detail report of the leak point should be contained in the leak report, overview sketch of the site should be added as an appendix 1)

Additional observations around the spill point: ON EXCAVATION, THE JOINT INVESTIGATION TEAM OBSERVED A 4" FAILED HOT-TAP VALVE, ILLEGALLY ATTACHED TO THE 20" OTUMARA-ES CRAVOS PIPELINE AT 12 O'CLOCK POSITION. IT WAS LEAKING AT THE SPILL POINT AS AT THE TIME OF THIS INVESTIGATION

4" FAILED ILLEGAL HOT-TAP
VALVE WELDED AT 12 O'CLOCK
POSITION
