THE SHELL PETROLEUM DEVELOPMENT COMPANY OF NIGERIA LIMITED.

JOINT INVESTIGATION REPORT FOR INCIDENT NO: 1332320 JIV report S/N: 00633

1. Spill incident Number: 1332320 2. Type of incident* OIL SPILL
 3. Name of Location 20" OTUMARA - ESCRAVOS PIPELINE
 4. Name of nearest community UGBODEGUNGUNS 5. State: DELTA 6. LGA WARRI SOUTH-WEST
 7. Type of Production facility/Installation OIL PIPELINE 8. Asset owner/District PIPELINES

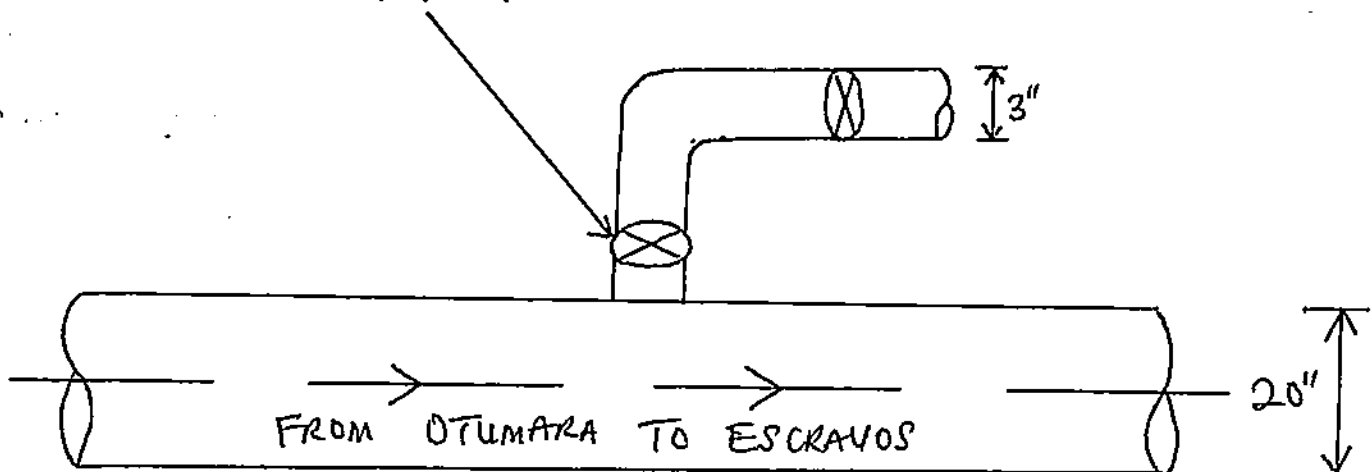
Additional observations around the spill point: UPON EXCAVATION, THE JIT OBSERVED THAT A 3" FAILED ILLEGAL HOT TAP VALVE WAS WELDED ON THE 20" OTUMARA - ESCRAVOS PIPELINE AT 12 O'CLOCK POSITION. THE FAILED VALVE WAS STILL DRIPPING CRUDE OIL AT THE TIME OF JIV.

3" FAILED WELD - ON ILLEGAL HOT TAP VALVE AT 12 O'CLOCK POSITION

20" OTUMARA - ESCRAVOS PIPELINE AT UGBDEGWGUN

If yes to item 14, give brief description: REPAIR IS BEING PLANNED BY THE PIPELINES MAINTENANCE TEAM.

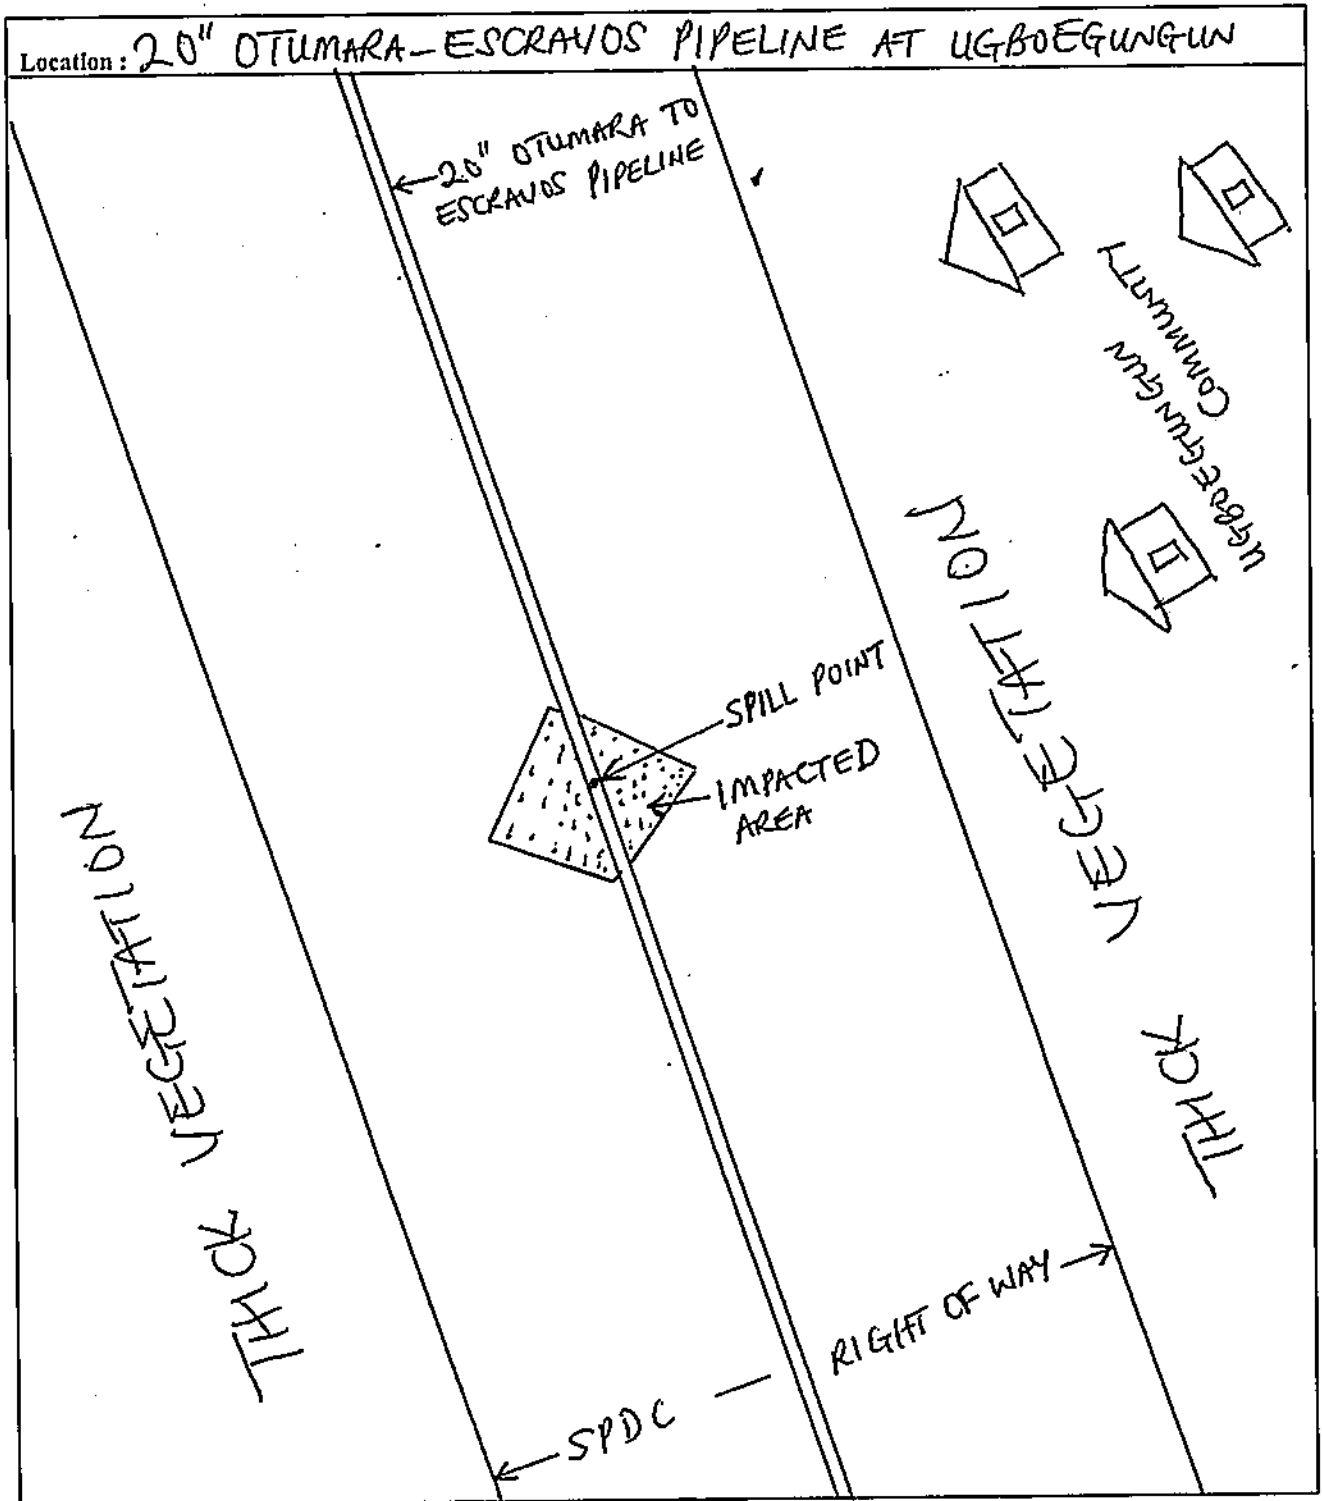
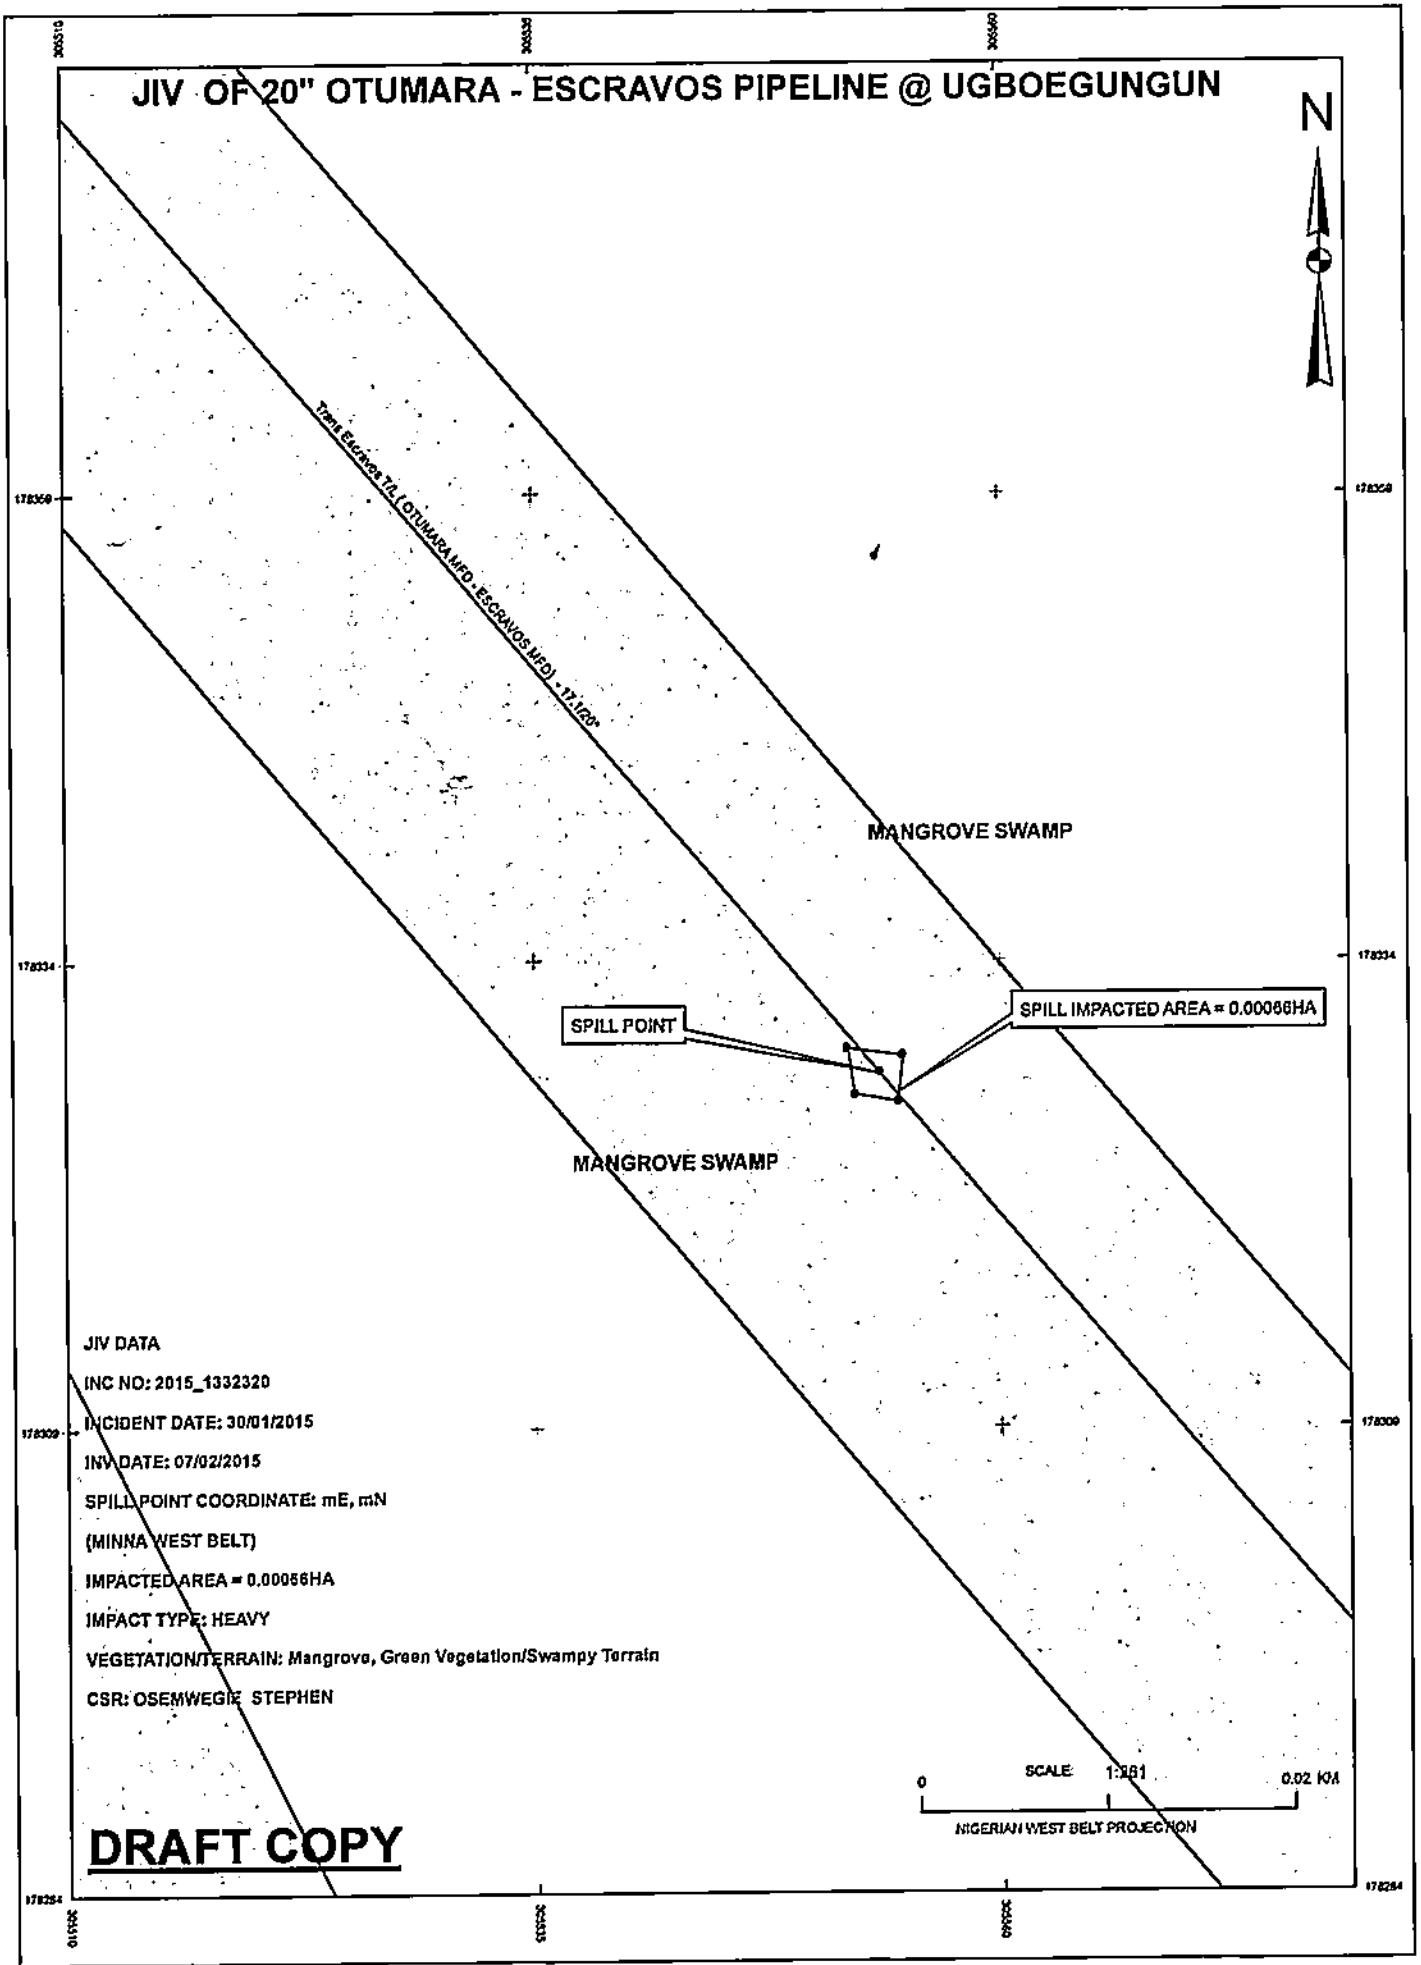
25. Appendix 1: Overview sketch of the site

JIV DATA
INC NO: 2015_1332320
INCIDENT DATE: 30/01/2015
INV DATE: 07/02/2015
SPILL POINT COORDINATE: mE, mN
(MINNA WEST BELT)
IMPACTED AREA = 0.00056HA
IMPACT TYPE: HEAVY
VEGETATION/TERRAIN: Mangrove, Green Vegetation/Swampy Terrain
CSR: OSEMWEGIE STEPHEN

SCALE 1:181
0 0.02 KM
NIGERIAN WEST BELT PROJECTION
