**THE SHELL PETROLEUM DEVELOPMENT COMPANY OF NIGERIA LIMITED.**

JOINT INVESTIGATION REPORT FOR INCIDENT NO: 1333156 JIV report S/N: 00831

1. Spill incident Number: 1333156 2. Type of incident\* OIL SPILL  
 3. Name of Location SANTA BARBARA WELL 12T WELL HEAD NEMBE  
 4. Name of nearest community BASSAMBIRI 5. State: BAYELSA 6. LGA NEMBE  
 7. Type of Production facility/Installation WELL HEAD 8. Asset owner/District SWAMP 2

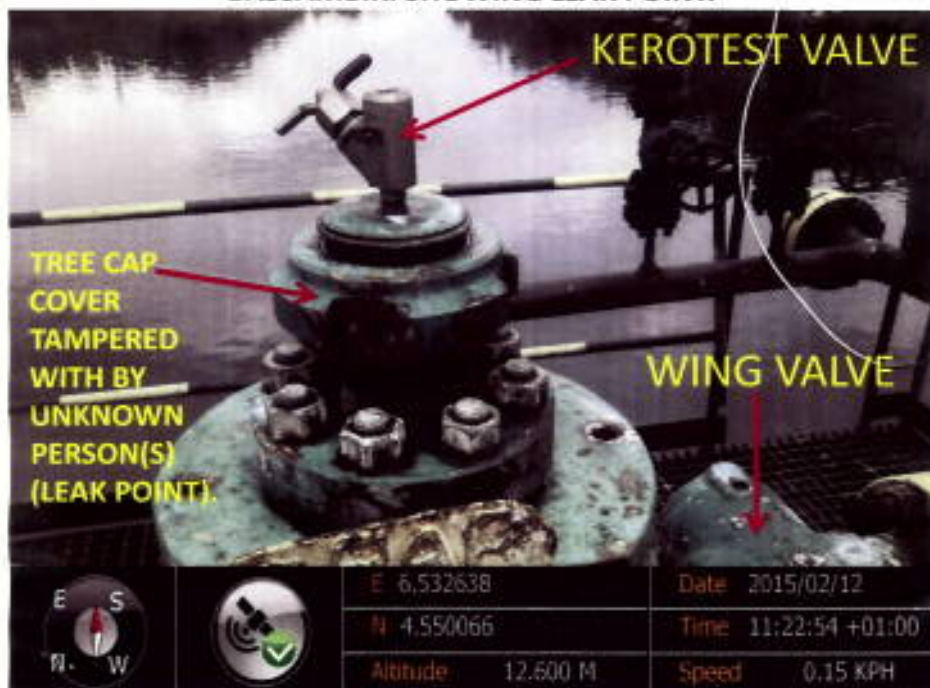
E. GRAPHIC DESCRIPTION OF LEAK POINT (while detail report of the leak point should be contained in the leak report, overview sketch of the site should be added as an appendix 1)

Additional observations around the spill point: **ON ARRIVAL AT SITE, THE JOINT INVESTIGATION TEAM NOTICED SOME MARKS ON THE TREE CAP COVER OF WELL 12T, INDICATING THAT THE TREE CAP COVER HAD BEEN TAMPERED WITH BY UNKNOWN PERSON(S). THIS CONFIRMED THE SPDC ASSET OWNER'S REPORT DURING INITIAL PRE-JIV SITE VISIT ON INCIDENT DATE OF 4TH FEBRUARY 2015, THAT THE TREE CAP COVER WAS OBSERVED TO BE NOT PROPERLY TIGHTENED. THE POSITION OF A WOODEN**

SECTION OF SANTA BARBARA WELL 12T WELL HEAD AT NEMBE BASSAMBIRI SHOWING LEAK POINT.
