THE SHELL PETROLEUM DEVELOPMENT COMPANY OF NIGERIA LIMITED.

JOINT INVESTIGATION REPORT FOR INCIDENT NO: 1328880 JIV report S/N: 00825

1. Spill incident Number: 1328880 2. Type of incident* OIL SPILL
 3. Name of Location NEMBE CREEK 3 WELL 33 S WELL HEAD
 4. Name of nearest community EWELLESUO 5. State: BAYELSA 6. LGA NEMBE
 7. Type of Production facility/Installation WELL HEAD 8. Asset owner/District SWAMP 2

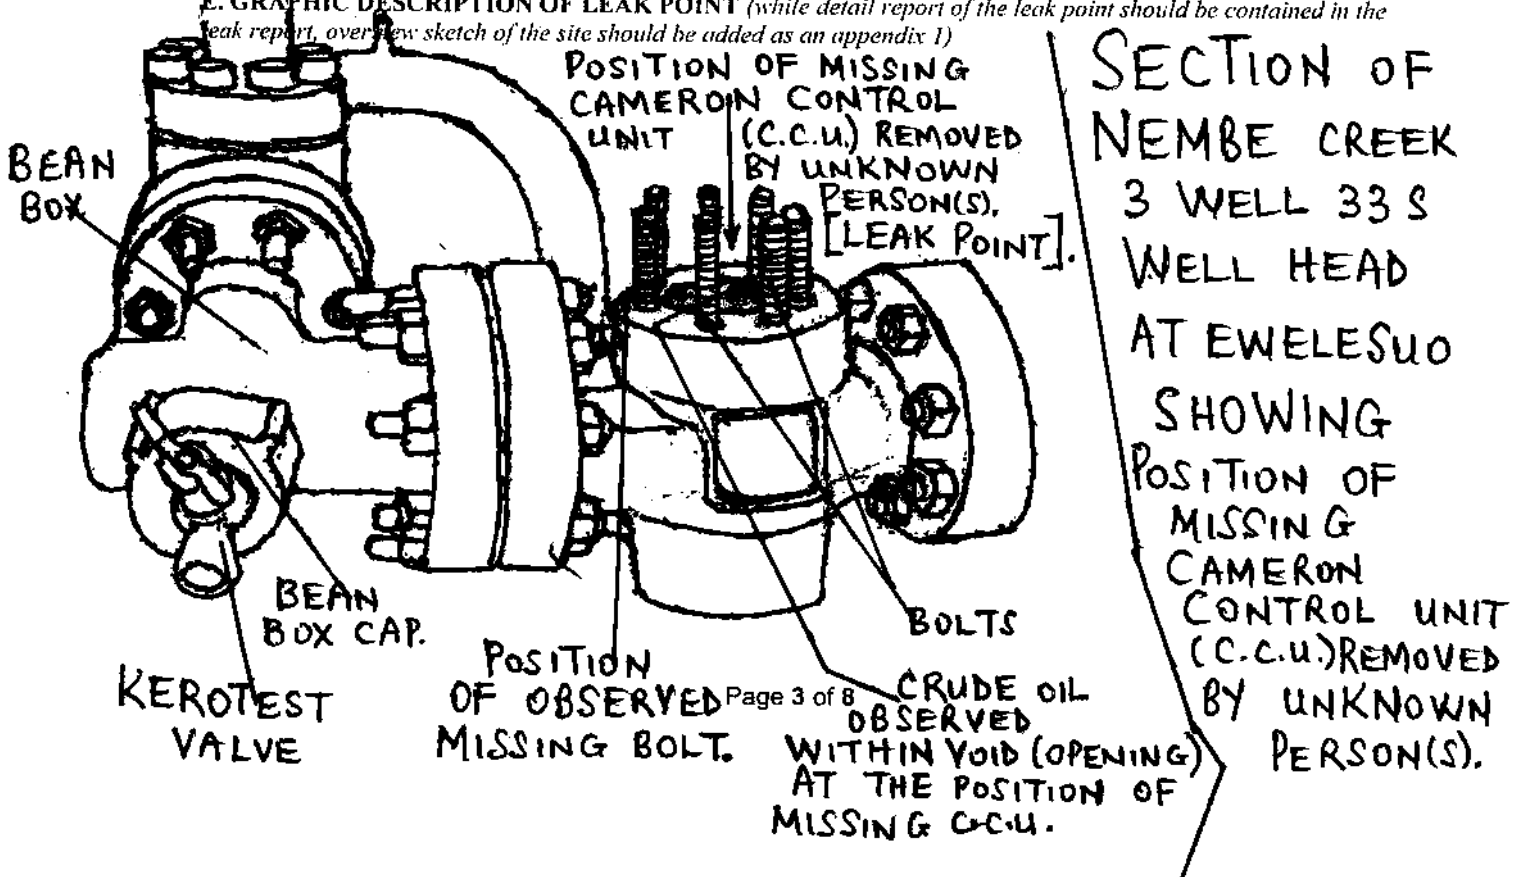
E. GRAPHIC DESCRIPTION OF LEAK POINT (while detail report of the leak point should be contained in the leak report, overview sketch of the site should be added as an appendix 1)

Additional observations around the spill point: **CRUDE OIL STAINS WERE OBSERVED ON THE WELL HEAD BODY, THOUGH SPILL WAS CONFIRMED TO HAVE OCCURRED FROM THE WELL 33 S ARM OF THE WELL HEAD, AT THE POSITION OF THE OBSERVED MISSING CAMERON CONTROL UNIT (CCU) WHICH HAD BEEN REMOVED BY UNKNOWN PERSON(S). INTERMITTENT BUBBLING WAS NOTICED FROM SOME CRUDE OIL CONTAINED INTERNALLY WITHIN THE VOID**

| <input type="checkbox"/> Relief valve failure | <input checked="" type="checkbox"/> Others (specify) CAMERON CONTROL UNIT (C.C.U) | |

- REMOVAL BY UNKNOWN PERSON(S).**
