THE SHELL PETROLEUM DEVELOPMENT COMPANY OF NIGERIA LIMITED.

JOINT INVESTIGATION REPORT FOR INCIDENT NO: 1328417 JIV report S/N: 00826

1. Spill incident Number: 1328417 2. Type of incident* OIL SPILL
 3. Name of Location 28" BOMU - BONNY TRANS NIGER PIPELINE
 4. Name of nearest community BODO WEST 5. State: RIVERS 6. LGA GOKANA
 7. Type of Production facility/Installation PIPELINE 8. Asset owner/District PIPELINE (BONI)

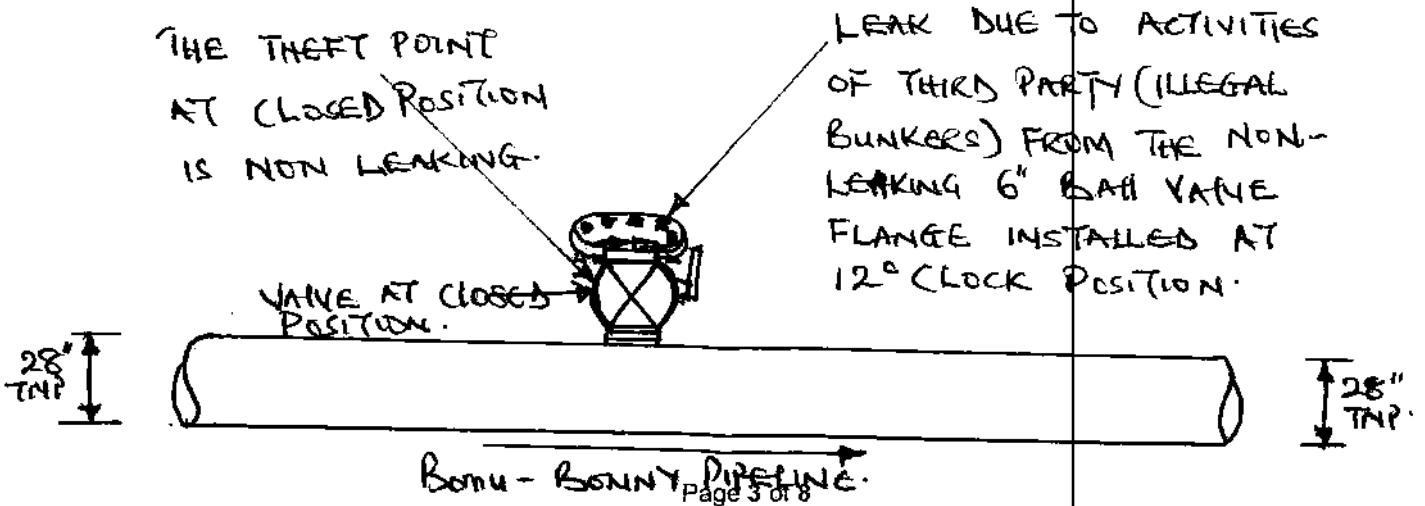
Additional observations around the spill point: THE ILLEGAL THEFT POINT WAS OBSERVED TO BE NON LEAKING WHEN THE ILLEGALLY INSTALLED VALVE IS CLOSED WHILE HEAVY IMPACT WARS OF CRUDE OIL WAS SEEN WITHIN AND OUTSIDE THE COFFERDAM DUE TO THIRD PARTY (BUNKERS) ACTIVITIES.

SECTIONAL VIEW OF 28" BOMU-BONNY TRANS NIGER PIPELINE AT.

BODO WEST SHOWING! - CRUDE OIL THEFT ILLEGAL POINT.

TEMPORARY REPAIR BY BLIND FLANGE THE THEFT POINT.
