JOINT INVESTIGATION REPORT

INCIDENT NO: 1434948 JIV report S/N: N° 0000030

1. Spill incident Number: 1434948 2. Type of incident* OIL SPILL
3. Name of Location 8" AFAM WELL 27 FLOWLINE
4. Name of nearest community EGBERU 5. State: RIVERS 6. LGA OBIGBO
7. Type of Production facility/Installation FLOWLINE
8. Asset owner/District THE SHELL PETROLEUM DEVELOPMENT COMPANY OF NIGERIA / LAND I

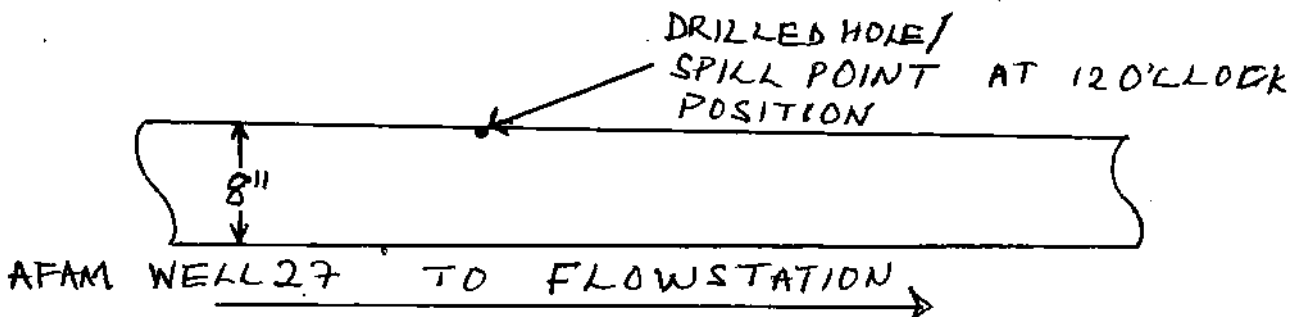
E. GRAPHIC DESCRIPTION OF LEAK POINT (while detail report of the leak point should be contained in the leak report, overview sketch of the site should be added as an appendix 1) SECTION OF 8" AFAM WELL 27 FLOWLINE AT EGBERU SHOWING DRILLED HOLE AT 12 O'CLOCK POSITION, DRILLED BY UNKNOWN PERSONS.
