THE SHELL PETROLEUM DEVELOPMENT COMPANY OF NIGERIA LIMITED.

JOINT INVESTIGATION REPORT FOR INCIDENT NO: 1361944 JIV report S/N: 00835

1. Spill incident Number: 1361944 2. Type of incident* OIL SPILL
 3. Name of Location 28" BOMU - BONNY TRANS NIGER PIPELINE
 4. Name of nearest community OWOKURI 5. State: RIVERS 6. LGA ANDONI
 7. Type of Production facility/Installation OIL PIPELINE 8. Asset owner/District PIPELINE/SWAMP

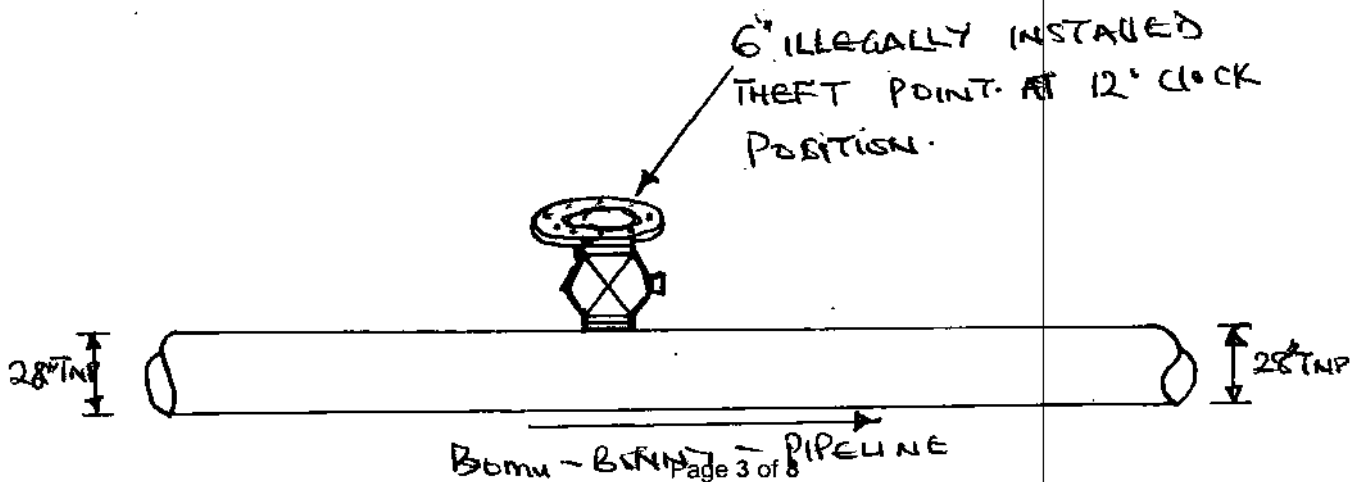
| <input checked="" type="checkbox"/> Crude oil theft (illegal bunkering) point, | | <input type="checkbox"/> Third party tampering with Clamp |

SECTIONAL VIEW OF 28" BOMU - BONNY TRANS NIGER PIPELINE

AT OWOKIRI SHOWING:- CRUDE OIL ILLEGAL THEFT POINT.

TEMPORARY REPAIR BY BLIND FLANGE THE THEFT POINT.
