# JOINT INVESTIGATION REPORT

INCIDENT NO: 1399520

1. Spill incident Number: 1399.520 2. Type of incident\* OIL SPILL  
3. Name of Location 14" OKORDIA - RUMUEKPE PIPELINE  
4. Name of nearest community AKINIMA 5. State: RIVERS 6. LGA AHOADA WEST  
7. Type of Production facility/Installation OIL PIPELINE  
8. Asset owner/District THE SHELL PETROLEUM DEVELOPMENT COMPANY OF NIGERIA LTD (SPDC)

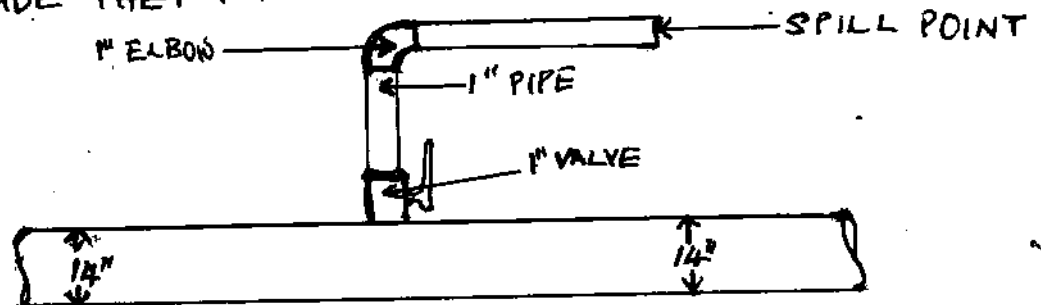
## E. GRAPHIC DESCRIPTION OF LEAK POINT (while detail report of the leak point should be contained in the leak report, overview sketch of the site should be added as an appendix 1)

A SECTION OF 14" OKORDIA-RUMUEKPE PIPELINE AT AKINIMA SHOWING ONE (1) NO. OF ONE (1) INCH CRUDE THEFT POINT INSTALLED AT 12 O'CLOCK POSITION.

REPAIR TEAM COMMENCED REPAIR IMMEDIATELY BY CLAMPING.
