JOINT INVESTIGATION REPORT

INCIDENT NO: 1488510 JIV report S/N: N° 0000073

1. Spill incident Number: 1488510 2. Type of incident* OIL SPILL
3. Name of Location 12" ADIBAWA - OKORDIA PIPELINE
4. Name of nearest community IKARAMA 5. State: BAYELSA 6. LGA YENAGOA
7. Type of Production facility/Installation OIL PIPELINE
8. Asset owner/District THE SHELL PETROLEUM DEVELOPMENT COMPANY OF NIGERIA LIMITED / PIPELINE

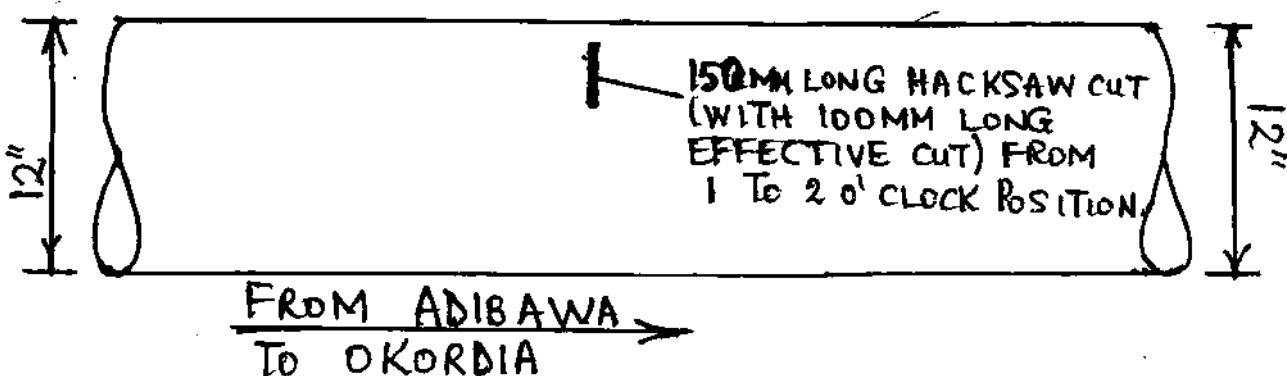
Additional observations around the spill point: NO FREE-PHASE OIL WAS OBSERVED ON SITE. SOIL IMPACTED ON SITE WAS WITHIN AN APPROXIMATE AREA OF 16M².

| <input type="checkbox"/> Drilled hole | <input checked="" type="checkbox"/> Hack saw cut | <input type="checkbox"/> Tear (_____) |

SECTION OF 12" ADIBAWA - OKORDIA
PIPELINE AT IKARAMA SHOWING POSITION OF
HACKSAW CUT.

SOURCE OF LEAK WAS STOPPED AFTER WHICH REPAIRS WERE DONE ON AFFECTED PIPELINE SECTION BY CLAMPING.
