JOINT INVESTIGATION REPORT

INCIDENT NO: 1907894 JIV report S/N: 1038

1. Spill incident Number: 1907894 2. Type of incident* SUSPECTED CONDENSATE SEEPAGE
 3. Name of Location SOKU GAS PLANT CONDENSATE SPIKING PUMP AREA
 4. Name of nearest community ELEM-SANGAMA 5. State: RIVERS 6. LGA AKUKU-TORU
 7. Type of Production facility/Installation GAS PLANT
 8. Asset owner/District THE SHELL PETROLEUM DEVELOPMENT COMPANY OF NIGERIA LIMITED/SWAMP EAST HUB

ESTIMATION OF VOLUME OF SUSPECTED CONDENSATE SHEEN NOTICED BY THE ASSET OWNER ON INCIDENT DATE WITHIN STORM WATER DRAIN AT THE CONDENSATE SPIKING PUMP AREA, SOKU GAS PLANT (INCIDENT NO. 1907894)

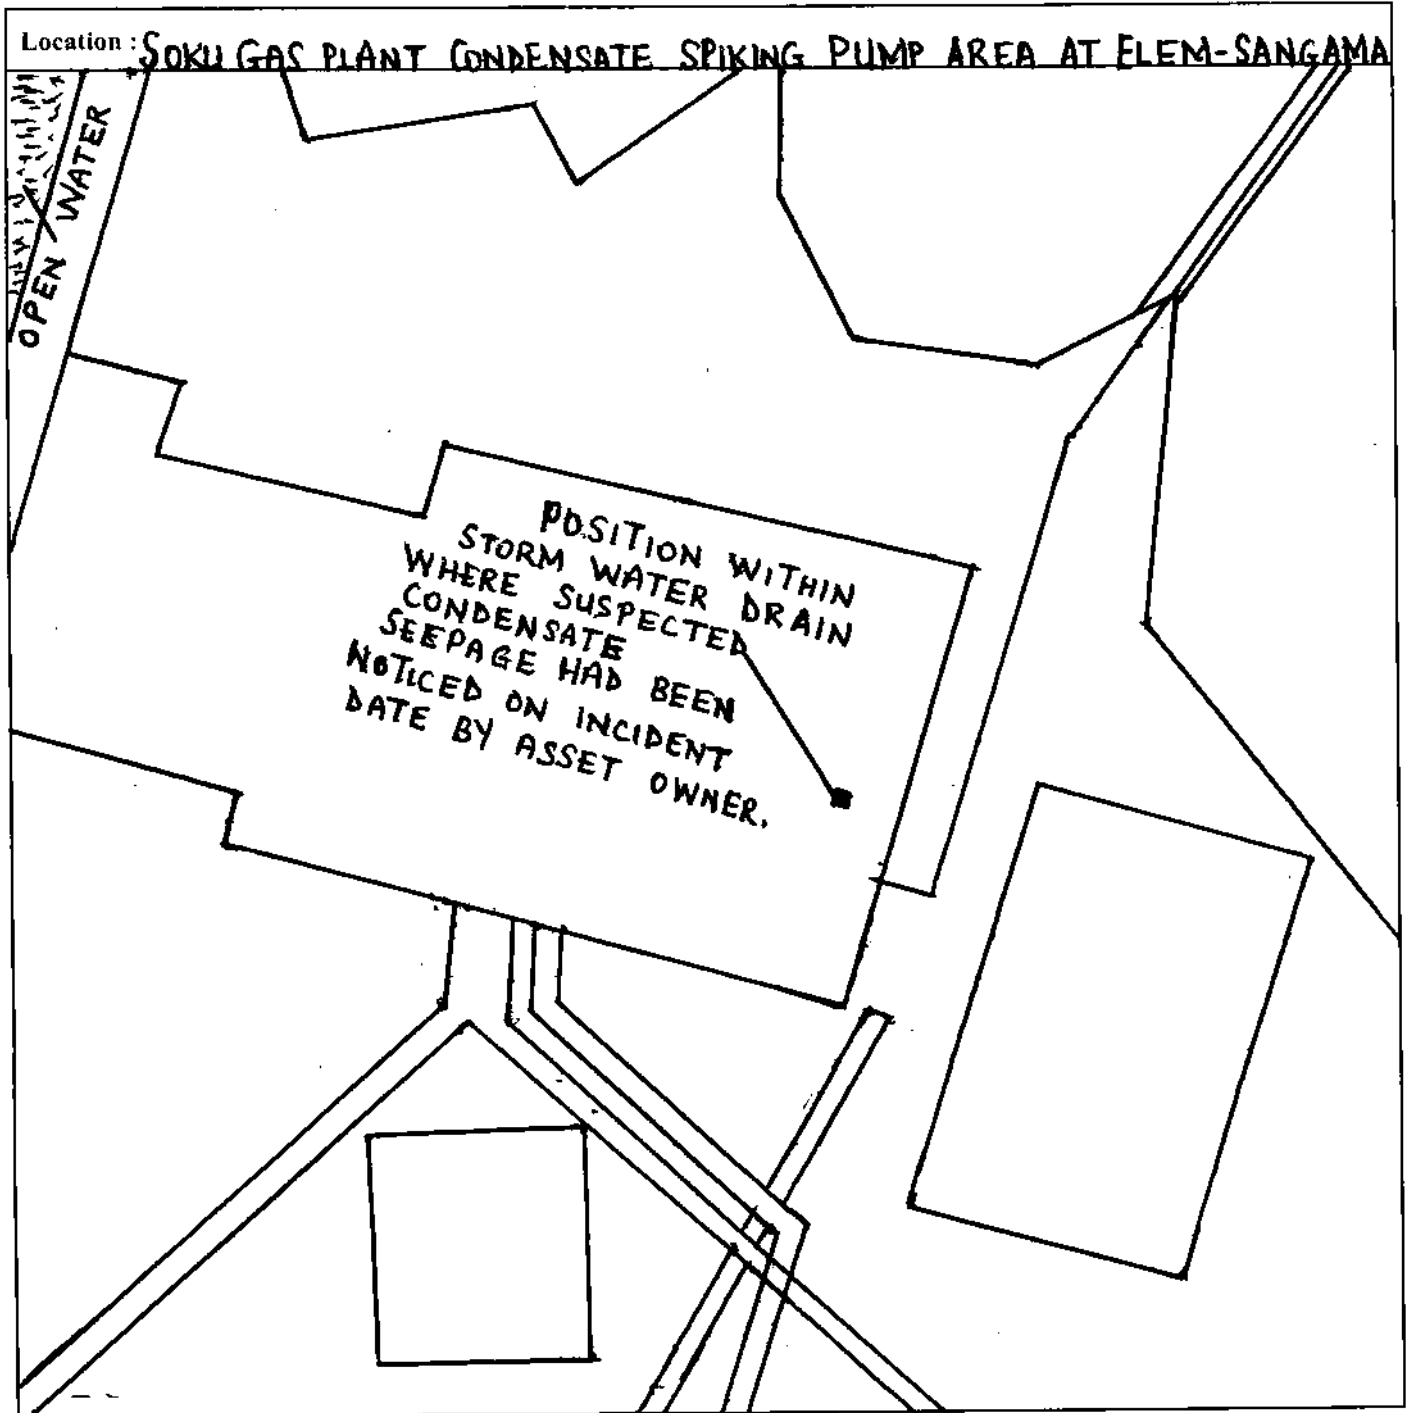
f. Appendix 1: Overview sketch of the site

Additional observations around the spill point: **THE JOINT INVESTIGATION TEAM NEITHER OBSERVED ANY SPILL POINT NOR NOTICED ANY SPILL IMPACT WITHIN THE SOKU GAS PLANT, THOUGH ON INCIDENT DATE, SUSPECTED CONDENSATE SHEEN HAD BEEN NOTICED BY THE ASSET OWNER WITHIN THE STORM WATER DRAIN BEHIND THE CONDENSATE SPIKING PUMPS. THE COORDINATES OF THE ORIGINAL POSITION WHERE THE SUSPECTED CONDENSATE SEEPAGE WAS NOTICED ARE 4.65733N AND 6.61357E.**
