JOINT INVESTIGATION REPORT

INCIDENT NO: 1796787 JIV report S/N: NO-0000306

1. Spill incident Number: 1796787 2. Type of incident* OIL SPILL
3. Name of Location 24" TRANS - ESCRAVOS PIPELINE
4. Name of nearest community OGIDIGBEN 5. State: DELTA 6. LGA WARRI SOUTH - WEST
7. Type of Production facility/Installation OIL PIPELINE
8. Asset owner/District THE SHELL PETROLEUM DEVELOPMENT COMPANY OF

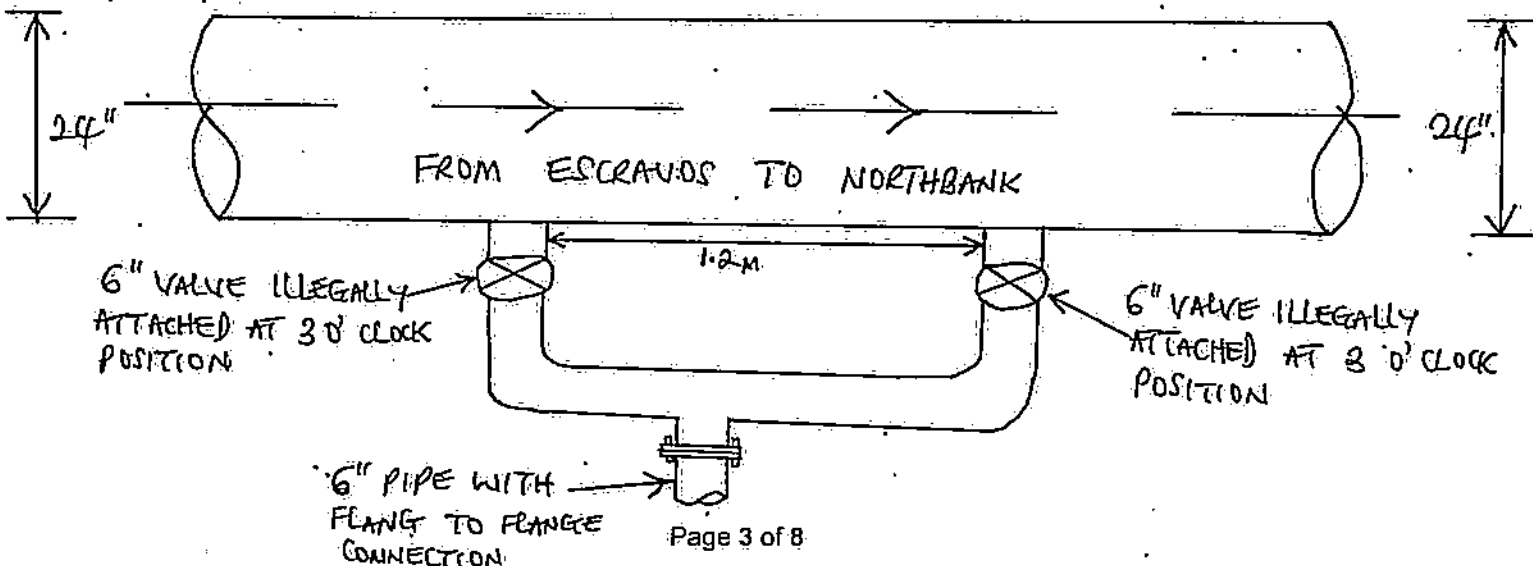
Additional observations around the spill point: ON EXCAVATION, THE JOINT INVESTIGATION TEAM OBSERVED 2 NUMBERS OF 6" VALVES (ABOUT 1.2M APART) ILLEGALLY ATTACHED TO THE 24" TRANS - ESCRAVOS PIPELINE AT 3 O'CLOCK POSITIONS RESPECTIVELY.

SECTION OF 24" TRANS - ESCRAVOS PIPELINE AT OELDIGBEN AXIS SHOWING; 2 NUMBERS OF 6" VALVES ILLEGALLY ATTACHED AT 3 O' CLOCK POSITIONS
