JOINT INVESTIGATION REPORT

INCIDENT NO: 1825711 JIV report S/N: Nº 0000269

1. Spill incident Number: 1825711 2. Type of incident* OIL SPILL
3. Name of Location AGBADA II WELL 34 S 4" FLOWLINE
4. Name of nearest community OMUEKE 5. State: RIVERS 6. LGA IKWERRE
7. Type of Production facility/Installation OIL FLOWLINE
8. Asset owner/District THE SHELL PETROLEUM DEVELOPMENT COMPANY OF NIGERIA LIMITED

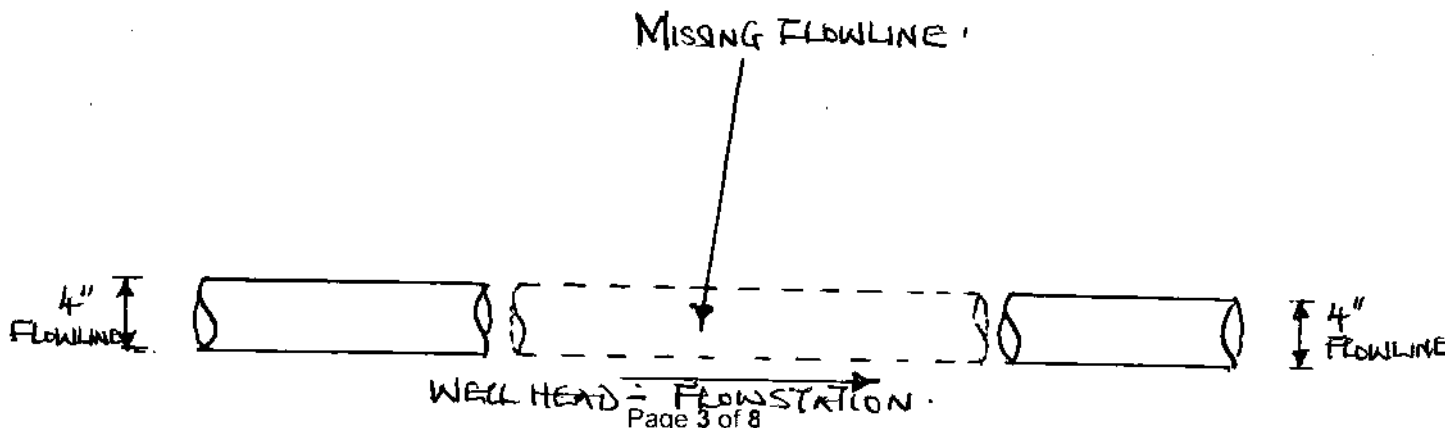
E. GRAPHIC DESCRIPTION OF LEAK POINT (while detail report of the leak point should be contained in the leak report, overview sketch of the site should be added as an appendix 1)

SECTIONAL VIEW OF AGBADA II WELL 34'S 4" FLOWLINE AT OMUEKE
SHOWING: MISSING FLOWLINE (STOLEN FLOWLINE BY UNKNOWN PERSON(S))

REPAIR WORK WAS ONGOING
