JOINT INVESTIGATION REPORT

INCIDENT NO: 2078347 JIV report S/N: 1061

1. Spill incident Number: 2078347 2. Type of incident* OIL SPILL
3. Name of Location 16" BOOSTER PUMP 2 (P-2102A) RECYCLE LINE
4. Name of nearest community BONNY 5. State: RIVERS 6. LGA BONNY
7. Type of Production facility/Installation OIL AND GAS TERMINAL
8. Asset owner/District THE SHELL PETROLEUM DEVELOPMENT COMPANY OF NIGERIA LIMITED/SWAMP EAST HUB

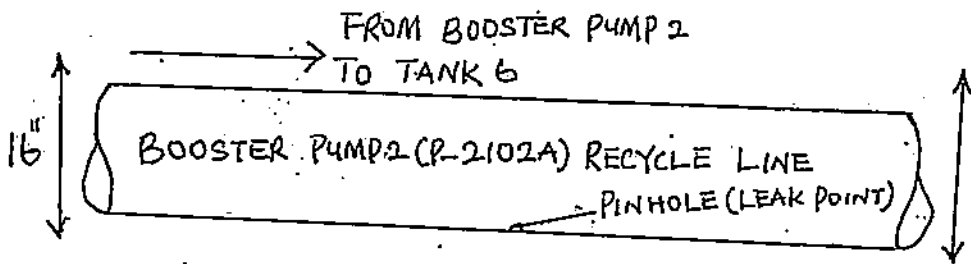
Additional observations around the spill point: THE SPILL POINT IS CLOSE TO A TARRED ACCESS ROAD AND IS SITUATED PARALLEL TO A 48" PIPELINE

| <input checked="" type="checkbox"/> Corrosion | <input type="checkbox"/> Others(specify) _____ | |

SECTION OF 16" BOOSTER PUMP 2 (P-2102A) RECYCLE LINE AT BONNY OIL AND GAS TERMINAL SHOWING PINHOLE (LEAK POINT) AT 6 O'CLOCK POSITION
