JOINT INVESTIGATION REPORT

INCIDENT NO: 2525578 JIV report S/N: 1030188

1. Fountain Incident Number: 2525578 2. Type of incident* OIL SPILL
3. Name of Location 20" KOLOCREEK - RUMUETKPE PIPELINE
4. Name of nearest community ODAN (KPO) 5. State: RIVERS 6. LGA ABUA/ODUAL
7. Type of Production facility/Installation OIL PIPELINE
8. Asset owner/District THE SHELL PETROLEUM DEVELOPMENT COMPANY OF NIGERIA LIMITED / PIPELINE

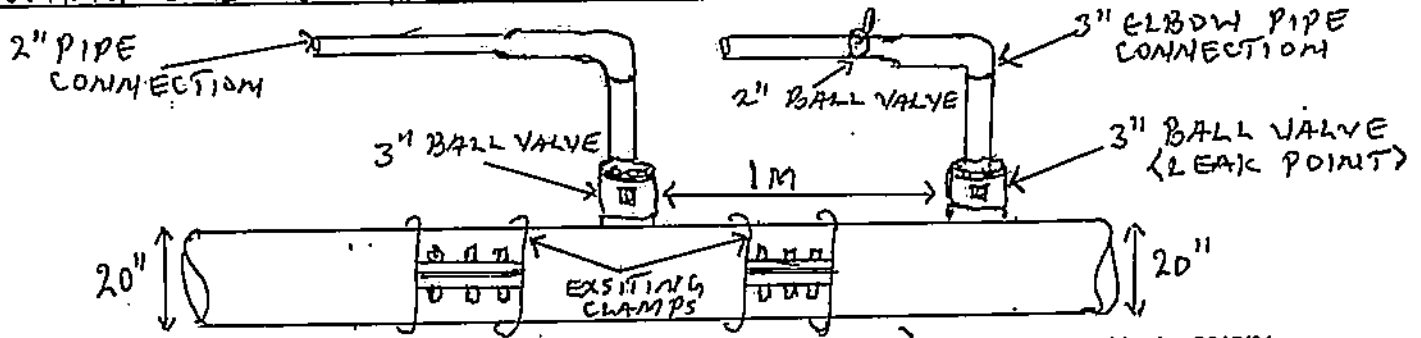
E. GRAPHIC DESCRIPTION OF LEAK POINT (while detail report of the leak point should be contained in the leak report, overview sketch of the site should be added as an appendix 1)

| <input checked="" type="checkbox"/> Failed Weld-on illegal hot tap valve | <input type="checkbox"/> Failed Clamp, | <input type="checkbox"/> Missing Pipeline/Flowline |
| <input checked="" type="checkbox"/> Crude oil theft (illegal bunkering) point, | <input type="checkbox"/> Saver-pit over flow | <input type="checkbox"/> Third party tampering with Clamp |

SECTION OF 20" KOLOCREEK - RUMUEKPE PIPELINE AT ODAY KP 19
SHOWING CRUDE OIL THEFT POINTS INSTALLED AT 12 O'CLOCK POSITION.
