# JOINT INVESTIGATION REPORT

INCIDENT NO: 2577414 JIV report S/N: 1030235

1. Fountain Incident Number: 2577414 2. Type of incident\* OIL SPILL  
3. Name of Location 28" BOMU - BONNY PIPELINE  
4. Name of nearest community BODO WEST 5. State: RIVERS 6. LGA GOKANA  
7. Type of Production facility/Installation OIL PIPELINE  
8. Asset owner/District THE SHELL PETROLEUM DEVELOPMENT COMPANY OF NIGERIA LTD (SPDC) / PIPELINE

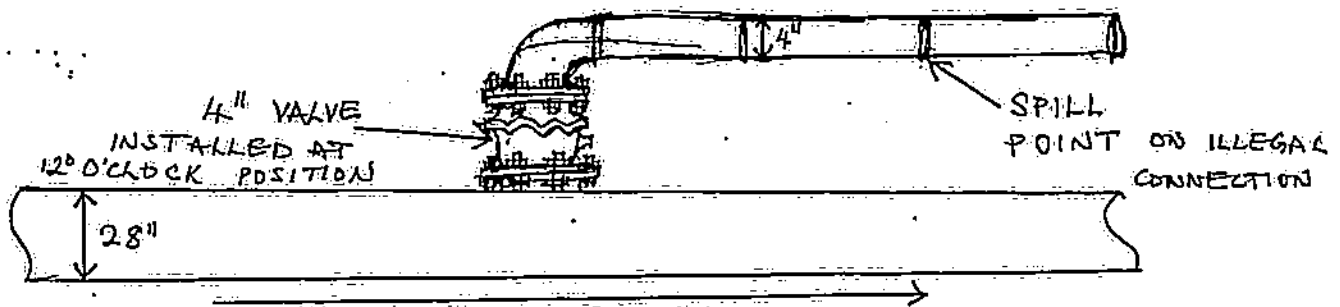
**E. GRAPHIC DESCRIPTION OF LEAK POINT** (while detail report of the leak point should be contained in the leak report, overview sketch of the site should be added as an appendix 1) A SECTION OF 28" BOTMU - BONNY PIPELINE AT BODO WEST SHOWING 4" VALVE ILLEGAL CONNECTION INSTALLED AT 12 O'CLOCK POSITION BY UNKNOWN PERSON(S)

BOMU TO BONNY

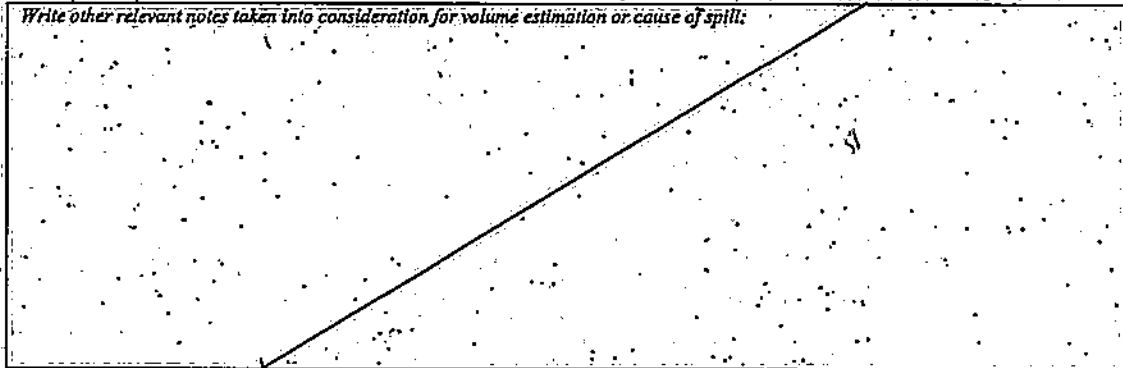
- Volume estimation was done using an excel based tool. (see attached for details on the calculation)
- Reported spilled volume is an estimate

Write other relevant notes taken into consideration for volume estimation or cause of spill:
