# JOINT INVESTIGATION REPORT

INCIDENT NO: 2551682 JIV report S/N: 1030229

1. Fountain Incident Number: 2551682 2. Type of incident\* OIL SPILL  
3. Name of Location 12' IMIRIVERI-OGALE PIPELINE AT UMUOLOLO  
4. Name of nearest community UMUOLOLO 5. State: ABIA 6. LGA UKIWA WEST  
7. Type of Production facility/Installation OIL PIPELINE  
8. Asset owner/District THE SHELL PETROLEUM DEVELOPMENT COMPANY OF NIGERIA LIMITED (SPDC) PIPELINE

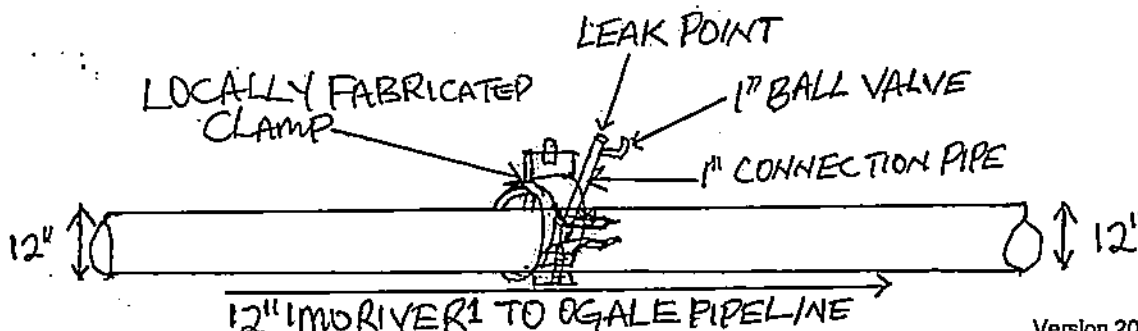
| <input checked="" type="checkbox"/> Crude oil theft (illegal bunkering) point, | <input type="checkbox"/> Saver-pit over flow | <input type="checkbox"/> Third party tampering with Clamp |

**E. GRAPHIC DESCRIPTION OF LEAK POINT** (while detail report of the leak point should be contained in the leak report, overview sketch of the site should be added as an appendix 1) A SECTION OF 12" IMDRIVER1-OGALE PIPELINE AT UMUOLDO SHOWING 1" PIPE CONNECTED AT 12 O'CLOCK POSITION BY UNKNOWN PERSON(S).

CLAMPING ON GOING
