JOINT INVESTIGATION REPORT

INCIDENT NO: 2660117 JIV report S/N: 0544

1. Fountain Incident Number: 2660117 2. Type of incident* OIL SPILL
3. Name of Location 28th NKPOKI-BOMU PIPELINE
4. Name of nearest community RUMUWITA 5. State: RIVER 6. LGA OBIO-AKPOR
7. Production Facility/Installation CRUDE OIL PIPELINE
8. Asset Owner/Hub THE SHELL PETROLEUM DEVELOPMENT COMPANY OF NIGERIA LIMITED (SPDC)/PIPELINE

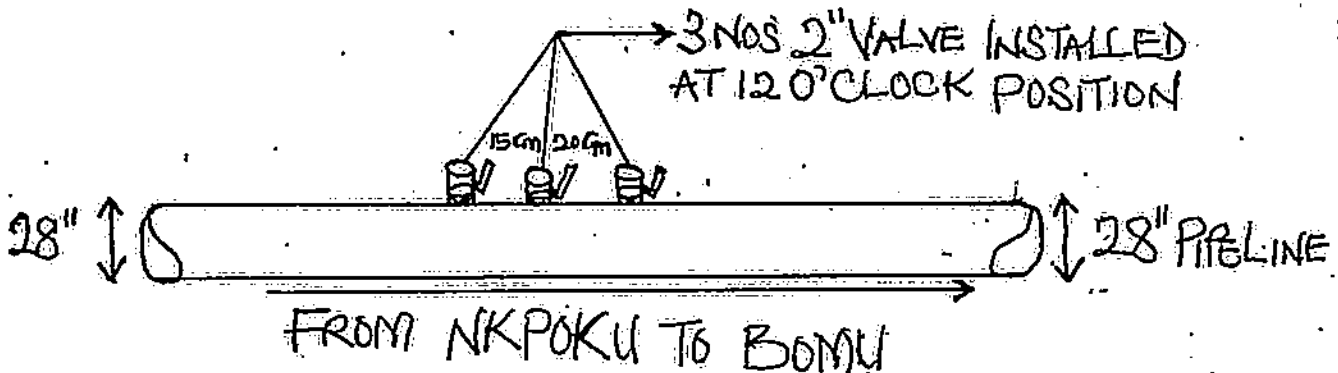
E. GRAPHIC DESCRIPTION OF LEAK POINT (while detailed description of the leak point should be contained

| <input checked="" type="checkbox"/> Crude oil-theft (illegal bunkering) point, | <input type="checkbox"/> Saver-pit over flow | <input type="checkbox"/> Third party tampering with Clamp |

in the leak report, overview sketch of the site should be added as appendix 1) A SECTION OF 28" NKPOKU-BOMU PIPELINE AT RUMUDWHA SHOWING 3 NOS 2" VALVES INSTALLED AT 12 O'CLOCK POSITION BY UNKNOWN PERSON(S).

RECOVERY OF FREE PHASE OIL IN PROGRESS.
