# JOINT INVESTIGATION REPORT

INCIDENT NO: 2659606 JIV report S/N: 0540

1. Fountain Incident Number: 2659606 2. Type of incident\* OIL SPILL  
3. Name of Location 14" OKORDIA - RUMUKPE PIPELINE  
4. Name of nearest community ULA-IKATA 5. State: RIVERS 6. LGA AAHADA EAST  
7. Production Facility/Installation: CRUDE OIL PIPELINE  
8. Asset Owner/Hub THE SHELL PETROLEUM DEVELOPMENT COMPANY  
OF NIGERIA LIMITED / PIPELINE

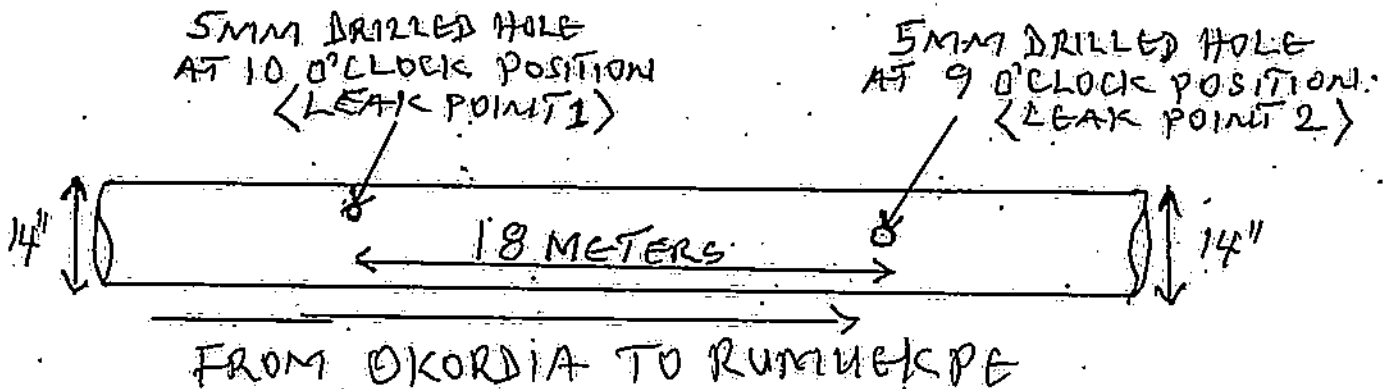
**E. GRAPHIC DESCRIPTION OF LEAK POINT** (while detailed description of the leak point should be contained in the leak report, overview sketch of the site should be added as appendix 1)

| <input checked="" type="checkbox"/> Smooth round-edge hole | <input type="checkbox"/> Rough-edge hole | <input type="checkbox"/> Hack saw cut |

SECTION OF 14" OKORDIA - RUMUKEPE PIPELINE AT ULA-IKATA SHOWING 2 NOS OF SMOOTH ROUND-EDGE HOLES (DRILLED HOLES) BY UNKNOWN PERSONS.

REPAIR WAS DONE BY CLAMPING
