JOINT INVESTIGATION REPORT

INCIDENT NO: 2611470 JIV report S/N: 0557

1. Fountain Incident Number: 2611470 2. Type of incident* OIL SPILL
3. Name of Location 28th NKPOKU - BOMU PIPELINE
4. Name of nearest community RUMUEKHARA 5. State: RIVERS 6. LGA OBIO /AKPOR
7. Production Facility/Installation OIL PIPELINE
8. Asset Owner/Hub THE SHELL PETROLEUM DEVELOPMENT COMPANY OF NIGERIA LIMITED (SPDC) / PIPELINE

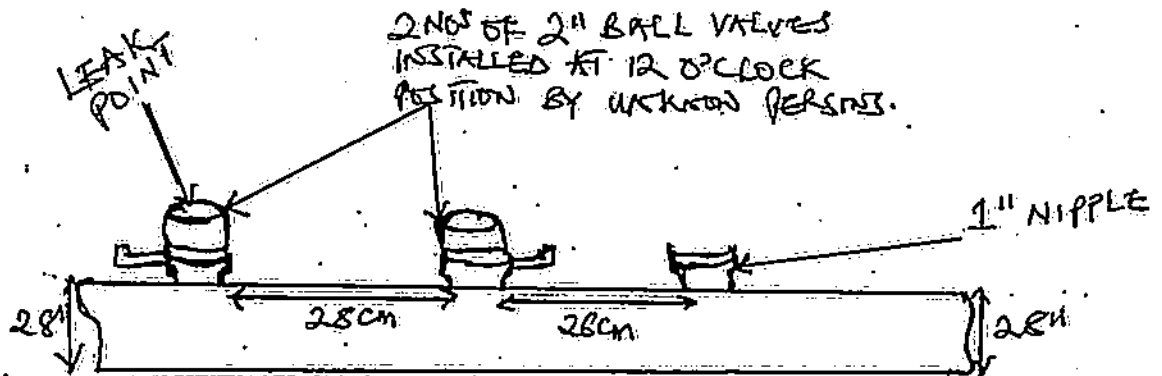
A SECTION OF 28" NIKPOKU - BOMU PIPELINE AT RUMUKHARA SHOWING 2 NOS OF 2" BALL VALVES AND 1 NO OF 1" NIPPLE INSTALLED AT 12 O'CLOCK POSITION BY UNKNOWN PERSONS.

FROM NIKPOKU - BOMU PIPELINE
