JOINT INVESTIGATION REPORT

INCIDENT NO: 2731466 JIV report S/N: 0551

UBIE FLOWSTATION SAVER PIT AT IDU-EKPEYE

INCIDENT NO:2731466

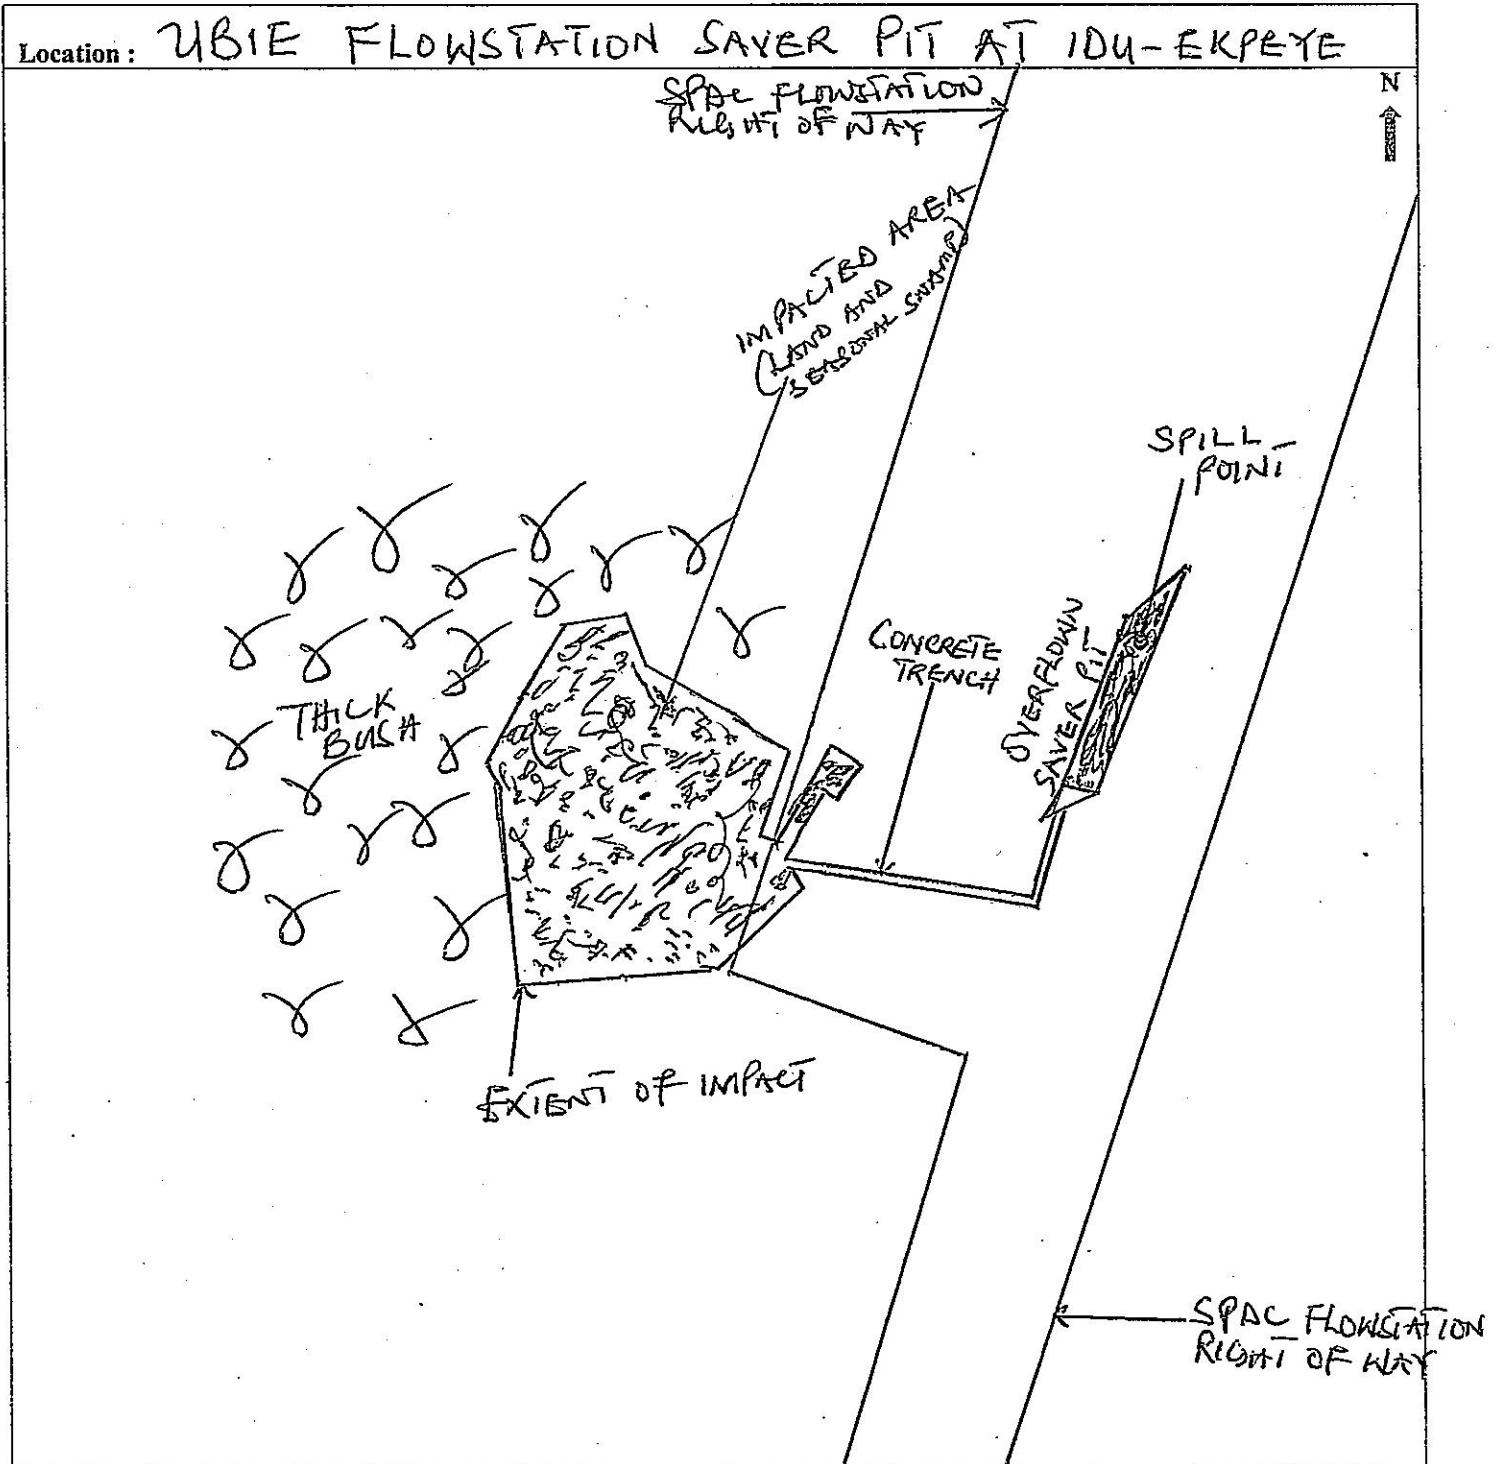
f. Appendix 1: Overview sketch of the site

E. GRAPHIC DESCRIPTION OF LEAK POINT (while detailed description of the leak point should be contained in the leak report, overview sketch of the site should be added as appendix 1) A SECTION OF UBIE FLOW STATION SAVER PIT AT IDU-EKPEYE SHOWING OVERFLOWN SAVER PIT.
