JOINT INVESTIGATION REPORT

INCIDENT NO: 2911074 JIV report S/N: 0511

1. Fountain Incident Number: 2911074 2. Type of incident* OIL SPILL
3. Name of Location 18" ASSA - RUMUEKPE (TRUNKLINE) PIPELINE
4. Name of nearest community ELELE ALUMINS 5. State: RIVERS 6. LGA EMOHTUA
7. Production Facility/Installation OIL PIPELINE
8. Asset Owner/Hub THE SHELL PETROLEUM DEVELOPMENT COMPANY OF NIGERIA LIMITED / PIPELINE

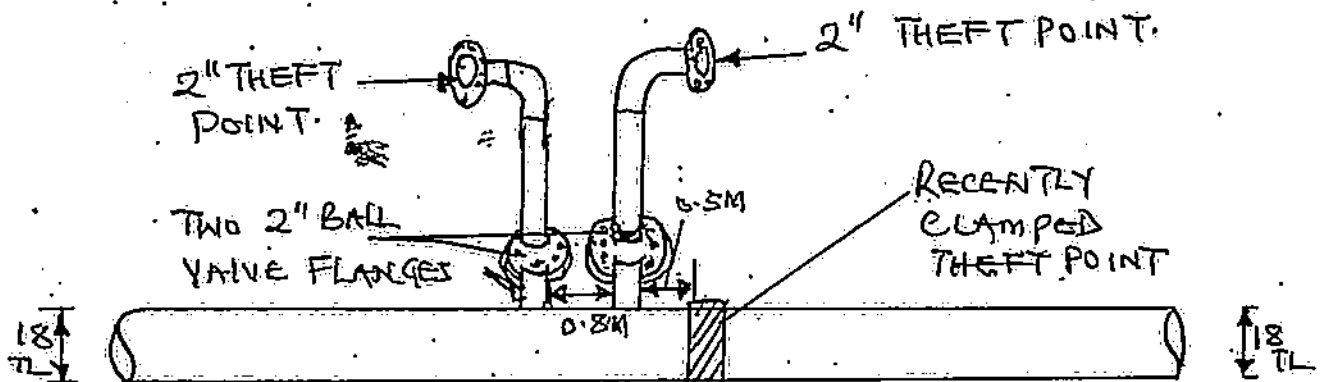
Additional observations around the spill point: THE INVESTIGATION TEAM OBSERVED THAT THE SPILL OCCURRED AS A RESULT OF TWO THEFT POINTS INSTALLED AT 0.5M AWAY FROM THE RECENTLY CLAMPED THEFT POINT INCIDENT.

| <input checked="" type="checkbox"/> Failed Weld-on-illegal hot tap valve | <input type="checkbox"/> Failed Clamp, | <input type="checkbox"/> Missing Pipeline/Flowline |
| <input checked="" type="checkbox"/> Crude oil theft (illegal bunkering) point, | <input type="checkbox"/> Saver-pit over flow | <input type="checkbox"/> Third party tampering with Clamp |

SECTIONAL VIEW OF 18" ASSA-RUMUKEPE (TRUNKLINE) PIPELINE AT ELELE ALIMINI. SHOWING TWO 2" THEFT FITTINGS INSTALLED AT 12 O'CLOCK POSITION.

RECOVERY WORK OF SPILL CRUDE COMMENCE AND IS ON GOING WHILE REPAIR WORK BY CLAMPING COMPLETED.
