JOINT INVESTIGATION REPORT

INCIDENT NO: 2917010 JIV report S/N: 0000760

1. Fountain Incident Number: 2917010 2. Type of incident* OIL SPILL
3. Name of Location 14" OKORDIA - RUMUEKPE PIPELINE
4. Name of nearest community UKPELEDEGE, State RIVERS 6. LGA AHEADADA-WEST
7. Production Facility/Installation OIL PIPELINE
8. Asset Owner Hub THE SHELL PETROLEUM DEVELOPMENT COMPANY OF NIGERIA LIMITED (SPDC) / PIPELINE

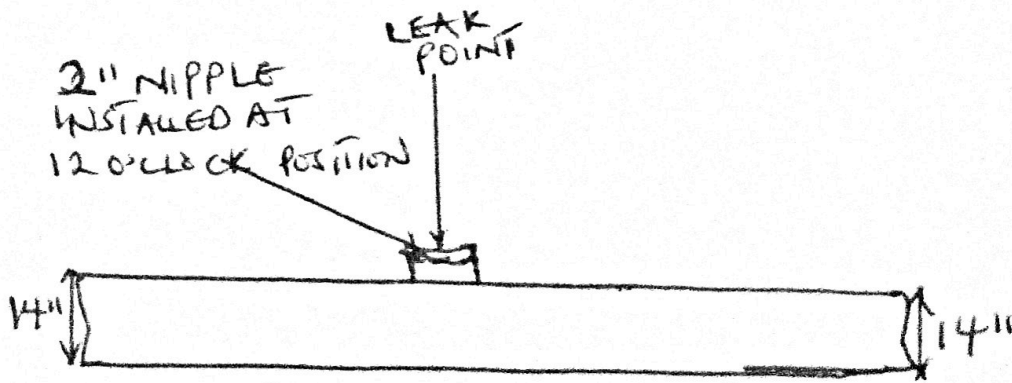
E. GRAPHIC DESCRIPTION OF LEAK POINT (while detailed description of the leak point should be contained in the leak report, overview sketch of the site should be added as appendix 1)

| <input checked="" type="checkbox"/> Crude oil theft (illegal bunkering) point, | <input type="checkbox"/> Saver-pit over flow | <input type="checkbox"/> Third party tampering with Clamp |

A SECTION OF 14" OKORDIA-RUMUKEPE PIPING AT UKPELEDE SHOWING A 2" NIPPLE INSTALLED AT 12 O'CLOCK POSITION DONE BY UNKNOWN PERSONS.

FROM OKORDIA TO RUMUKEPE PIPING

REPAIR BY CLAMPING

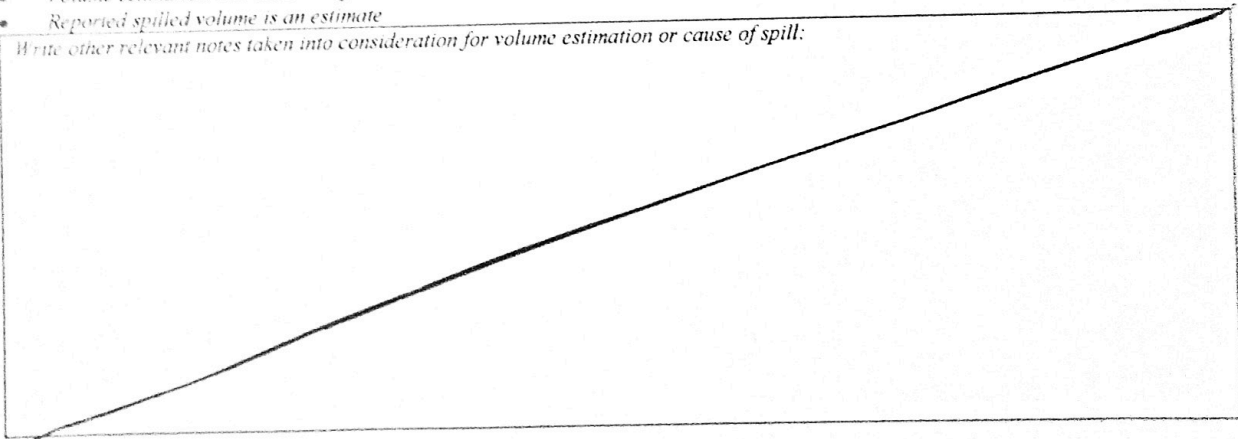
c. Net Estimated Spilled Volume $V_{\text{Est}}(\text{bbbls})^* = \underline{8.47 \text{ BARRELS}}$

- Volume estimation was done using an excel based tool. (see attached for details on the calculation)
- Reported spilled volume is an estimate
