JOINT INVESTIGATION REPORT

INCIDENT NO: 2919714 JIV report S/N: 0000835

1. Fountain Incident Number: 2919714 2. Type of incident* OIL SPILL
3. Name of Location 36" RUMUEKPE - NKPOKU PIPELINE
4. Name of nearest community ADANTA-ISIKPO 5. State: RIVERS 6. LGA IKWERRE
7. Production Facility/Installation PIPELINE
8. Asset Owner/Hub THE STEEL PETROLEUM DEVELOPMENT COMPANY OF NIGERIA LIMITED (SPD)/PIPELINE

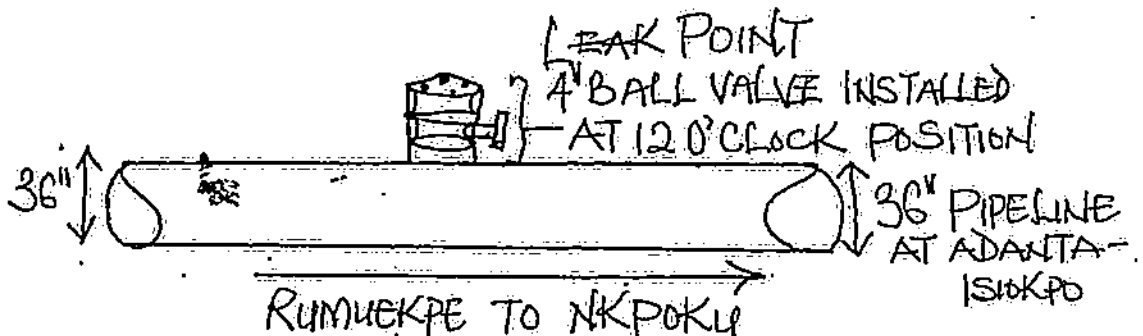
| <input checked="" type="checkbox"/> Crude oil theft (illegal bunkering) point, | <input type="checkbox"/> Saver-pit over flow | <input type="checkbox"/> Third party tampering with Clamp |

E. GRAPHIC DESCRIPTION OF LEAK POINT (while detailed description of the leak point should be contained in the leak report, overview sketch of the site should be added as appendix 1) A SECTION OF 36" RUMUEKPE-NKPOKU PIPELINE AT ADANTA-ISIOKPO SHOWING A 4" BALL VALVE INSTALLED AT TWELVE 12 O'CLOCK POSITION BY UNKNOWN PERSON(S)

REPAIR BY CLAMPING

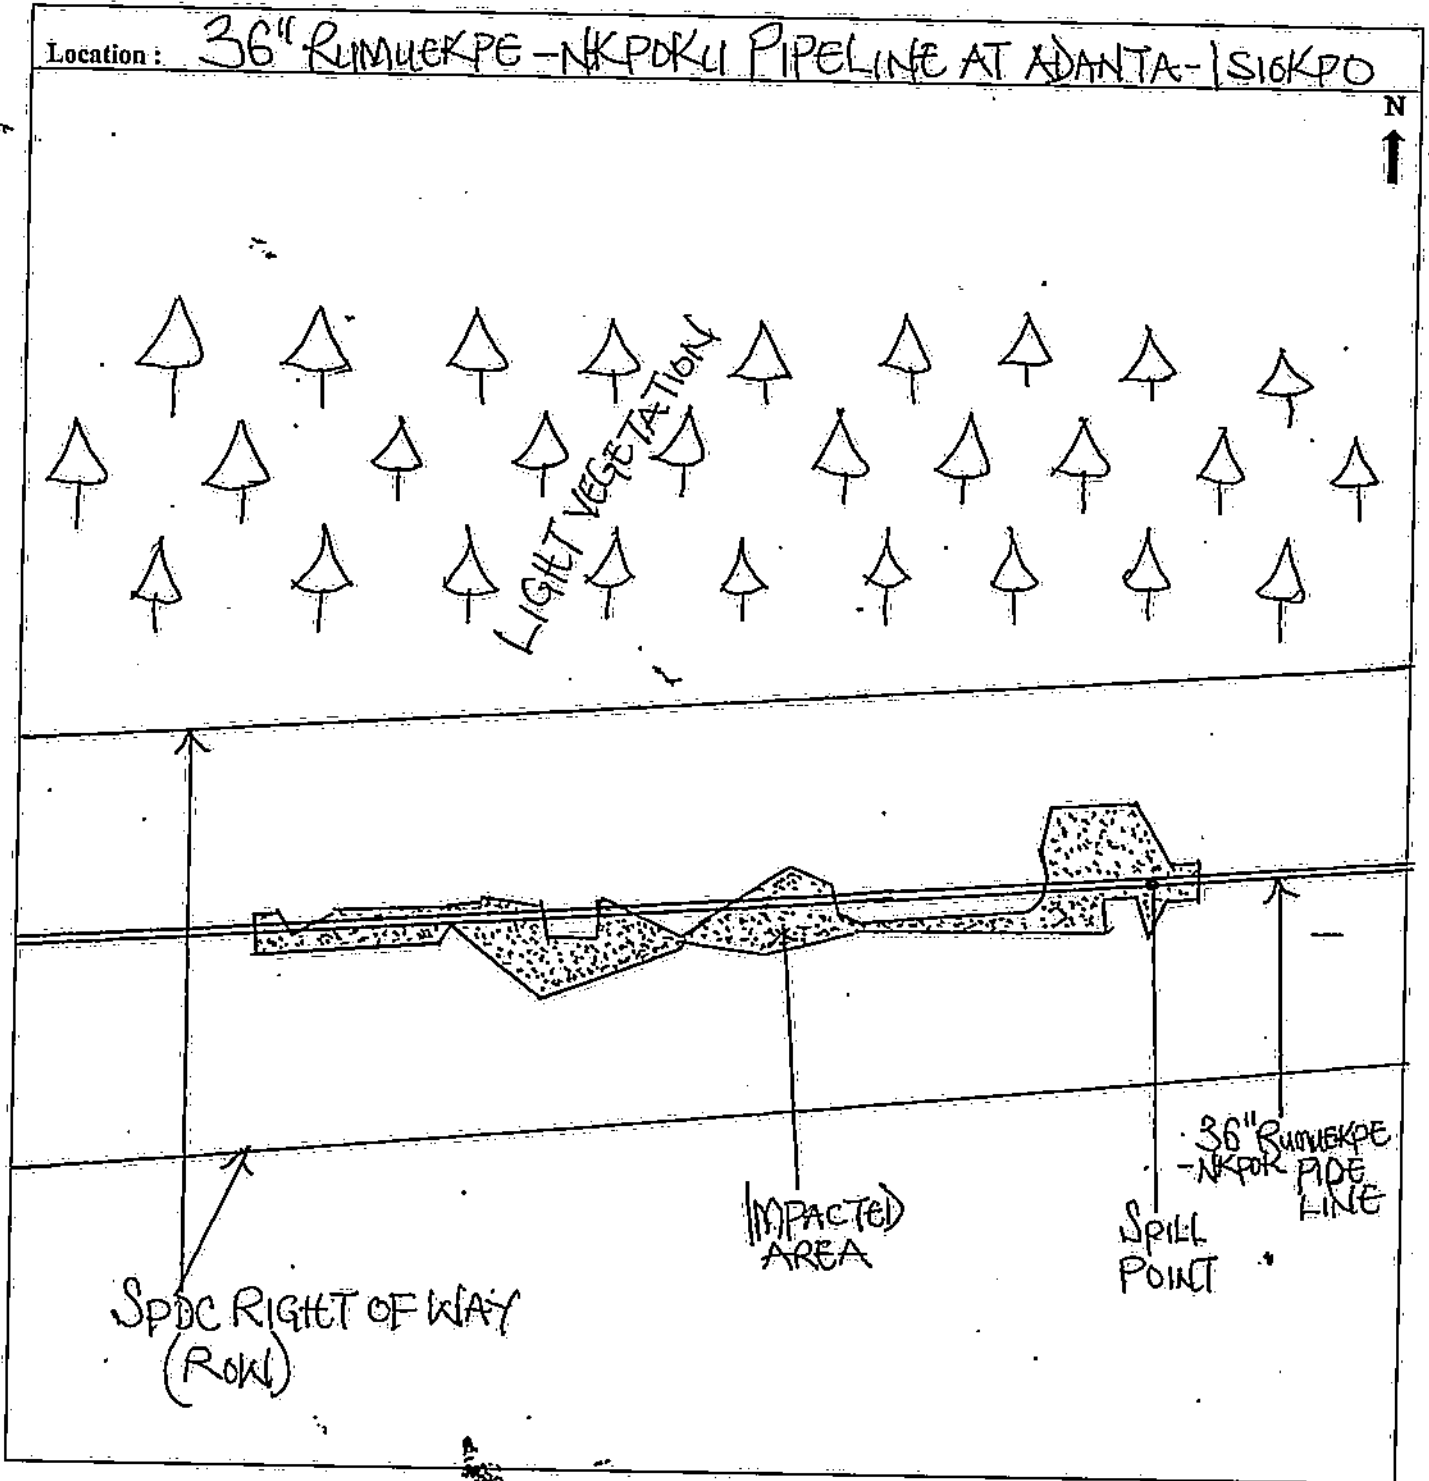
f. Appendix 1: Overview sketch of the site.

Spill along 36" Rumuekpe to Nkpoku Pipeline at Adanta - Isiokpo
Incident No.: 2919714, Date of incident:18/04/2021 Date of Jiv: 20/04/2021.

PT_ID	LONG	LAT
80	6.88374	4.9519
81	6.88378	4.95189
82	6.88378	4.95187
83	6.88371	4.95184
84	6.8837	4.9518
85	6.88369	4.95186
86	6.88362	4.95187
87	6.88362	4.9518
88	6.88322	4.95181
89	6.88313	4.95181
90	6.88302	4.9518
91	6.88294	4.95178
92	6.88253	4.9518
93	6.88248	4.95182
94	6.88239	4.9519
95	6.88238	4.95192
96	6.88235	4.95189
97	6.88198	4.95188
98	6.88199	4.95192
99	6.88201	4.95192
100	6.88203	4.9519
101	6.88213	4.95193
102	6.88231	4.95193
103	6.88242	4.95193
104	6.88248	4.95194
105	6.88251	4.95195
106	6.88257	4.95192
107	6.8826	4.95189
108	6.8826	4.95185
109	6.88272	4.95182
110	6.88275	4.95185
111	6.88287	4.9518
112	6.88292	4.95187
113	6.88296	4.95191
114	6.88301	4.95188
115	6.88302	4.95184
116	6.88308	4.95182
117	6.8834	4.95184
118	6.88344	4.95186
119	6.88346	4.95189
120	6.88346	4.95195
121	6.88349	4.95201
122	6.88367	4.95201
123	6.88374	4.9519
SP	6.88371	4.95187

- Total calculated area of impact (Ha) 0.1491 Ha
- Impact within SPDC R.O.W YES
- Impact outside SPDC R.O.W NO
