JOINT INVESTIGATION REPORT

INCIDENT NO: 2929141 JIV report S/N: 0000838

1. Fountain Incident Number: 2929141 2. Type of incident* OIL SPILL
3. Name of Location 28" BOMU - BONNY PIPELINE
4. Name of nearest community MOGHO 5. State: RIVERS 6. LGA GOKANA
7. Production Facility/Installation CRUDE OIL PIPELINE
8. Asset Owner/Hub THE SHELL PETROLEUM DEVELOPMENT COMPANY
OF NIGERIA LIMITED / PIPELINE

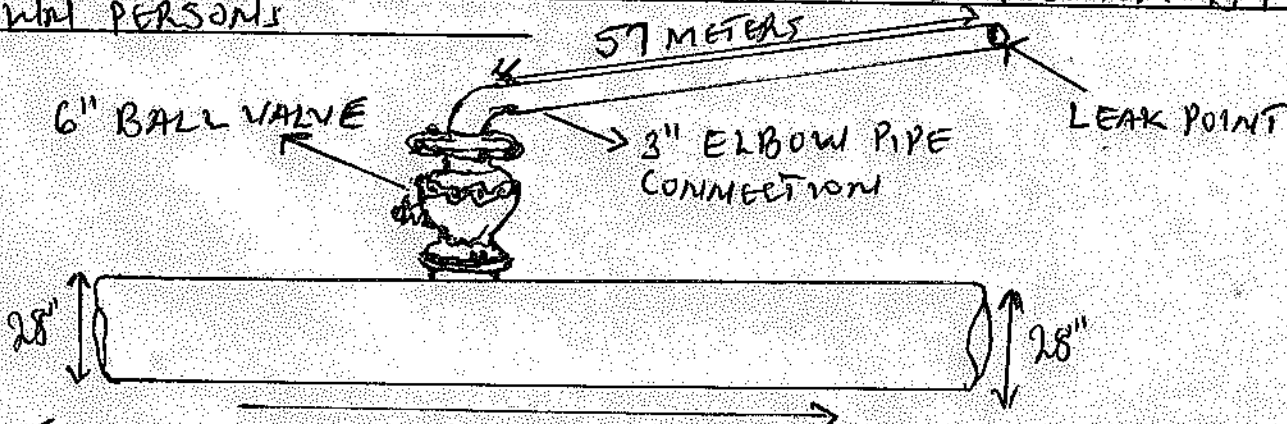
| <input checked="" type="checkbox"/> Crude oil theft (illegal bunkering) point, | <input type="checkbox"/> Saver-pit over flow | <input type="checkbox"/> Third party tampering with Clamp |

SECTION OF 28" BOMU - BONNY PIPELINE AT MOGHO SHOWING CRUDE OIL LEAK POINT INSTALLED AT 12 O'CLOCK POSITION BY UNKNOWN PERSONS

FROM BOMU TO BONNY

REPAIR WORK ONGOING.
