JOINT INVESTIGATION REPORT

INCIDENT NO: 2999591 JIV report S/N: 0000892

1. Fountain Incident Number: 2999591 2. Type of incident* OIL SPILL
3. Name of Location 4" IMORIVER WELL HT FLOWLINE
4. Name of nearest community OWAZA 5. State: ABIA 6. LGA UKWA WEST
7. Production Facility/Installation CRUDE OIL FLOWLINE
8. Asset Owner/Hub THE SHELL PETROLEUM DEVELOPMENT COMPANY
OF NIGERIA LIMITED / LAND EAST HUB

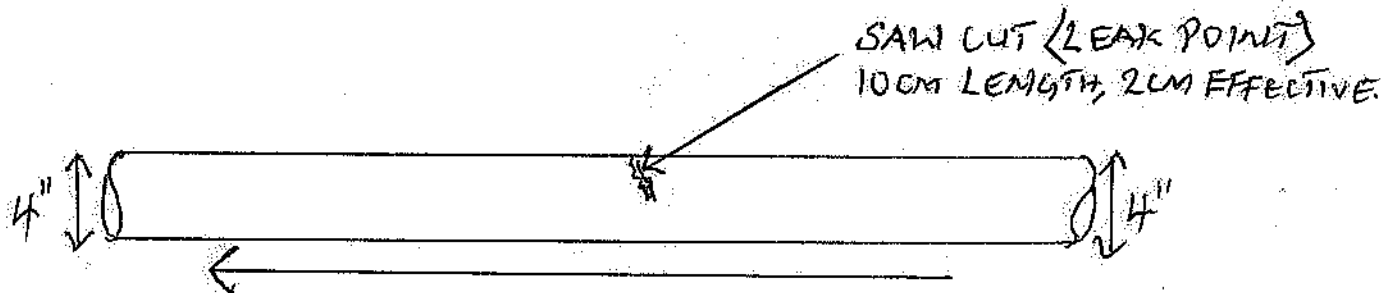
E. GRAPHIC DESCRIPTION OF LEAK POINT (while detailed description of the leak point should be contained in the leak report, overview sketch of the site should be added as appendix 1)

LONG STRETCH OF AN EXCAVATED TRENCH WAS OBSERVED.

| <input type="checkbox"/> Smooth round-edge hole | <input type="checkbox"/> Rough-edge hole | <input checked="" type="checkbox"/> Hack saw cut |

SECTION OF 4" IMP RIVER WELL 4T FLOWLINE AT DWAZA SHOWING SAW CUT BY UNKNOWN PERSONS AT 10-11 O'CLOCK POSITION.

FROM WELL 4T TO FLOW STATION.
