# JOINT INVESTIGATION REPORT

INCIDENT NO: 2935473 JIV report B/N: 0000771

1. Fountian Incident Number: 2935473 2. Type of incident\* OIL SPILL  
3. Name of Location 18<sup>th</sup> ASSA - RUMUEKPE PIPELINE  
4. Name of nearest community OCHIA 5. State: IMO 6. LGA OHAIJI-EGBENNA  
7. Production Facility/Installation PIPELINE  
8. Asset Owner/Hub THE SHELL PETROLEUM DEVELOPMENT COMPANY OF NIGERIA LIMITED (SPDC)/PIPELINE

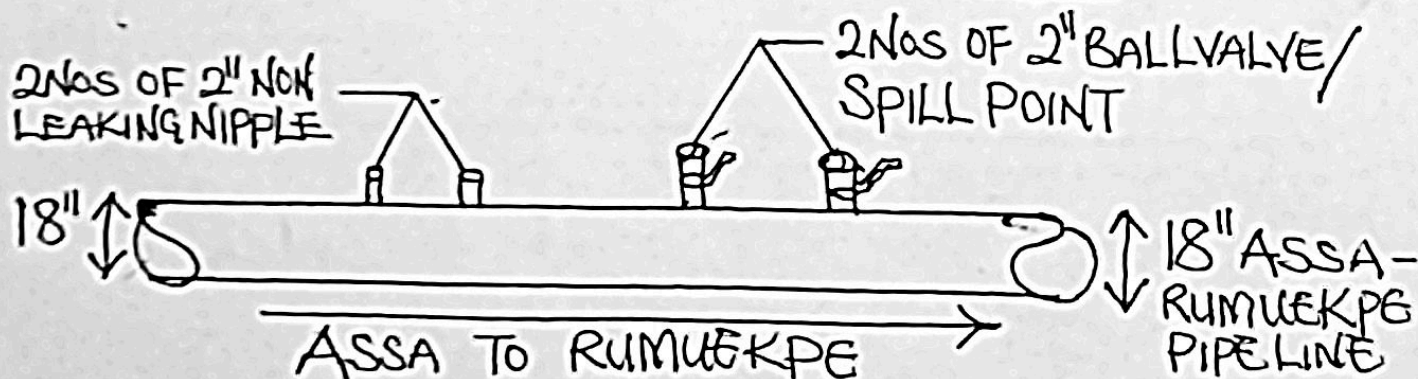
E. GRAPHIC DESCRIPTION OF LEAK POINT (while detailed description of the leak point should be contained in the leak report overview sketch of the site should be added as appendix 1)

A SECTION OF 18" ASSA-RUMUEKPE PIPELINE AT OCHIA SHOWING 2 NOS OF 2" LEAKING BALL VALVES AND 2 NOS OF NON-LEAKING 2" NIPPLE INSTALLED AT 12 O'CLOCK POSITION BY UNKNOWN PERSON(S).

REPAIR BY CLAMPING
