JOINT INVESTIGATION REPORT

INCIDENT NO: 1692847 JIV report S/N: Nº 0000172

1. Spill incident Number: 1692847 2. Type of incident* OIL SPILL
3. Name of Location OBIGBO NORTH WELL 12 WELL HEAD
4. Name of nearest community UZUAKU 5. State: ABIA 6. LGA UKWA WEST
7. Type of Production facility/Installation WELL HEAD
8. Asset owner/District THE SHELL PETROLEUM DEVELOPMENT COMPANY OF NIGERIA LIMITED

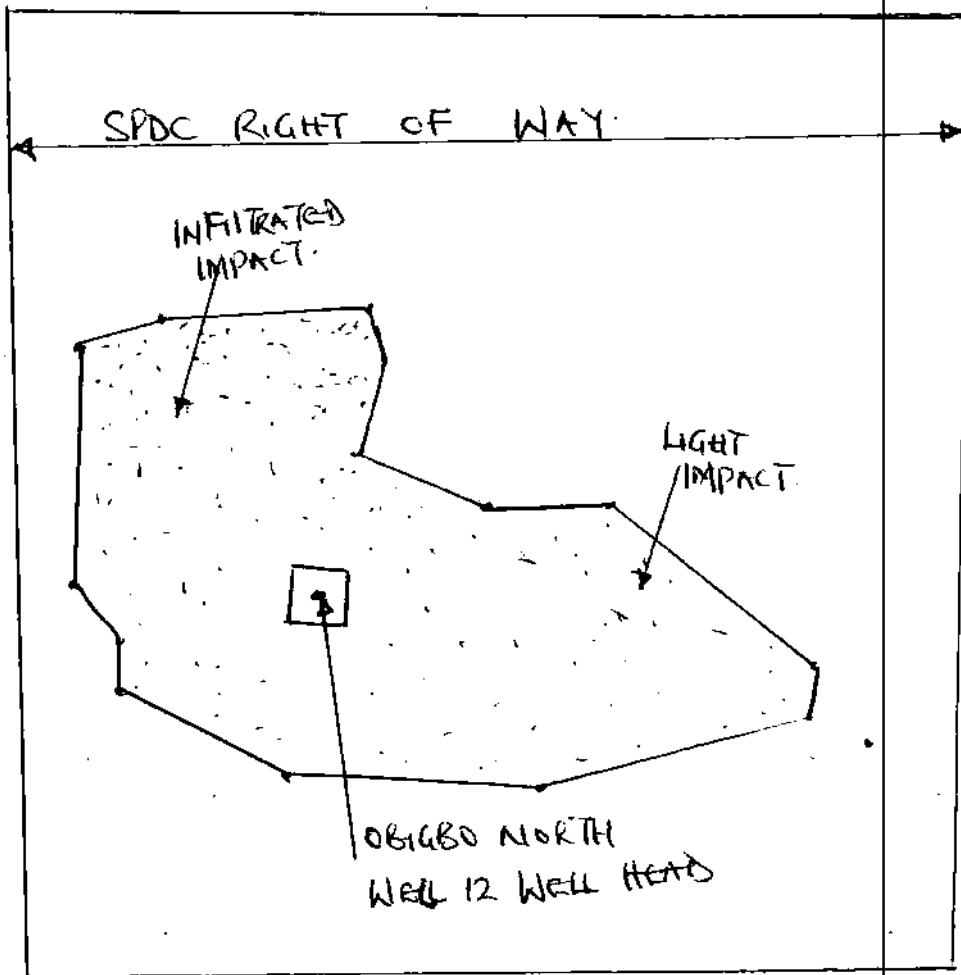
f. Appendix 1: Overview sketch of the site

SPILL DUE TO CRUDE OIL DISCHARGE BY UNKNOWN PERSON(S) AROUND THE
OBIGBO WELL 12 WELL HEAD AT UZUAKY WITH EVIDENCE OBSERVED AS
STATED BELOW:-

- * NO SPILL POINT (MYSTERY SPILL)
- * NONE RETURN VALVE (NRV) WAS INSTALLED IN 2003.
- * TYRE TRACKS FROM VEHICLE SUSPECTED TO HAVE DISCHARGED CRUDE OIL WERE NOTICED.
- * VISUAL CHECK SHOWS NO INDICATION OF ANY LEAK FROM WELL HEAD
- * CLEAN BLACK WATER AROUND WELL HEAD CELLAR PIT.

Location: OBIGBO NORTH WELL 12 WELL HEAD AT UZUNKU
