THE SHELL PETROLEUM DEVELOPMENT COMPANY OF NIGERIA LIMITED.

JOINT INVESTIGATION REPORT FOR INCIDENT NO: 1158417 JIV report S/N: 0561

1. Spill incident Number: 1158417 2. Type of incident* OIL SPILL
 3. Name of Location OTUMARA WELL-41s FLOWLINE
 4. Name of nearest community UGBOEGUNGUN State: DELTA 6. LG WARRI SOUTH WEST
 7. Type of Production facility/Installation FLOWLINE 8. Asset owner/District PNWS

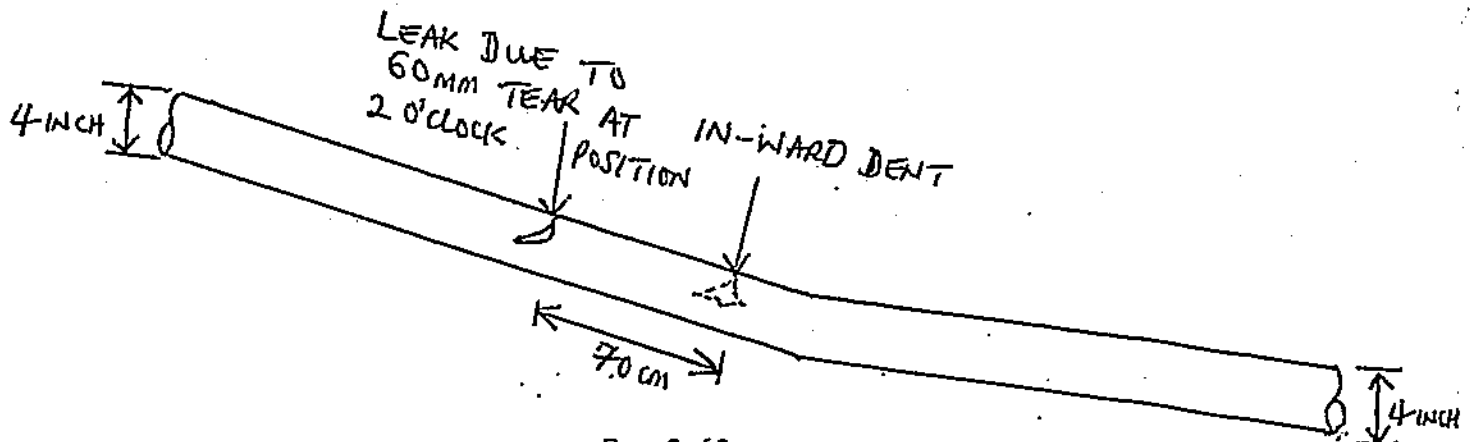
| <input type="checkbox"/> Drilled hole | <input type="checkbox"/> Hack saw cut | <input checked="" type="checkbox"/> Tear (<u>60mm</u>), |
| <input type="checkbox"/> Complete Rupture | <input checked="" type="checkbox"/> Inward dent, | <input type="checkbox"/> Well head tampering |
| <input type="checkbox"/> Relief valve failure | <input checked="" type="checkbox"/> Others (specify) <u>ACCIDENTAL FLOWLINE DAMAGE AT 2 O' CLOCK POSITION</u> | |

SECTIONAL VIEW OF OTUMARA WELL-415 FLOWLINE AT UGBOEGUNGUN
SHOWING :- PIPE TEAR AND INWARD DENT

If yes to item 14, give brief description:
FURTHER ORR RESPONSE IS NOT REQUIRED (OIL SHEEN ON SURFACE WATER),
SECTIONAL REPLACEMENT OF FLOWLINE COMMENCED IMMEDIATELY.

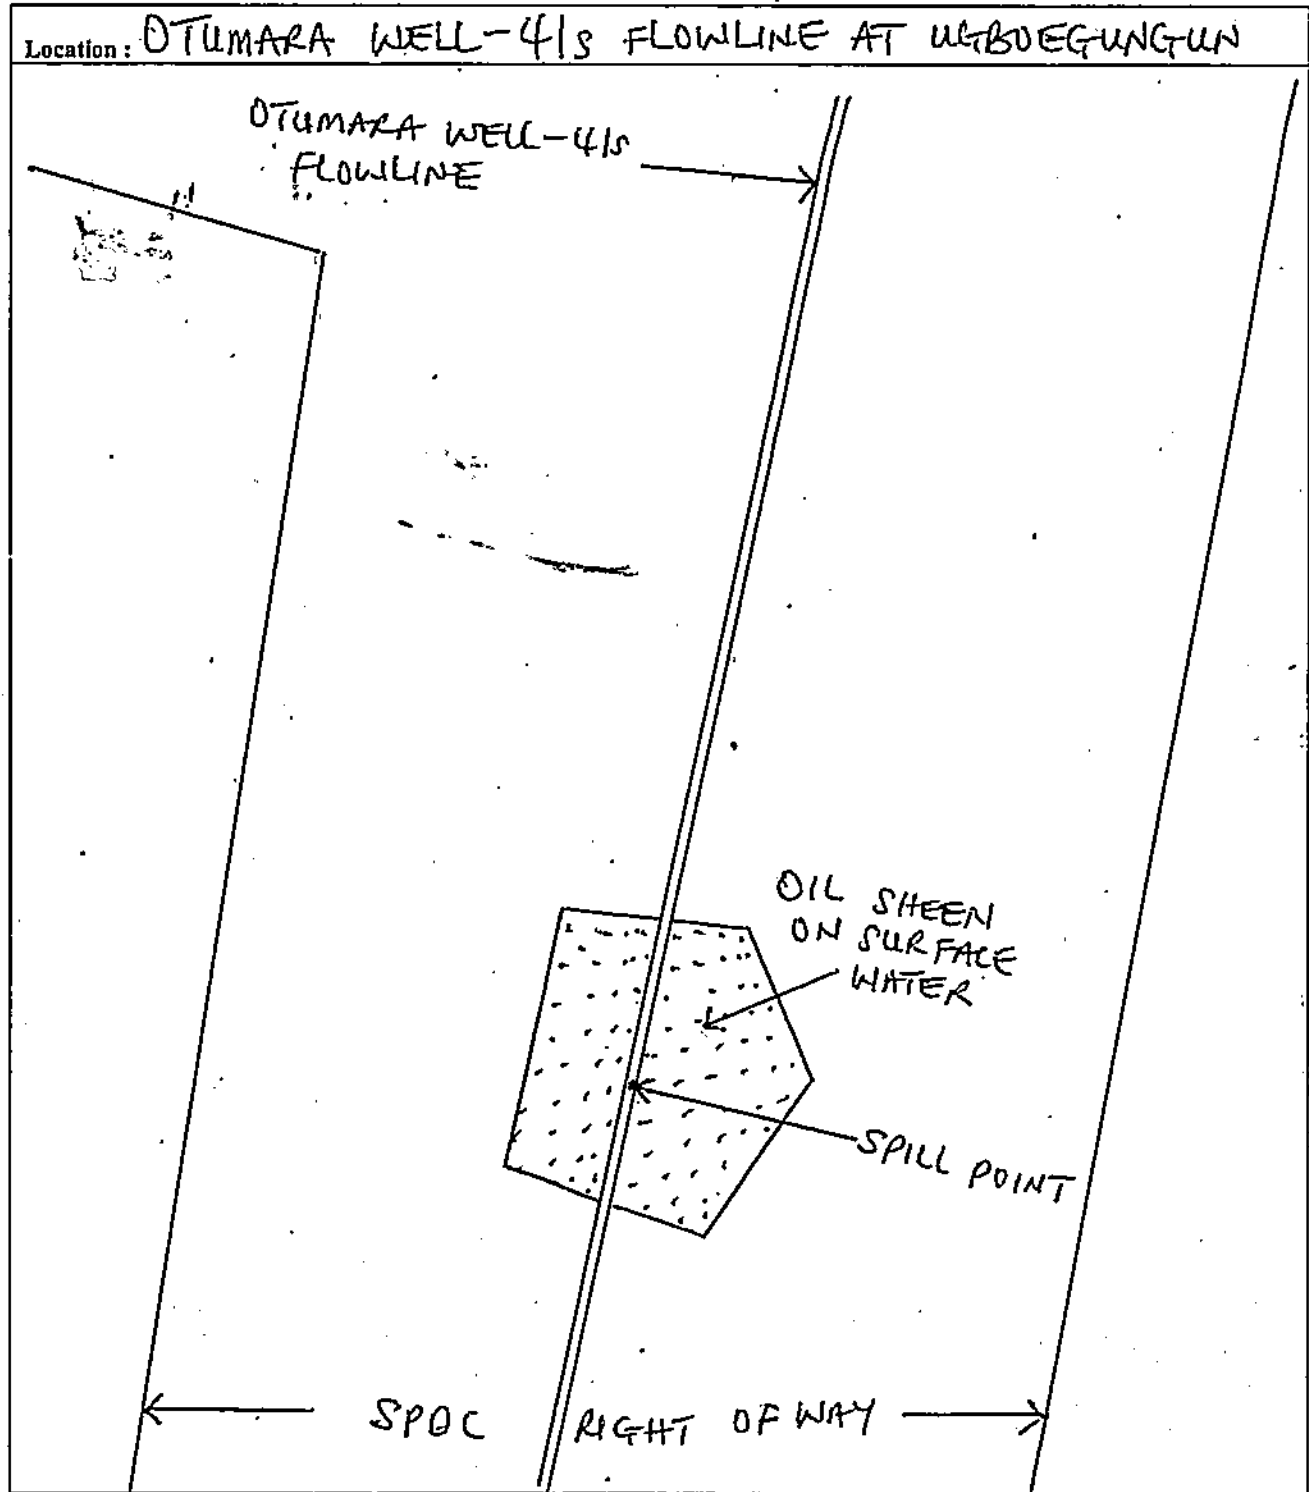
25. Appendix 1: Overview sketch of the site

Additional observations around the spill point: THE LEAK POINT WAS SUB-MERGED AND THERE WERE VARIABLE COLORATION OF OIL SHEEN AROUND THAT POINT. THE LEAK POINT IS LESS THAN 5M FROM THE DAEWOD CONSTRUCTION WORK SITE.
