**THE SHELL PETROLEUM DEVELOPMENT COMPANY OF NIGERIA LIMITED.**

JOINT INVESTIGATION REPORT FOR INCIDENT NO: 1157398 JIV report S/N: 0516

1. Spill incident Number: 1157398 2. Type of incident\* OIL SPILL  
 3. Name of Location 36" NKPOKU - BOMU PIPELINE  
 4. Name of nearest community AIALI 5. State: RIVERS 6. LGA OBIO/AKPO  
 7. Type of Production facility/Installation OIL PIPELINE 8. Asset owner/District PIPELINE

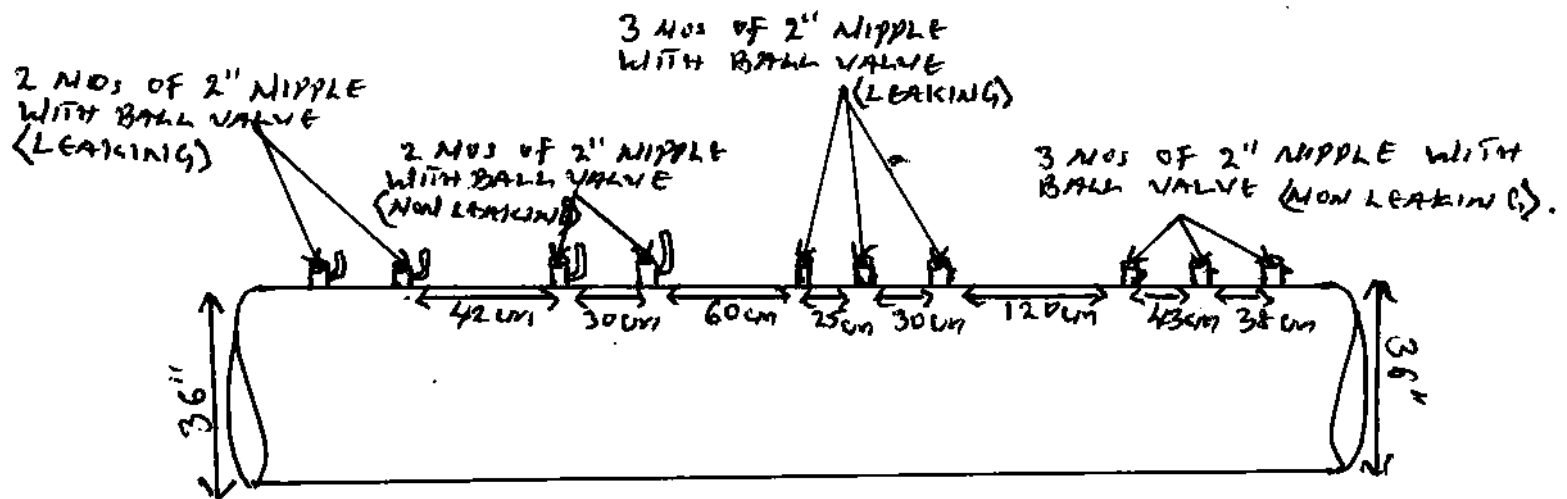
E. GRAPHIC DESCRIPTION OF LEAK POINT (while detail report of the leak point should be contained in the leak report, overview sketch of the site should be added as an appendix 1)

SECTION OF 36" NKPOKU - BOMU PIPELINE AS AIALI SHOWING POSITIONS OF 10 NOS CRUDE OIL THEFT POINTS AT 12 O'CLOCK POSITION

FROM NKPOKU TO BOMU.

Additional observations around the spill point: THE SPILL POINT AREA WAS PREVIOUSLY EXCAVATED. CONCRETE WAS OBSERVED AT SPILL POINT. SEVEN OUT OF TEN CRUDE OIL THEFT POINTS WAS REPAIRED BY SLAMPING, ONE BY CAPPING AND OTHER TWO ARE YET TO BE REPAIRED.
