**THE SHELL PETROLEUM DEVELOPMENT COMPANY OF NIGERIA LIMITED.**

JOINT INVESTIGATION REPORT FOR INCIDENT NO: 1230972 JIV report S/N: 00101

1. Spill incident Number: 1230972 2. Type of incident\* OIL SPILL  
 3. Name of Location 10" DIEBU CREEK - NUNI RIVER PIPELINE  
 4. Name of nearest community EKOWE 5. State: BAYELSA 6. LGA SOUTHERN IJAW  
 7. Type of Production facility/Installation OIL PIPELINE Asset owner/District PIPELINE

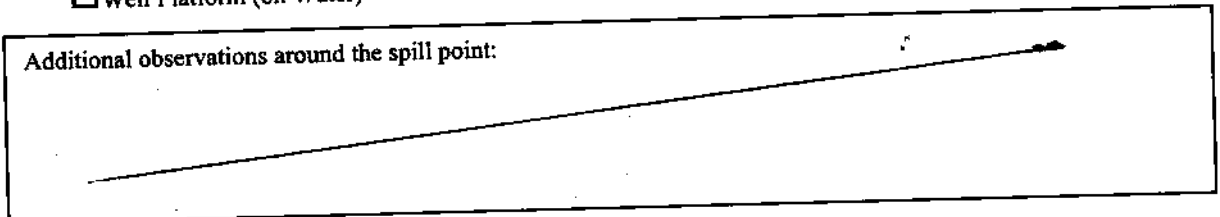
Additional observations around the spill point:

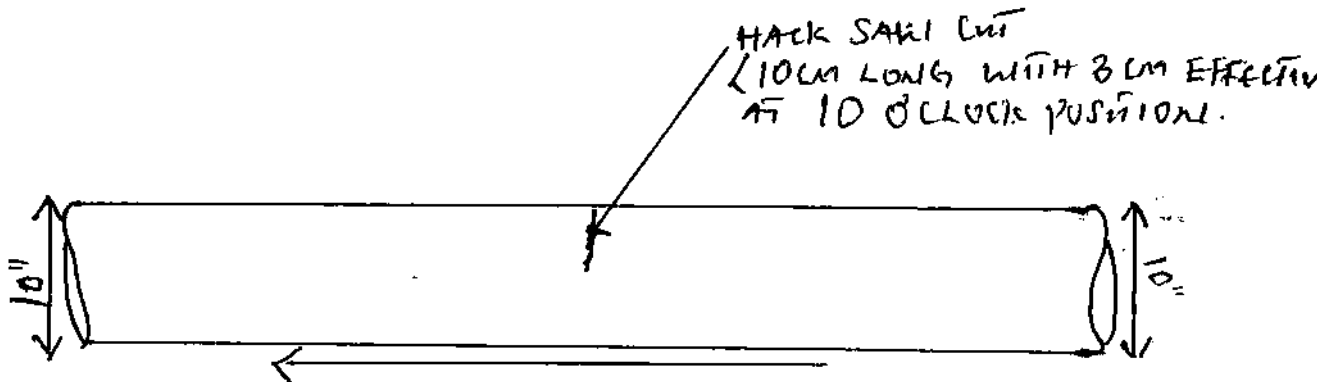
SECTION OF 10" DIEBU CREEK - NUNI RIVER PIPELINE AT EKOWI  
SHOWING POSITION OF HACK SAW CUT AT 10 O'CLOCK POSITION.

REPAIR WORK WAS DONE BY CLAMPING.
