THE SHELL PETROLEUM DEVELOPMENT COMPANY OF NIGERIA LIMITED.

JOINT INVESTIGATION REPORT FOR INCIDENT NO: 1300603 JIV report S/N: 00628

1. Spill incident Number: 1300603 2. Type of incident* OIL SPILL
3. Name of Location 6" YOKRI MANIFOLD - 8 TEST FLOWLINE
4. Name of nearest community YOKRI 5. State: DELTA 6. LGA BURUTU
7. Type of Production facility/Installation FLOWLINE 8. Asset owner/District SWAMP WEST / YOKRI

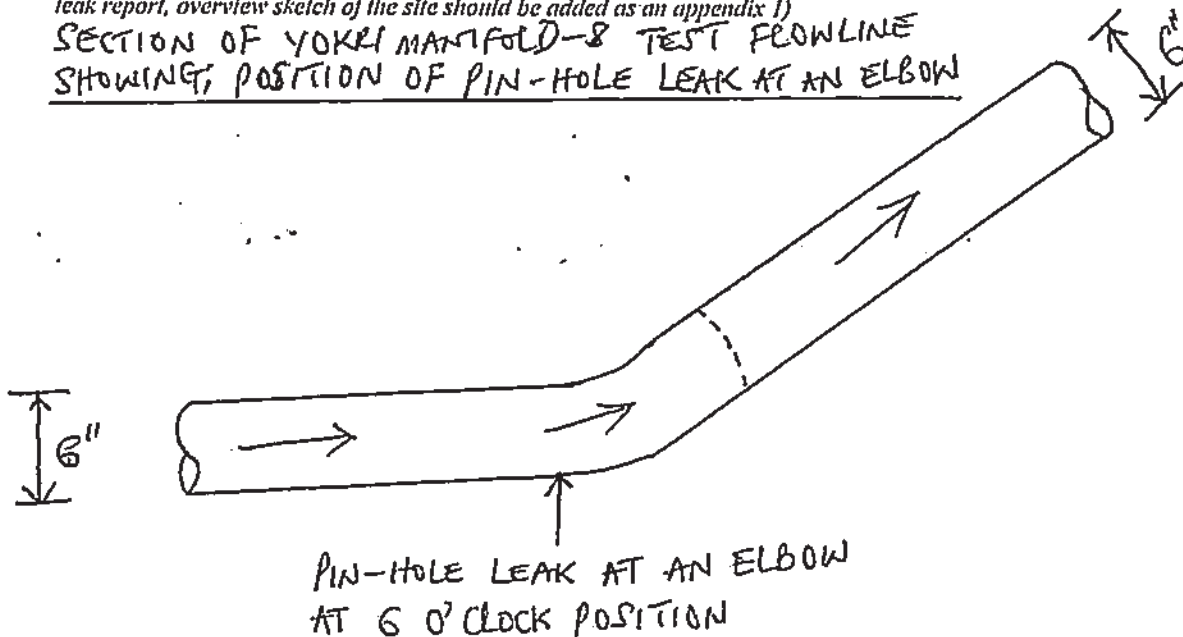
Additional observations around the spill point: UPON EXCAVATION, THE JIT OBSERVED A PIN-HOLE AT AN ELBOW ON THE 6" MANIFOLD-8 TEST FLOWLINE AT 6 O'CLOCK POSITION.

| <input checked="" type="checkbox"/> Corrosion (PIN-HOLE) | <input type="checkbox"/> Saver-pit over flow, | <input type="checkbox"/> Surge vessel overflow, | |

SECTION OF YOKRI MANIFOLD-8 TEST FLOWLINE
SHOWING POSITION OF PIN-HOLE LEAK AT AN ELBOW

PIN-HOLE LEAK AT AN ELBOW
AT 6 O'CLOCK POSITION

If yes to item 14, give brief description: REPAIR IS BEING PLANNED BY THE ASSET ENGINEERING TEAM.
