THE SHELL PETROLEUM DEVELOPMENT COMPANY OF NIGERIA LIMITED.

JOINT INVESTIGATION REPORT FOR INCIDENT NO: 936615 JIV report S/N: 0011

1. Spill incident Number: 936615 2. Type of incident* OIL SPILL
 3. Name of Location 4th ANOBA NORTH WEST WELL 1 LANDS FLOWLINE
 4. Name of nearest community BORO 5. State: RIVERS 6. LGA AKUKY-TORU
 7. Type of Production facility/Installation OIL FLOWLINE 8. Asset owner/District NES 2 / SWAMP 2

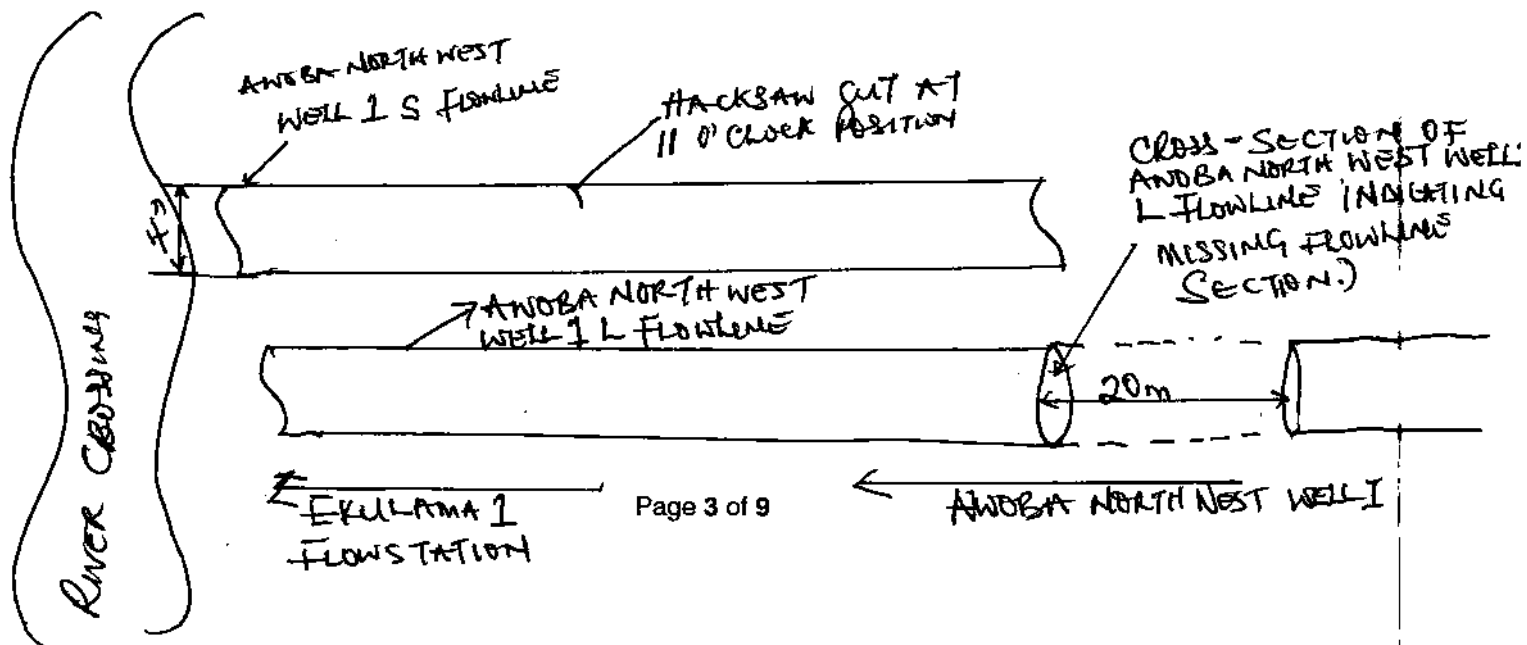
| <input type="checkbox"/> Drilled hole | <input checked="" type="checkbox"/> Hack saw cut | <input type="checkbox"/> Tear (_____), |
| <input type="checkbox"/> Failed Weld-on illegal hot tap valve, | <input type="checkbox"/> Failed Clamp | <input checked="" type="checkbox"/> Missing Pipeline/Flowline |

- Third party interference (Sabotage , crude theft ; Line theft ; Accidental 3rd party damage)
 Operational Others (including Mystery spills) _____

SECTION OF 4" ANOBA NORTH WEST WELL & LAND S FLOWLINE

AT BORD SHOWING MISSING FLOWLINE SEGMENT AND HACKSAW CUT RESPECTIVELY.

A. Joint investigation of the incident site found that there is no residual impact after the initial response and therefore recommend that the site be closed out <input type="checkbox"/>
B. Investigation of the incident site showed that there is residual impact on site requiring further works <input checked="" type="checkbox"/>

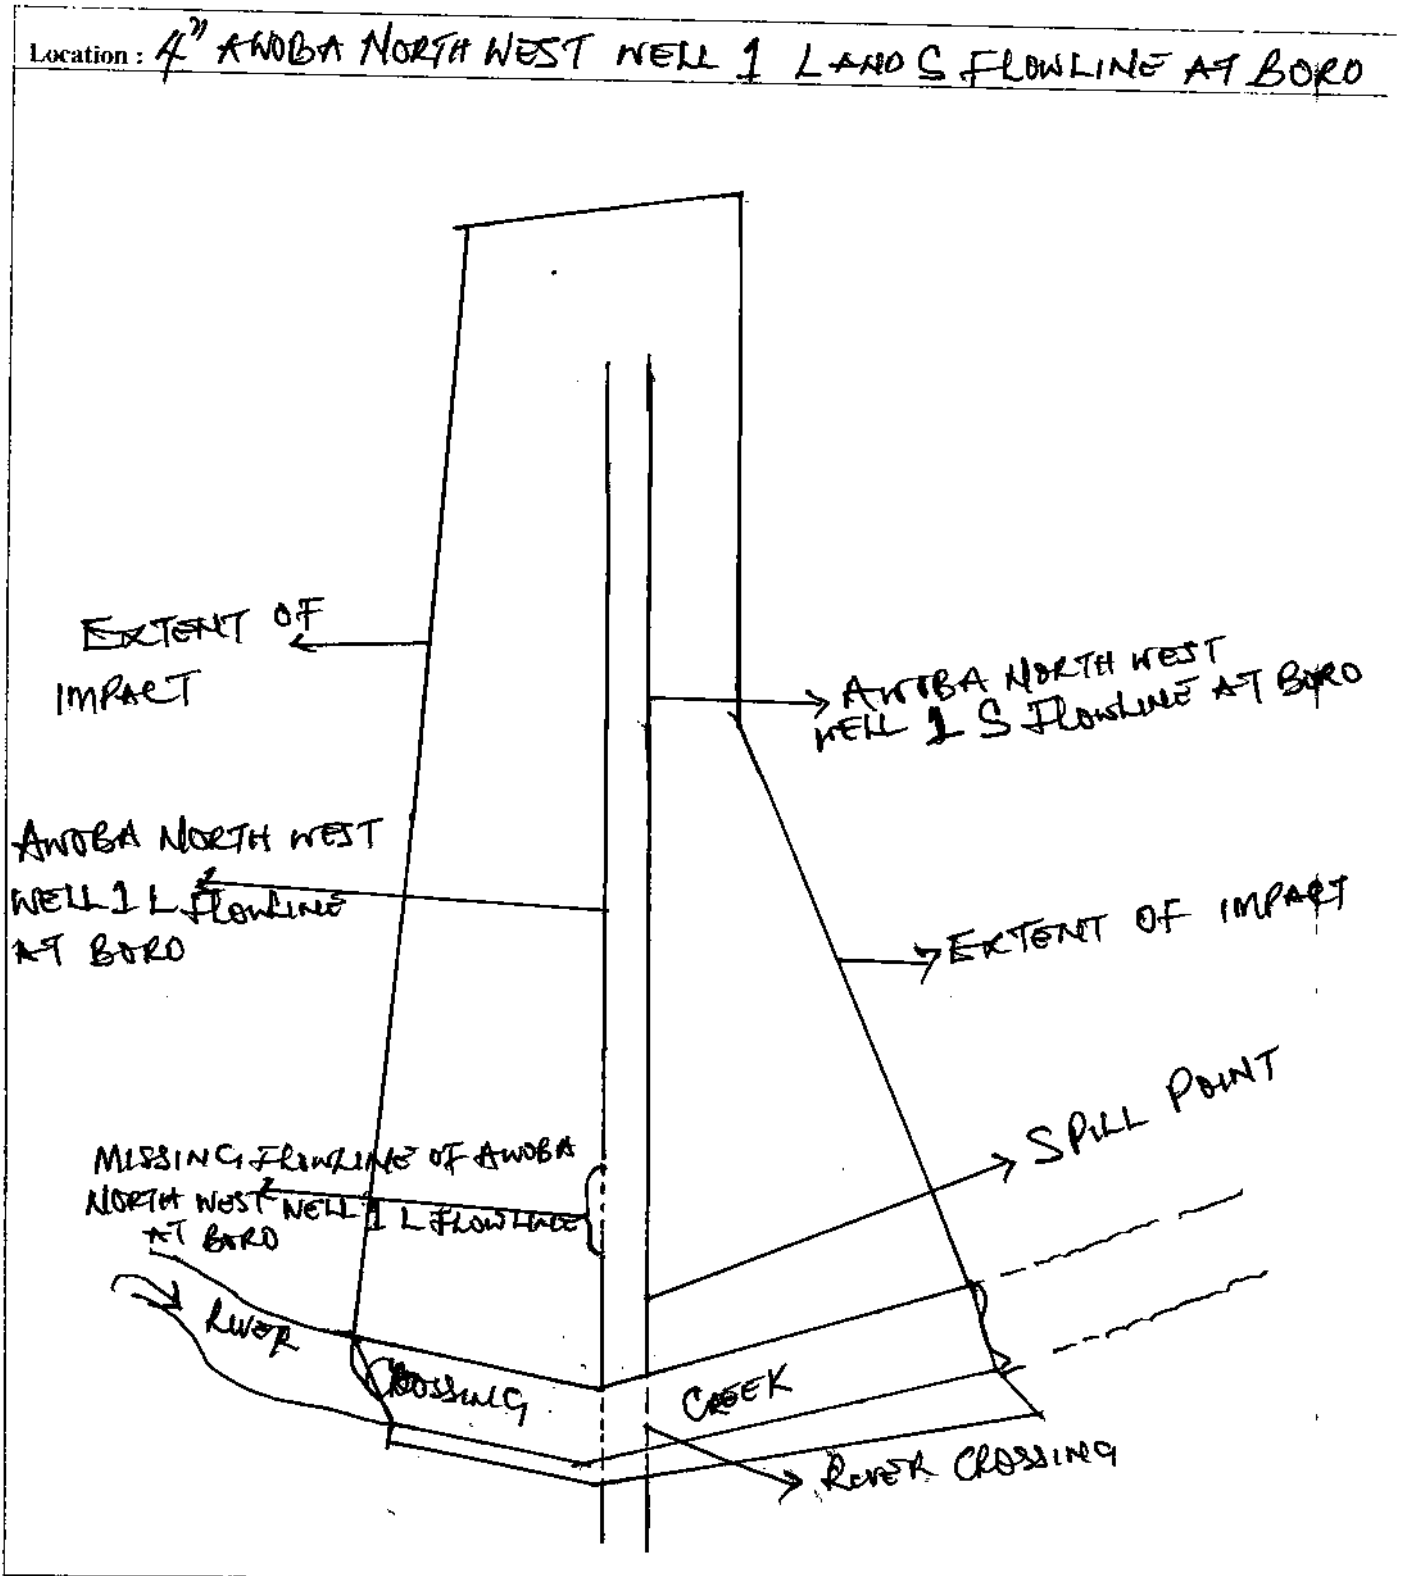
28. Appendix 1: Overview sketch of the site

Location: 4" ANOBA NORTH WEST WELL 1 LAND S FLOWLINE AT BORO
