THE SHELL PETROLEUM DEVELOPMENT COMPANY OF NIGERIA LIMITED.

JOINT INVESTIGATION REPORT FOR INCIDENT NO: 933252 JIV report S/N: 0021

1. Spill incident Number: 933252 2. Type of incident\* OIL SPILL  
 3. Name of Location 18" ASSA-RUMUEKPE PIPELINE  
 4. Name of nearest community ELELE-ALIMINI 5. State: RIVERS 6. LGA EMOHUA  
 7. Type of Production facility/Installation OIL PIPELINE 8. Asset owner/District NPE/EGBEMA

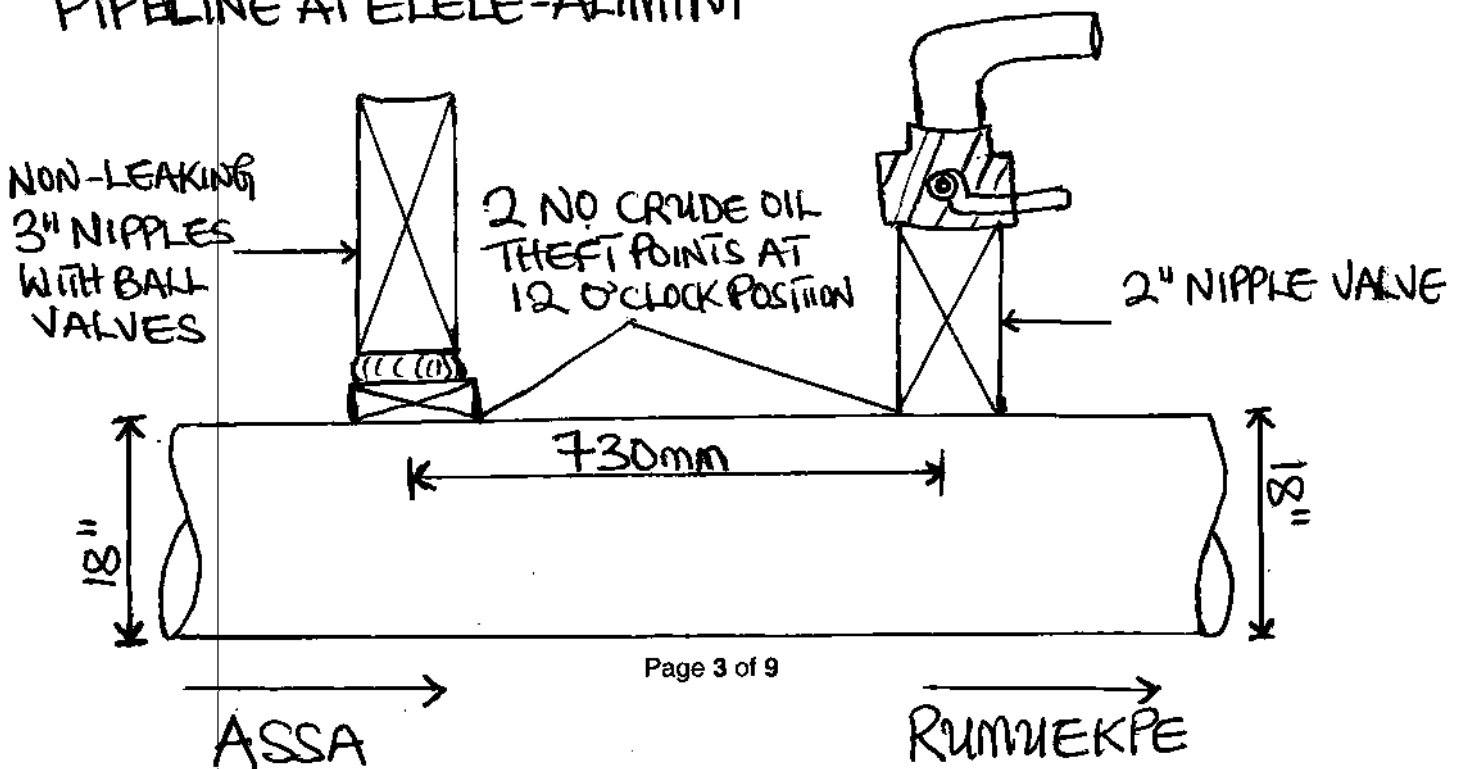
SECTION OF 18" ASSA-RUMUEKPE PIPELINE AT ELELE-ALIMINI

E. GRAPHIC DESCRIPTION OF LEAK POINT (while detail report of the leak point should be contained in the leak report, overview sketch of the site should be added as an appendix 1)

Area Impacted (Light Impact)
