THE SHELL PETROLEUM DEVELOPMENT COMPANY OF NIGERIA LIMITED.

JOINT INVESTIGATION REPORT FOR INCIDENT NO: 924356 JIV report S/N: 0009

1. Spill incident Number: 924356 2. Type of incident* OIL SPILL
 3. Name of Location 10" SANTA BARBARA PIPELINE
 4. Name of nearest community SANTA BARBARA 5. State: BAYELSA 6. LGA NEMBE
 7. Type of Production facility/Installation OIL PIPELINE 8. Asset owner/District NPE / NEMBE

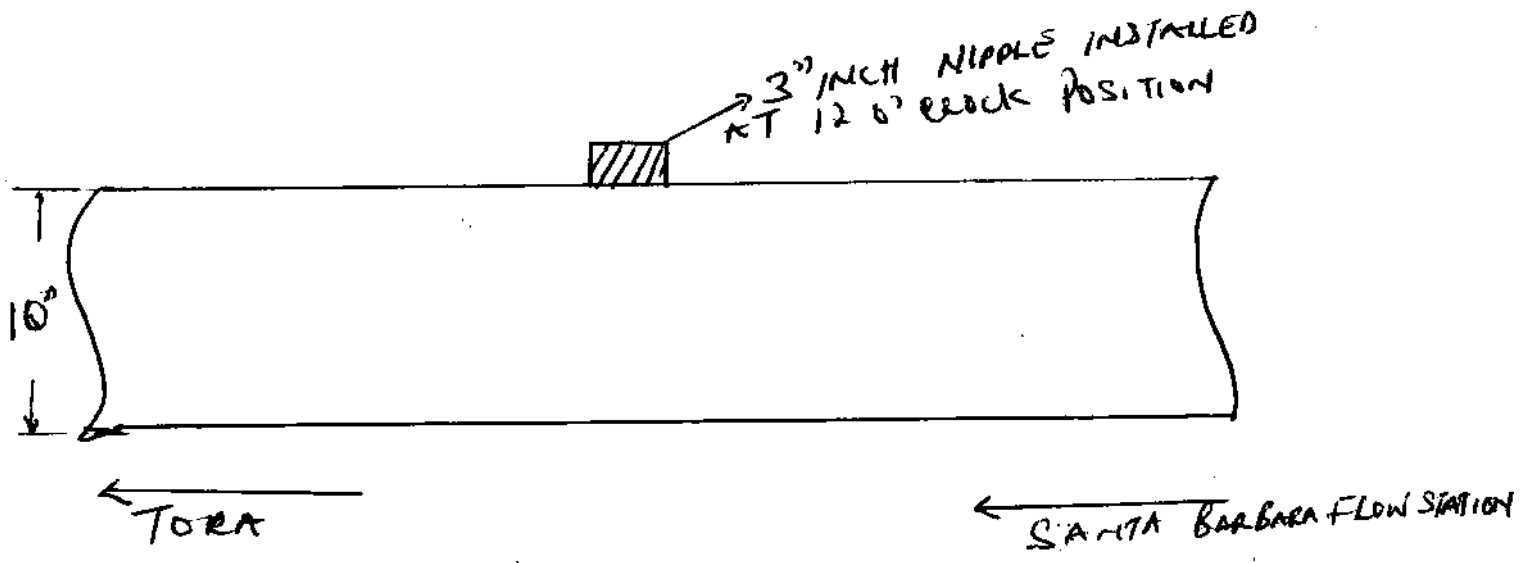
E. GRAPHIC DESCRIPTION OF LEAK POINT (while detail report of the leak point should be contained in the leak report, overview sketch of the site should be added as an appendix 1)

| <input checked="" type="checkbox"/> Failed Weld-on illegal hot tap valve, | <input type="checkbox"/> Failed Clamp | <input type="checkbox"/> Missing Pipeline/Flowline |
| <input checked="" type="checkbox"/> Crude oil theft (illegal bunkering) point, | | <input type="checkbox"/> Third party tampering with Clamp |

A SECTION OF 10" SANTA BARBARA PIPELINE AT SANTA BARBARA SHOWING ILLEGAL BUNKERING POINT AT 12 O' CLOCK POSITION
