THE SHELL PETROLEUM DEVELOPMENT COMPANY OF NIGERIA LIMITED.

JOINT INVESTIGATION REPORT FOR INCIDENT NO: 918668 JIV report S/N: 0001

1. Spill incident Number: 918668 2. Type of incident* OIL SPILL
 3. Name of Location CANTHORNE CHANNEL & WELL SOS FLOWLINE
 4. Name of nearest community OKPO-AMA 5. State: RIVERS 6. LGA DELGOMA
 7. Type of Production facility/Installation FLOWLINE 8. Asset owner/District NESI / SWAMP

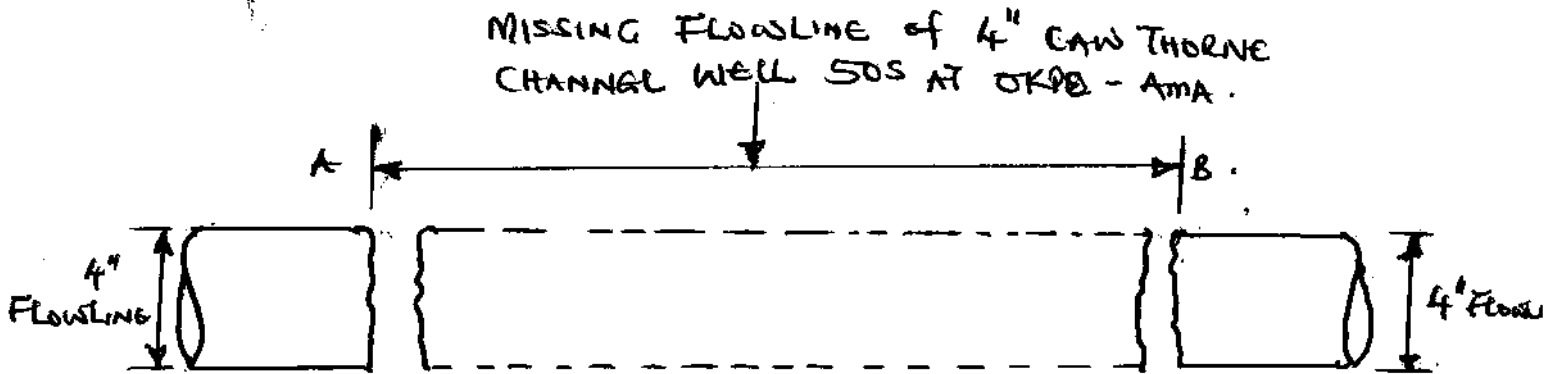
| <input type="checkbox"/> Failed Weld-on illegal hot tap valve, | <input type="checkbox"/> Failed Clamp | <input checked="" type="checkbox"/> Missing Pipeline/Flowline |

- Third party interference (Sabotage ; crude theft ; Line theft ; Accidental 3rd party damage
 Operational Others (including Mystery spills) _____

SECTION OF CAW THORNE CHANNEL | WELL SOS FLOWLINE AT OKPO-AMA SHOWING THE POSITION OF MISSING FLOWLINE.

A. Joint investigation of the incident site found that there is no residual impact after the initial response and therefore recommend that the site be closed out <input type="checkbox"/>
B. Investigation of the incident site showed that there is residual impact on site requiring further works <input checked="" type="checkbox"/>

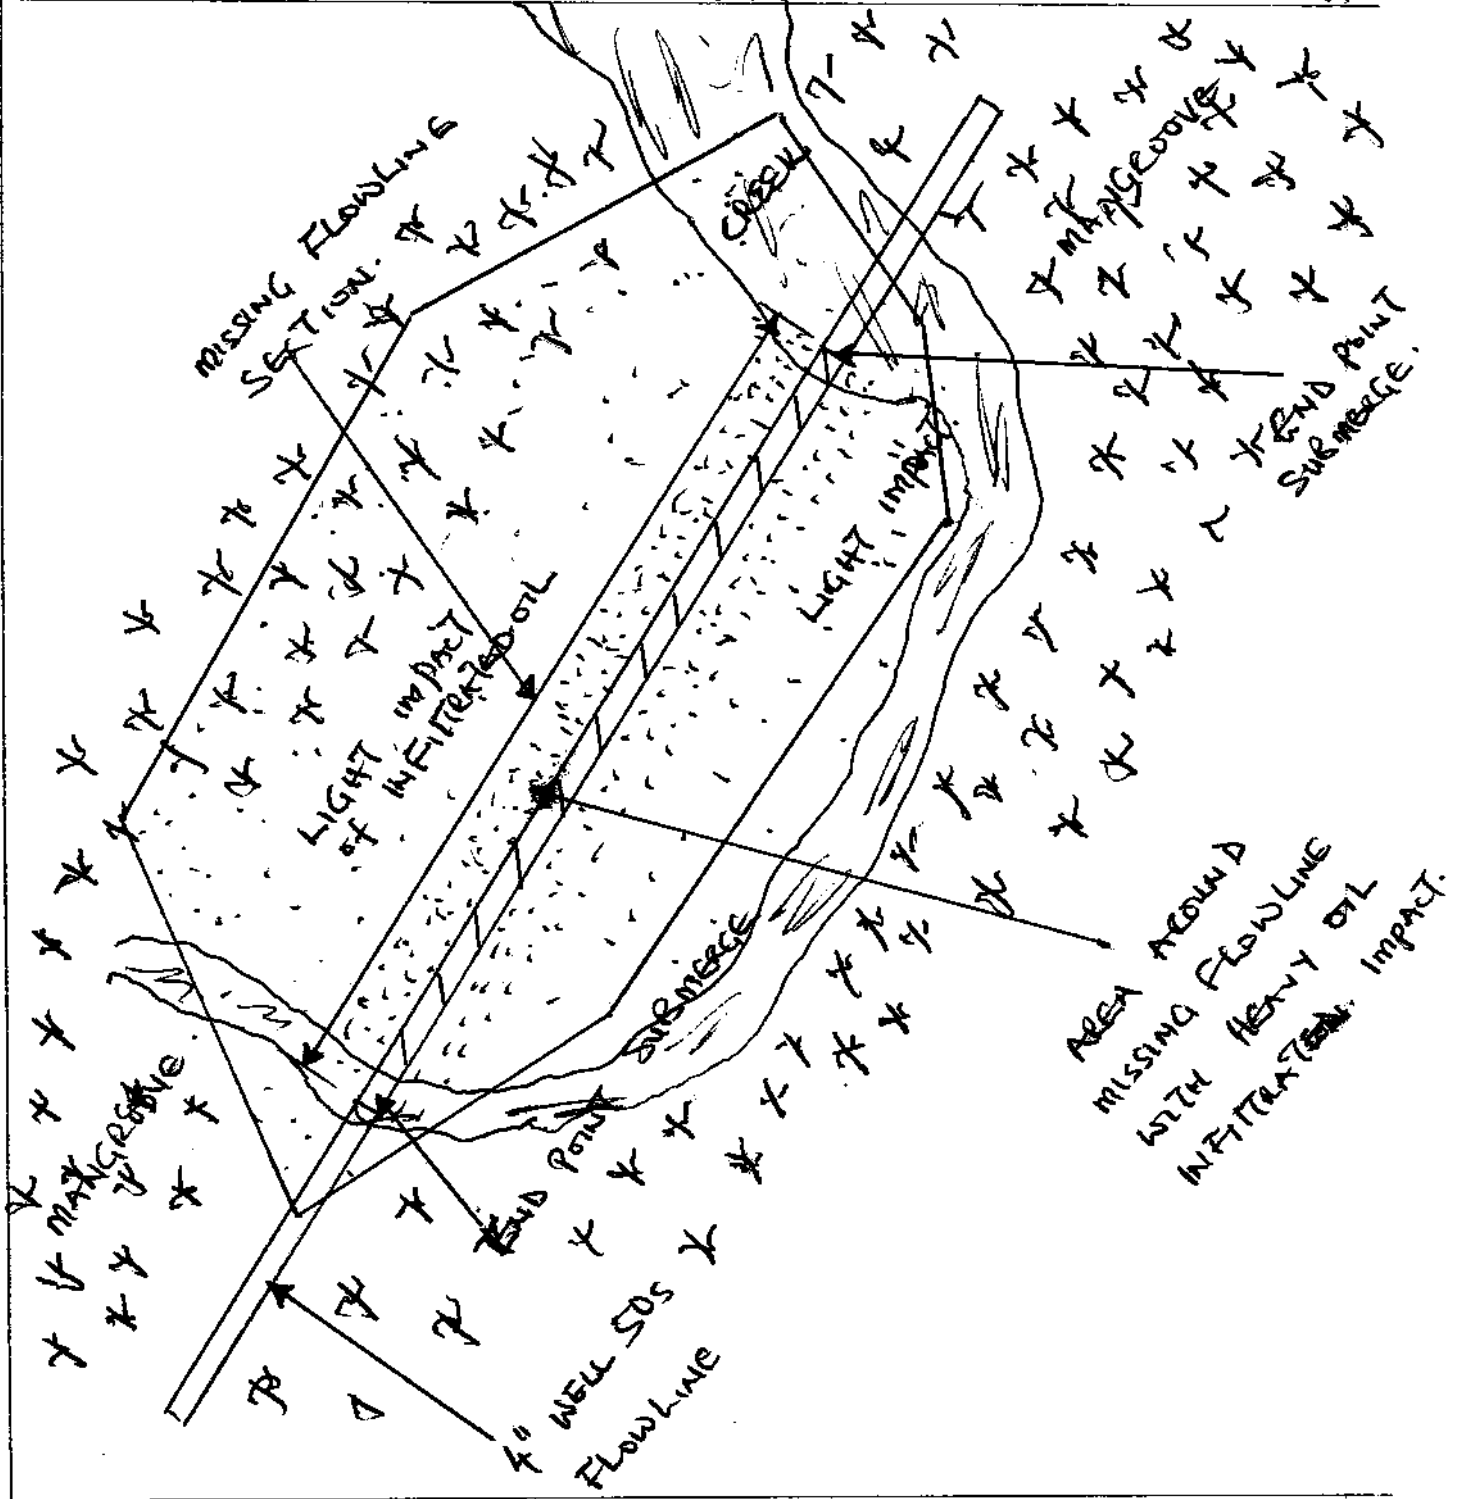
28. Appendix 1: Overview sketch of the site

Location: CANTHORNE CHANNEL 1 WELL 50 FLOWLINE AT OKPO-ANA
