THE SHELL PETROLEUM DEVELOPMENT COMPANY OF NIGERIA LIMITED.

JOINT INVESTIGATION REPORT FOR INCIDENT NO: 1018005 JIV report SN: 0174

1. Spill incident Number: 2013_1018005 2. Type of incident* OIL SPILL
 3. Name of Location 6" CAWTHORNE CITANNEL III WELL 4S
 4. Name of nearest community KRAKRAMA 5. State: RIVERS 6. LGA DEGEMA
 7. Type of Production facility/Installation FLOWLINE 8. Asset owner/District NES1

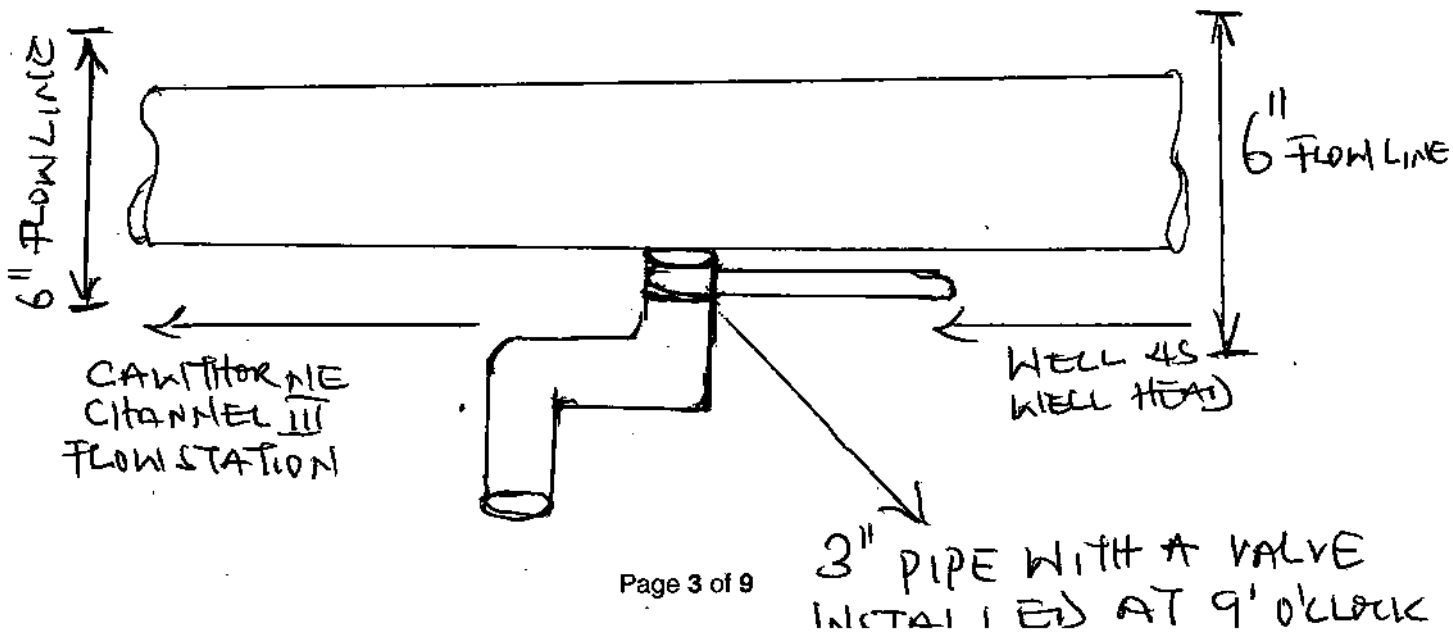
| <input checked="" type="checkbox"/> Crude oil theft (illegal bunkering) point, | | <input type="checkbox"/> Third party tampering with Clamp |

- Third party interference (Sabotage ; crude theft ; Line theft ; Accidental 3rd party damage
 Operational Others (including Mystery spills) _____

A SECTION OF 6" CAWTHORNE CHANNEL III FLOW LINE SHOWING THE ILLEGAL BUNKER POINT AT NINE (9) O'CLOCK POSITION
