# JOINT INVESTIGATION REPORT

INCIDENT NO: 1884942 JIV report S/N 0000004

1. Spill incident Number: 1884942 2. Type of incident\* OIL SPILL  
3. Name of Location 4" ADIBAWA WELL 25. FLOWLINE  
4. Name of nearest community EDAGBERI 5. State: RIVERS 6. LGA AHOADA WEST  
7. Type of Production facility/Installation OIL FLOWLINE  
8. Asset owner/District SPDC / CENTRAL HUB.

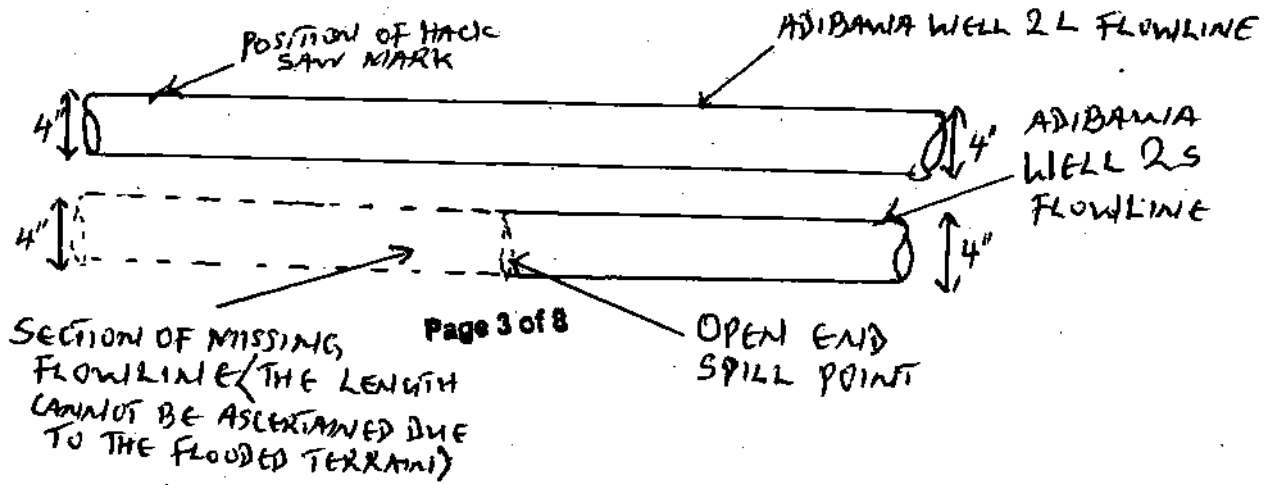
ON ARRIVAL AT SITE, JOINT INVESTIGATION TEAM OBSERVED MISSING FLOWLINE AND HACK SAW MARK WAS ALSO OBSERVED ON 4" ADIBAWA WELL 22 FLOWLINE ON FLOODED TERRAIN.

SECTION OF 4" ADIBAWIA WELL 2S FLOWLINE AT EDAGBERI BETER LAND SHOWING POSITION OF MISSING FLOWLINE.

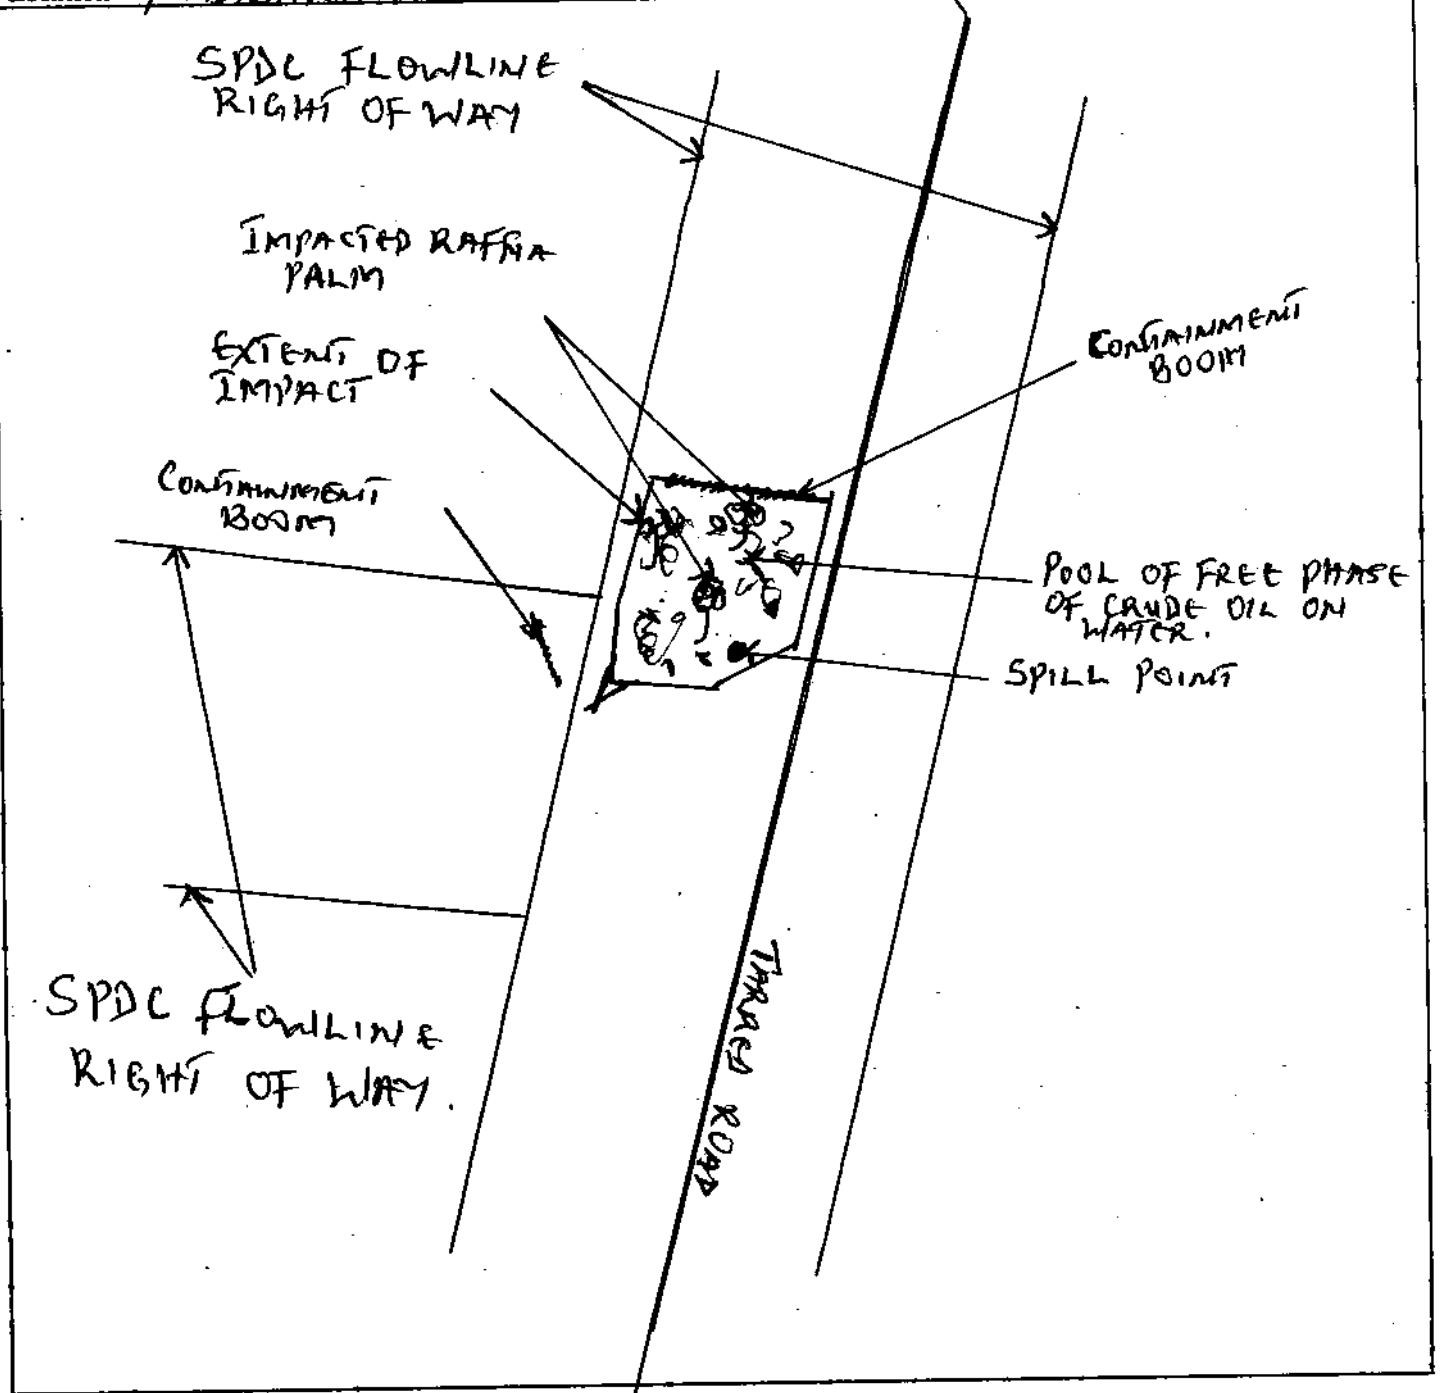
f. Appendix 1: Overview sketch of the site

Location: 4" ADIBAWA WELL 2'S FLOWLINE AT EDAGBERI BEERLAND
